Site Name: Warwick Tower
Structure Type: Guyed Tower
Structure Height: 250'
Make: Valmont
ASR: KD48X180
Tower Owner: Government of Bermuda
Address: Middle Road
Parish: Warwick
Latitude: 32.256385
Longitude: -64.833335
Date of Visit: 7/13/2022
Employees on Site: Angie Shyrigh
Ben Shyrigh

Proventus Structural Services, LLC

Purpose of this Site Visit

To fulfill the inspection requirements set forth in the TIA/EIA222-H, Annex J.1 standard for Maintenance and Condition Assessment of communication structures.

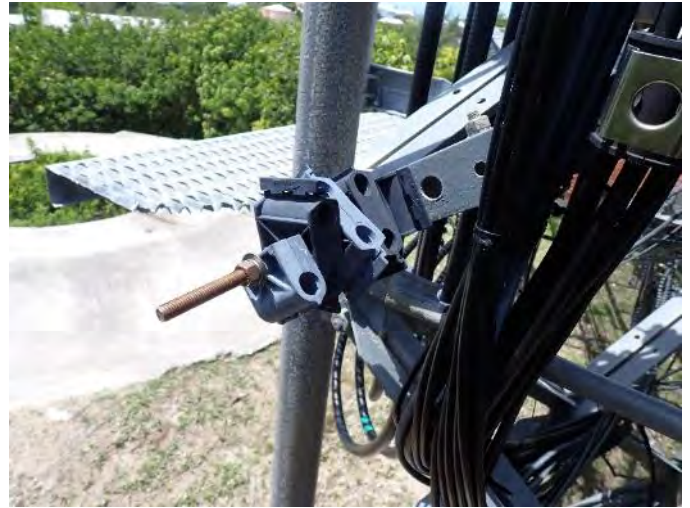
Abandoned feedline hangers
Photo File 26

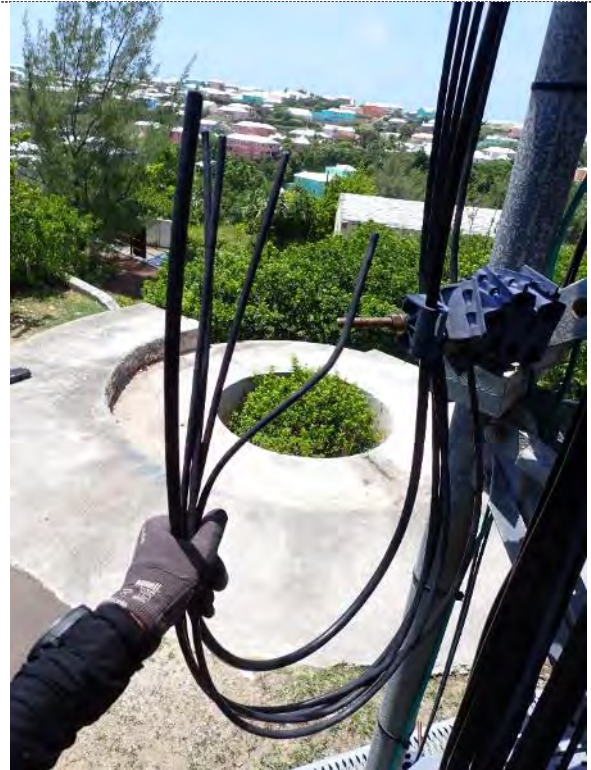
Abandoned feedlines
Photo File 32

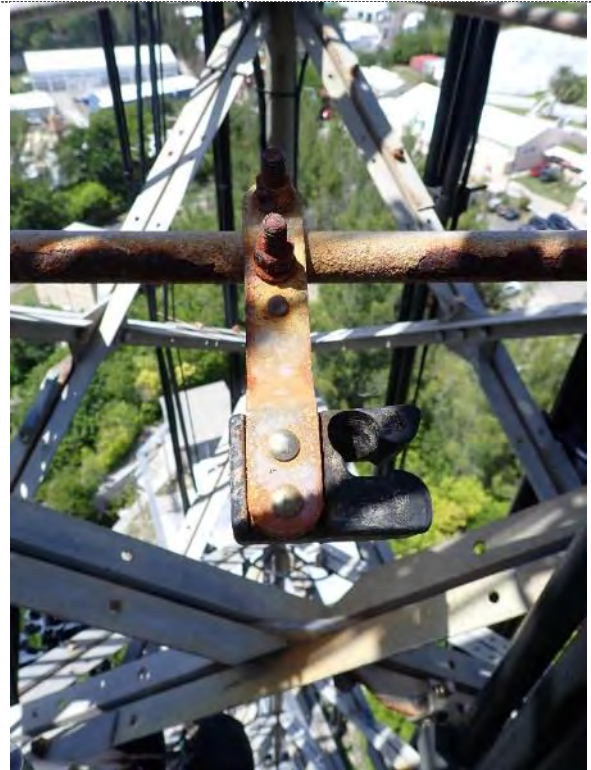
Safety cable keeper condition
Photo File 72

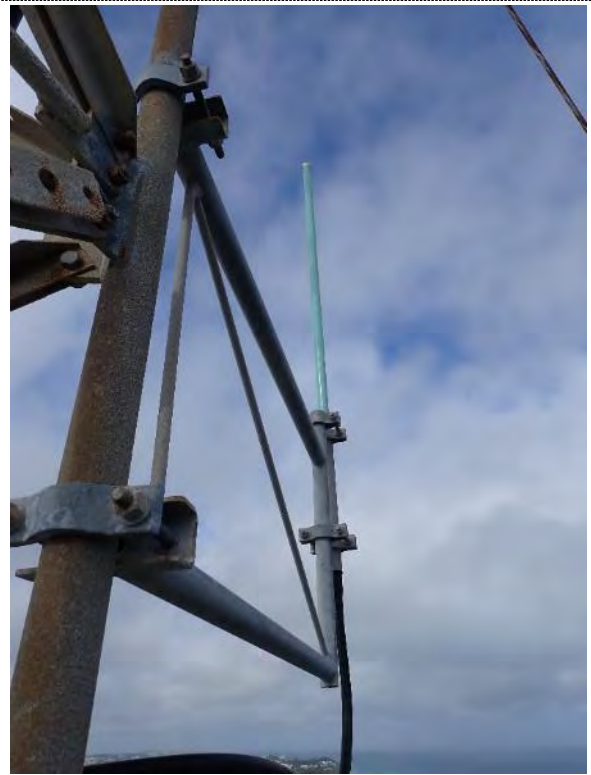
Antenna #92
Photo File 230

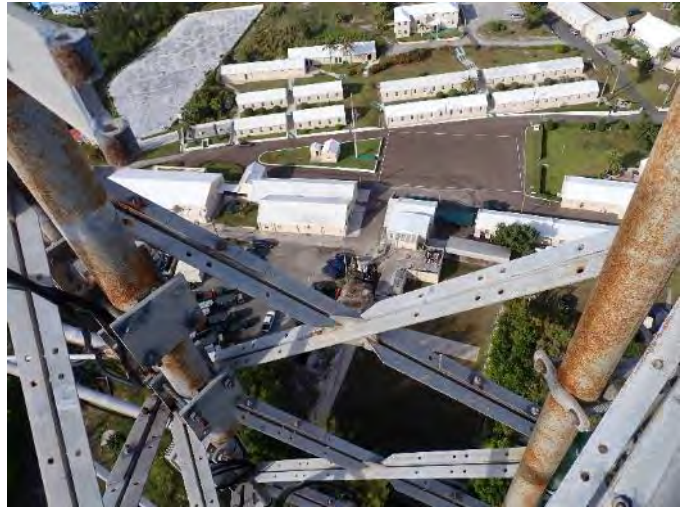
Elevation	Location	Description	Recommendation	Priority
248'	AB and CA Faces	Horizontal members are not installed on these faces.	Consult the engineer of record to determine if these horizontals require to be installed.	To be scheduled

Horizontal missing from top of tower
Photo File 258

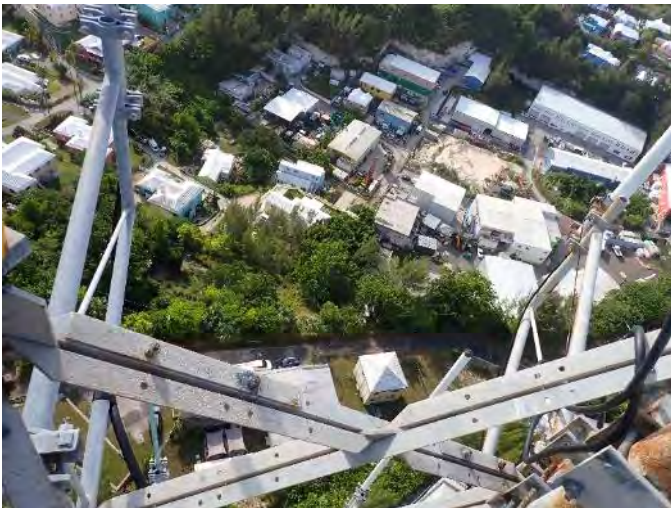
Horizontal missing from top of tower
Photo File 259

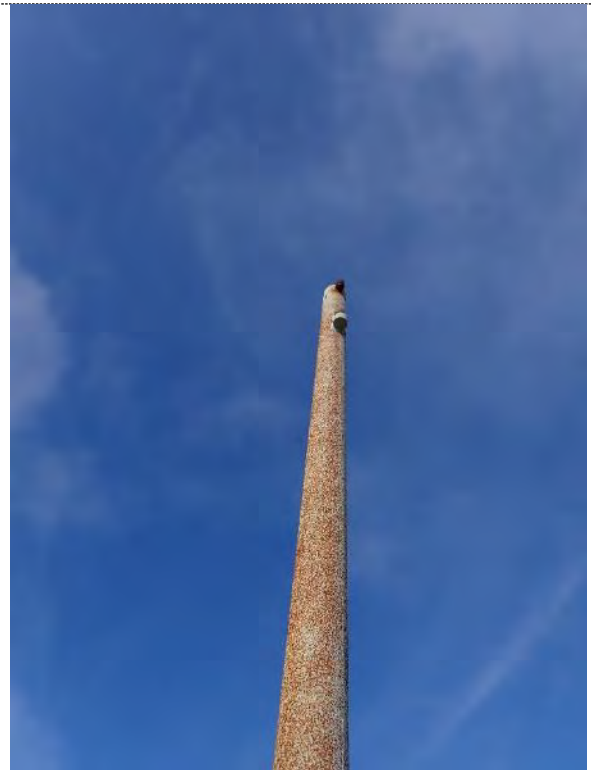
Elevation	Location	Description	Recommendation	Priority
255'	BC Leg	A lightning rod extension is present; however a lightning rod is not. At the time of the 2013 inspection the lightning rod was observed to be present.	Install a lightning rod.	To be scheduled

Lightning rod extension, no lightning rod
Photo File 260

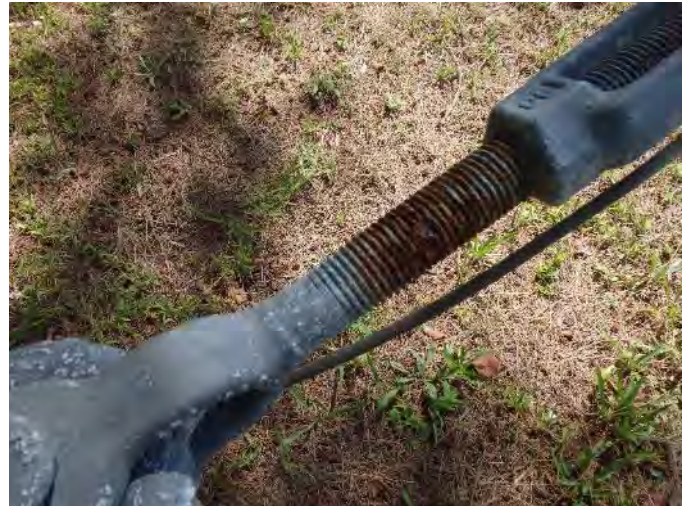
Anchor B hardware corrosion
Photo File 294

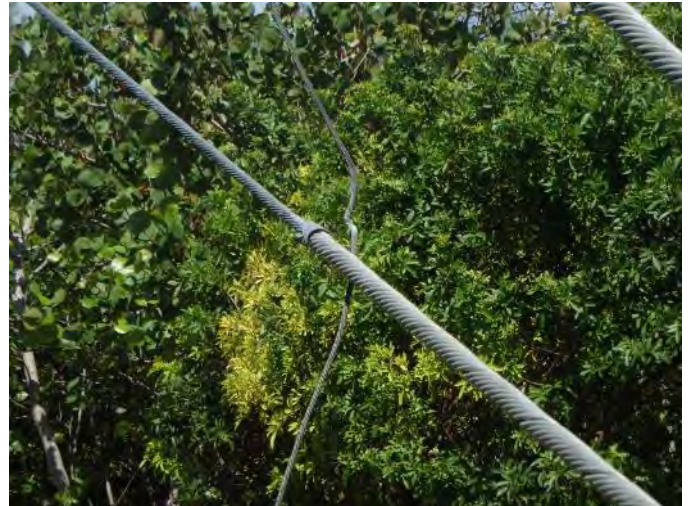
C 1 missing ground clamp
Photo File 322

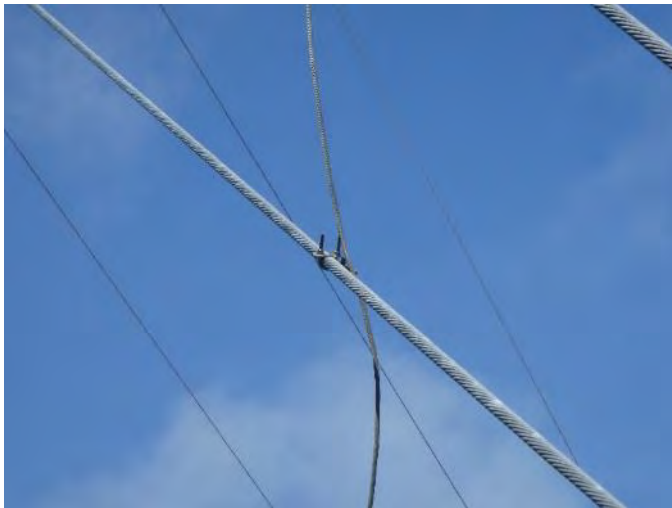
C 3 disconnected ground
Photo File 323

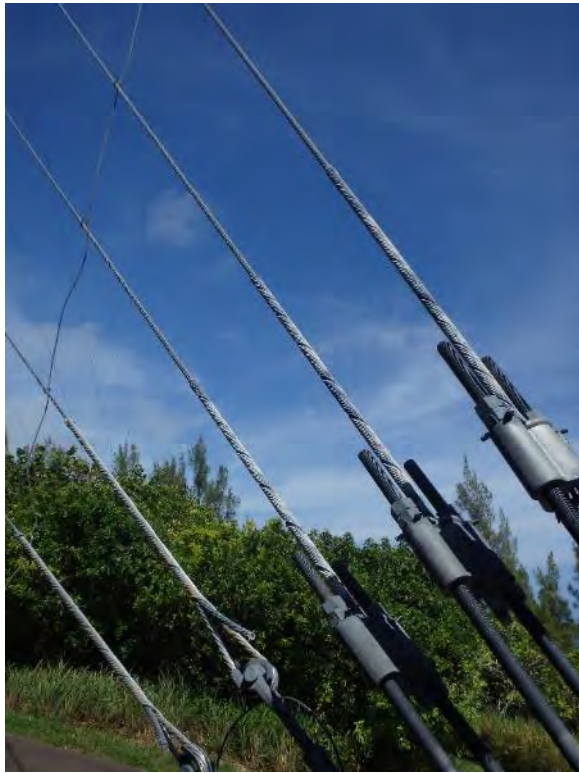
Ground	Varies	End sleeves are not present on the preformed ends of the 1" Ø guy wires. Mild "bird caging" (flaring of strand ends) was observed.	It is recommended end sleeves be installed to protect the ends of the guy grips. (9) 1" end sleeves are required to correct.	To be scheduled
0'	All anchors	The guy anchors are not secured with fencing or bollards.	It is recommended that the guy anchors be secured against vandalism by fencing or secured against farm equipment impacts with bollards.	To be scheduled
Ground	Varies	The guy ground wire has become detached from the wires at the following locations: <ul style="list-style-type: none"> Anchor A, levels 3 and 4 Anchor B, levels 3 and 5 Anchor C, levels 1, 3 and 4 	Reconnect the ground leads.	To be scheduled
Ground	Anchor B	The fan plate is not in alignment with the tower. It points approximately 3 degrees to the left as standing behind fan plate looking at the tower.	It is recommended the engineer of record be consulted to determine corrective course of action. Photo document the condition on a regular basis to determine if movement is occurring.	To be scheduled, monitor

Anchor C missing end sleeves
Photo File 325

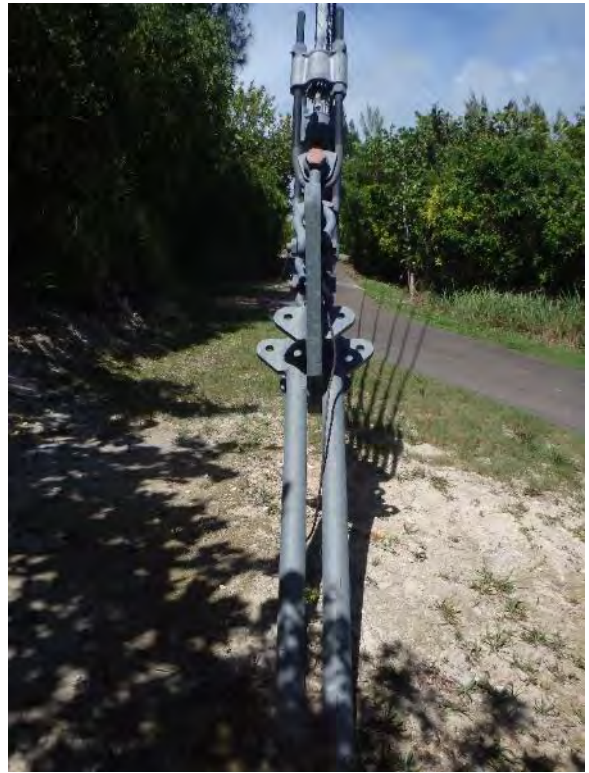
Anchor C fan plate out of alignment
Photo File 326
