# Heritage Wharf & Kings Wharf: Cruise Ship Docking Facilities Improvements

Cathodic Protection Performance Specification

March 2013

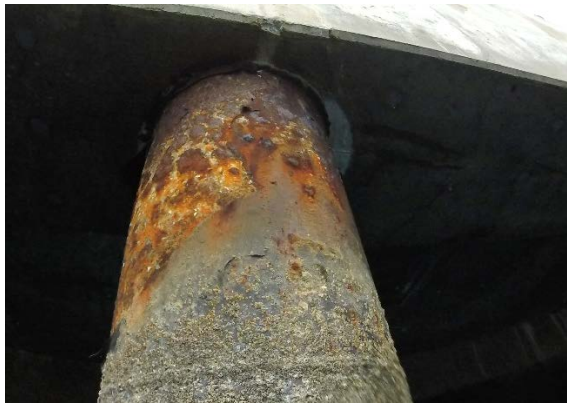
Fig. 1j – Compromised protective coating and corrosion in splash zone

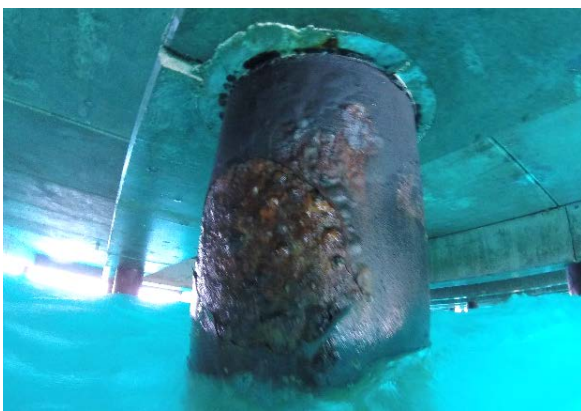
Fig. 1t - Typical example of corrosion of exposed steel in splash zone

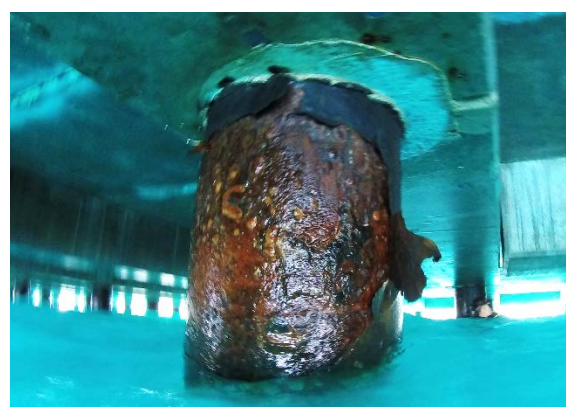
Fig. 1u Compromised protective coating and corrosion

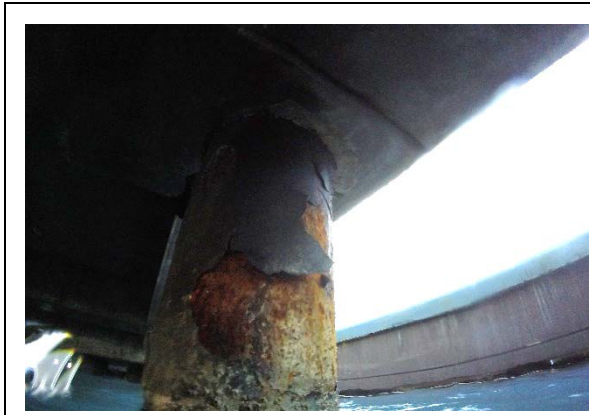
Fig. 1v – Coating peeling away

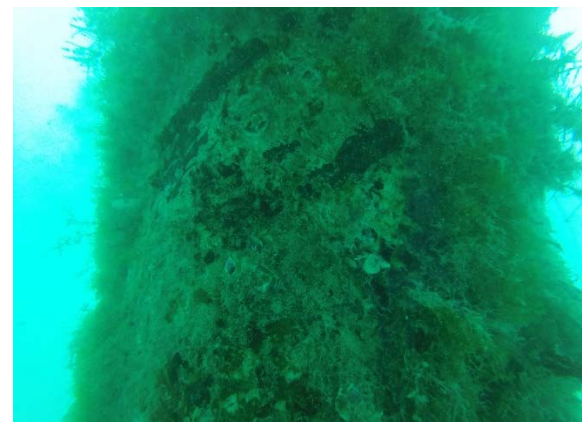
Fig. 2d 3<sup>rd</sup> Level 2 inspection, Pile 165, protective layer not present

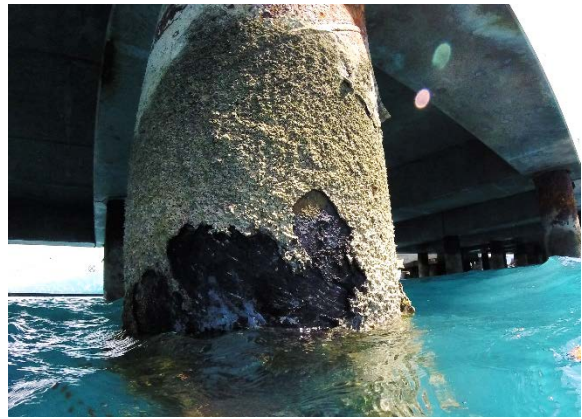
Fig. 2f – Extreme example of corrosion in splash zone

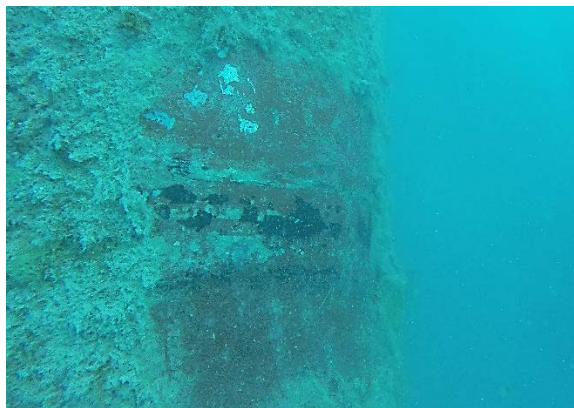
Fig. 3e - 1<sup>st</sup> Level 2 inspection, HMD6, very minor surface corrosion

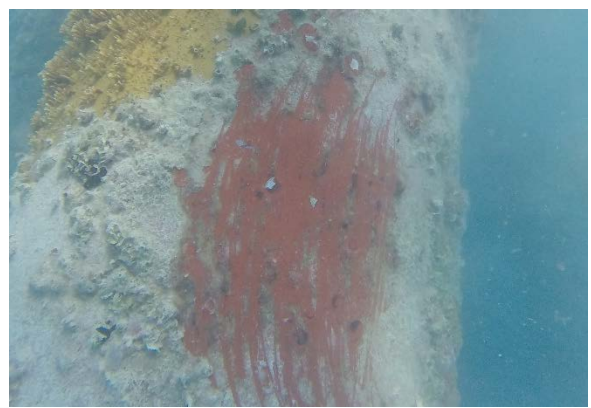
almost no signs of corrosion at this stage (Fig. 3f, 3w). There are large anodes installed on these piles and it is evident they are working effectively by the white compound building on the anodes surface. The anodes all exhibited some level of corrosion, some were noticeably more corroded than others indicating a differential rate of electrolysis across the structure.

Fig. 3f - 2<sup>nd</sup> Level 2 inspection, HMD6

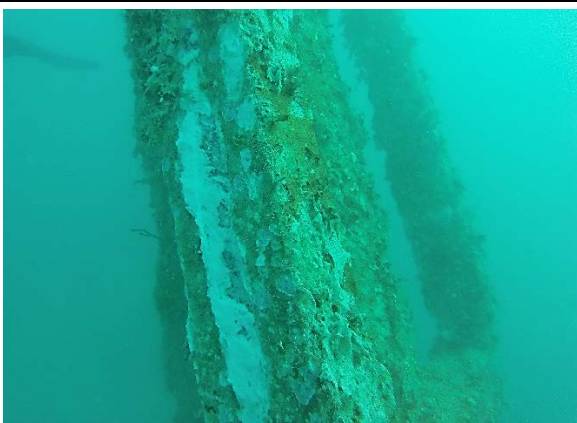
Fig. 3i - Anode of walkway dolphin, more corroded than others

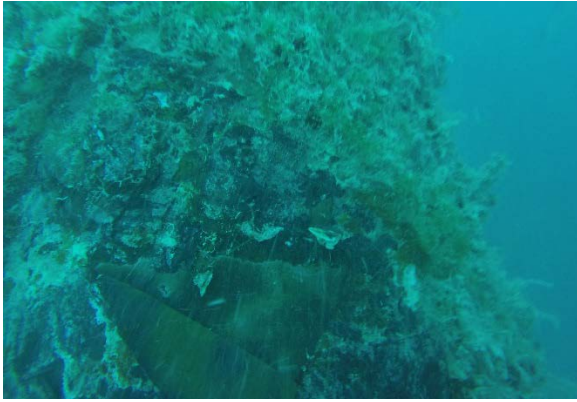
Fig. 3s - Protective coating peeling away on H-BD2, minimal corrosion

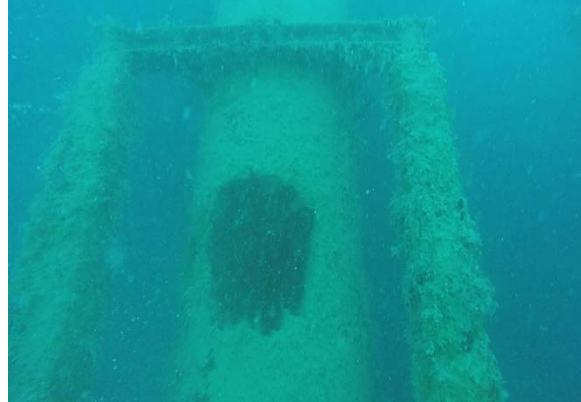
<ul style="list-style-type: none"><li>• Cathodic protection appears to be working effectively</li></ul>	
3t-3w	New Breasting Dolphins	H-BD3 & H-BD4	<ul style="list-style-type: none"><li>• Very good condition overall, compared to original structure.</li><li>• Very limited levels of corrosion observed on pile surface</li><li>• Red surface coating on piles still in good condition</li><li>• Cathodic protection appears to be working effectively</li></ul>	3

Fig. 3t – Anode and Level 2 inspection on H-BD3

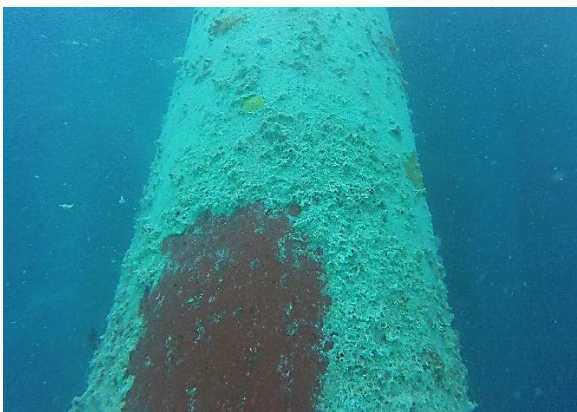
Fig. 3w - 2<sup>nd</sup> Level 2 inspection, H-BD3, minimal corrosion of pile

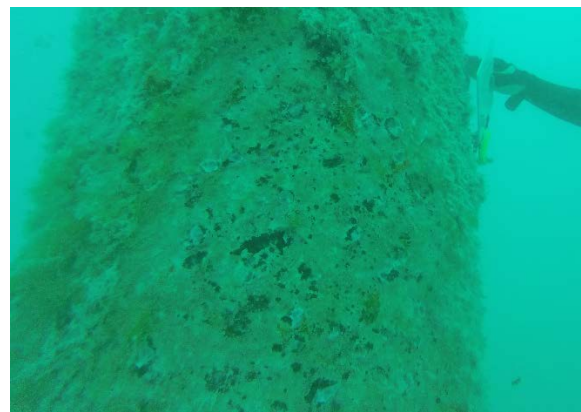
Fig. 3x - Level 2 inspection at base, H-BD1, no protective layer present

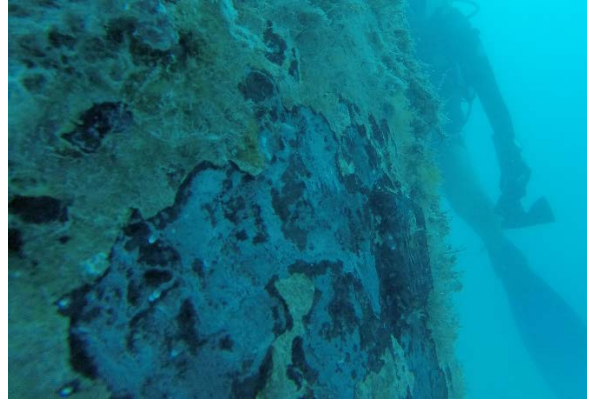
Fig. 3z - Level 2 inspection at base, H-MD2 – surface pitting and corrosion

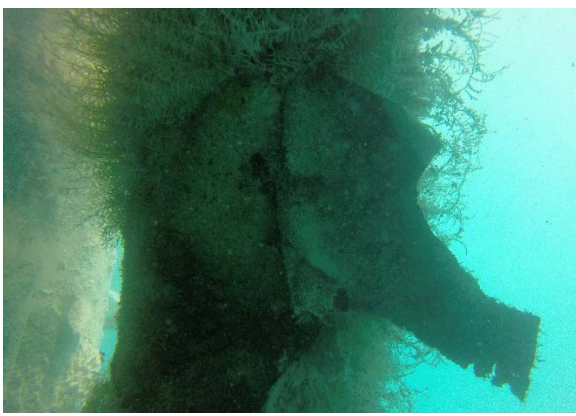
Fig. 3gg - Protective layer peeling away on H-MD2

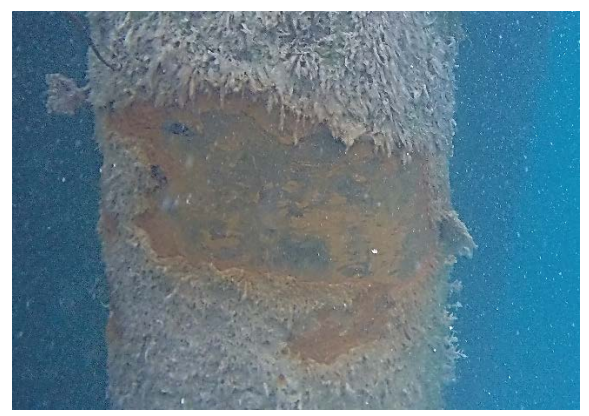
Fig. 3hh - Band of extreme corrosion, H-MD2

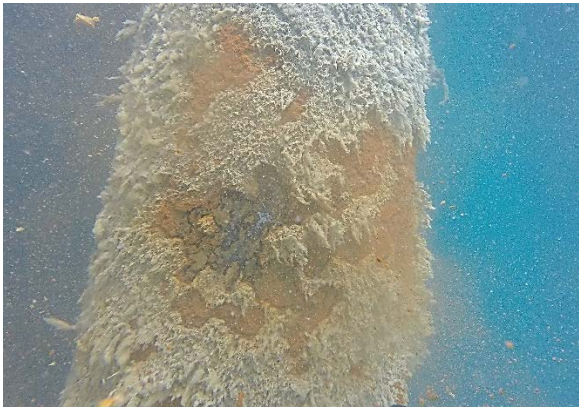
Fig. 3cc - Extensive ALWC, H-MD2

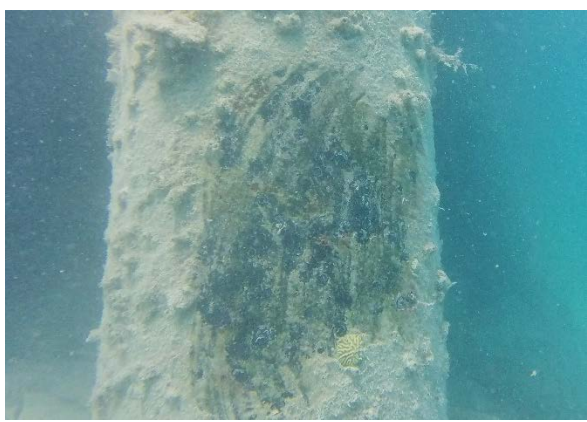
Fig. 3ff - Level 2 inspection, H-MD1, protective coating still intact.
