Repairs to Clarence Cove Landing Stage

Bermuda

Annex D Reference Documents

Project No. 61-57-50

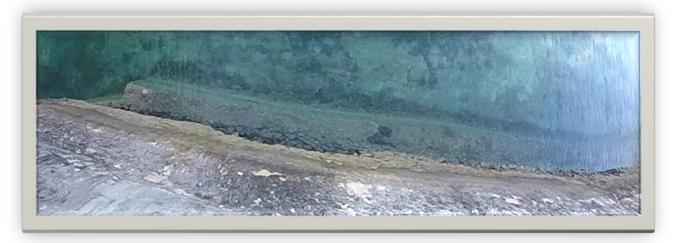
Figure 1: South East edge of landing located at Clarence Cove. View from top of landing.

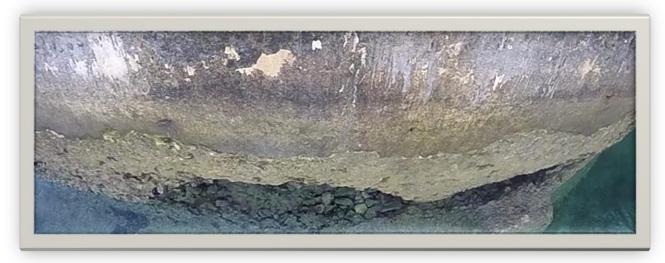
Figure 2: South Face view of South East edge of the landing showing erosion of the concrete from the bottom of landing above the footing to be repaired.

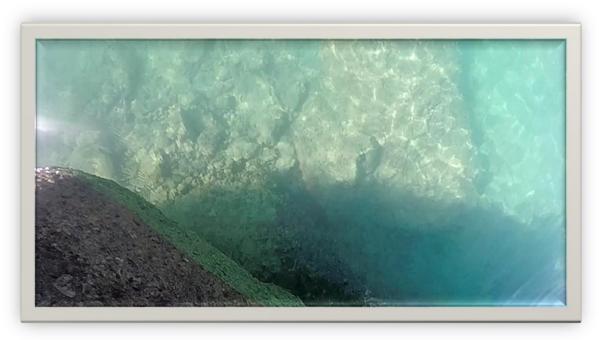
Figure 3: Boulder and rubble in water to be removed from East end of landing.

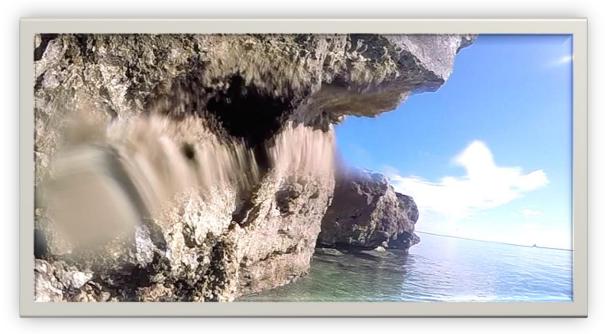
Figure 4: Eastern Face showing erosion of concrete below front edge of landing.

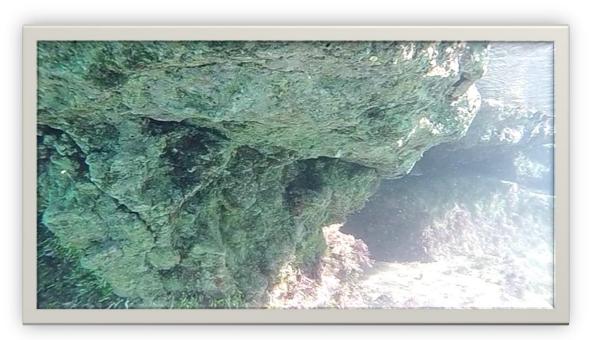
Figure 5: View from beneath water from Eastern Face of landing.

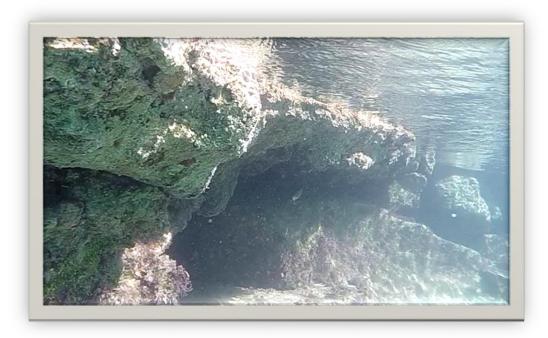
Figure 6: Eastern Face view of a cavity formed beneath the water.

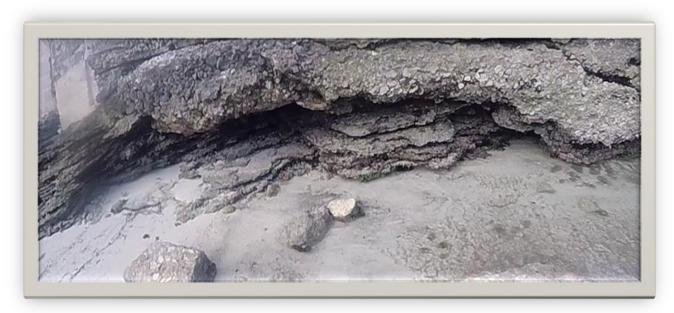
Figure 7: South Face showing undermining of the concrete slab.

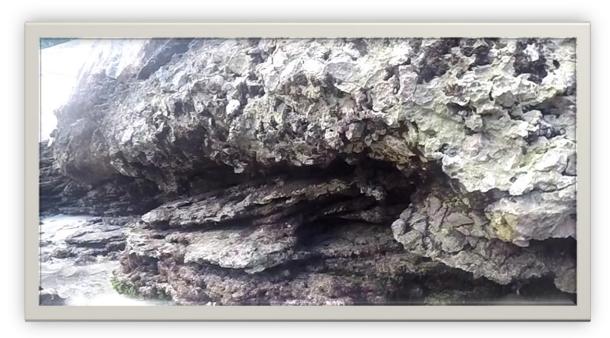
Figure 8: South Face enhanced view of undermining.

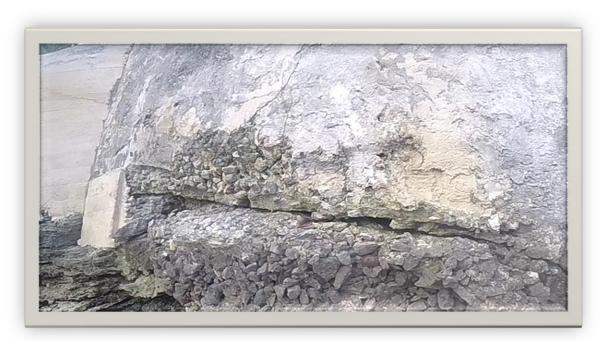
Figure 9: South Face showing a horizontal crack in the concrete slab and exposed aggregate.

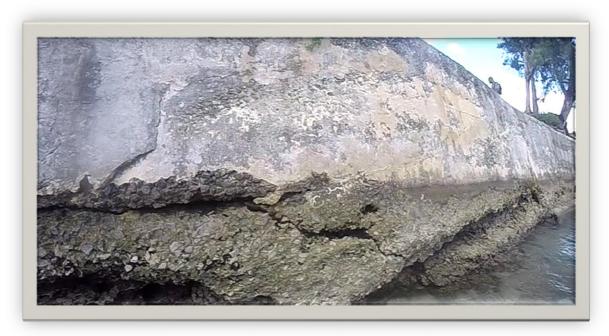
Figure 10: South Face showing exposed base of landing with horizontal cracking and undermining.

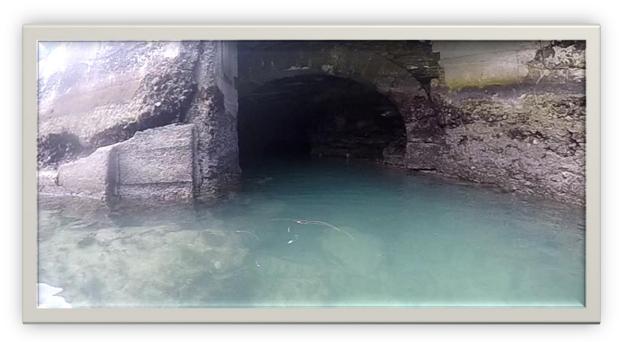
Figure 11: Arched pass though from South Face.

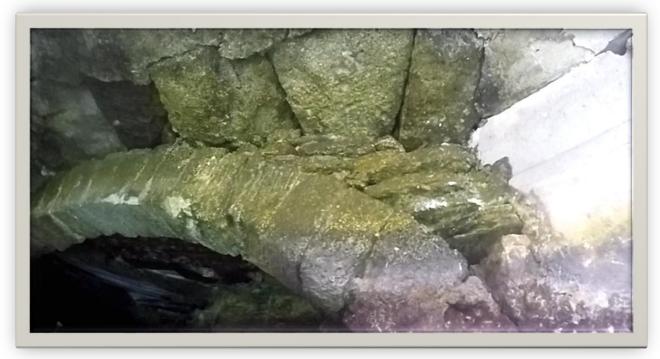
Figure 12: Structural detail of the arch beneath the landing from South Face.

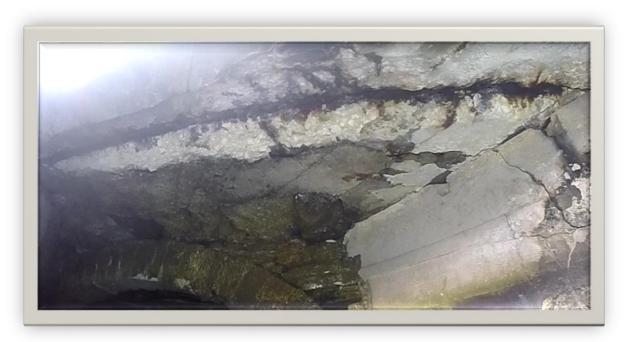
Figure 13: Exposed rebar above archway.

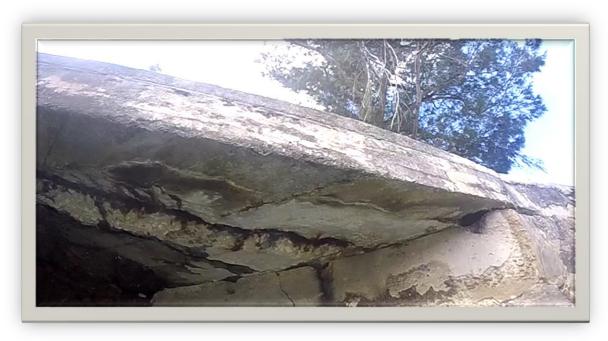
Figure 14: South Face view of exposed reinforcement bars and cracking in the wall.

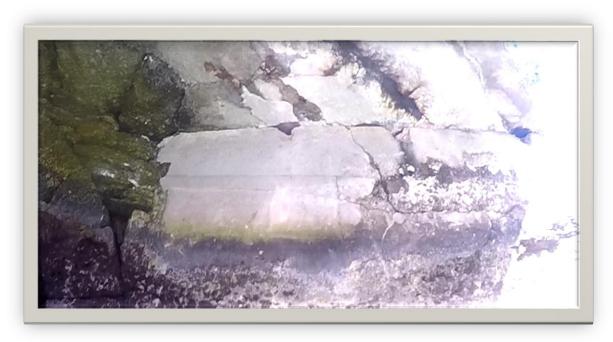
Figure 13: South Face view of crack on the East wall of archway.

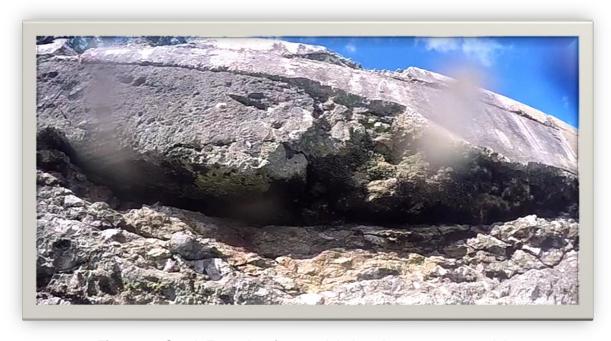
Figure 14: South Face showing crack below the top concrete slab.

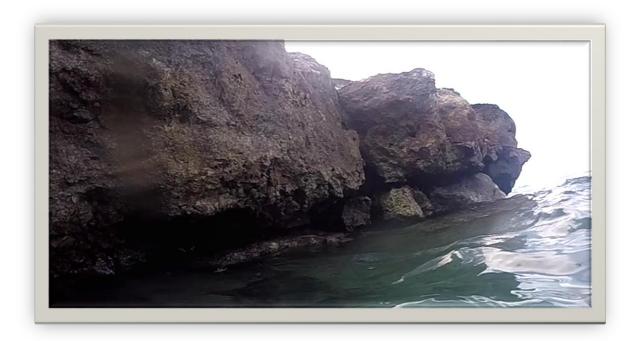
Figure 15: Eastern Face view of concrete overhang.

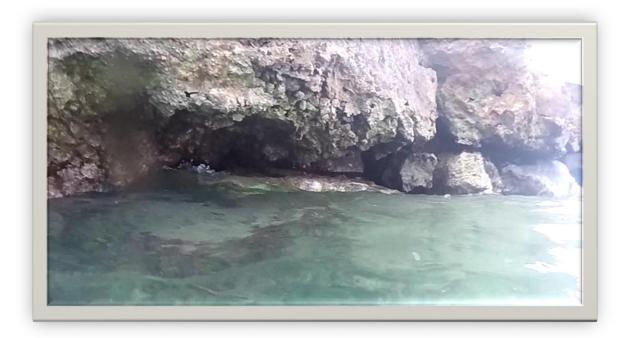
Figure 18: Eastern Face showing concrete overhang above a cavity below sea level.

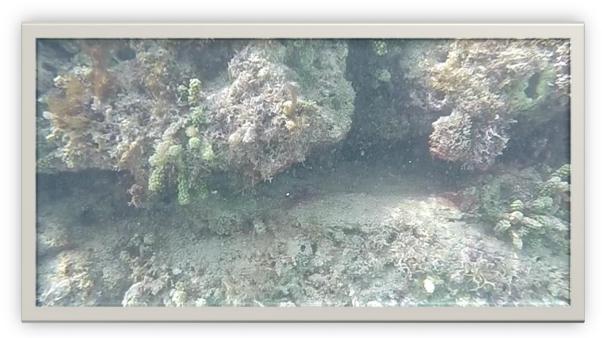
Figure 19: Typical undermining of landing at Clarence Cove.

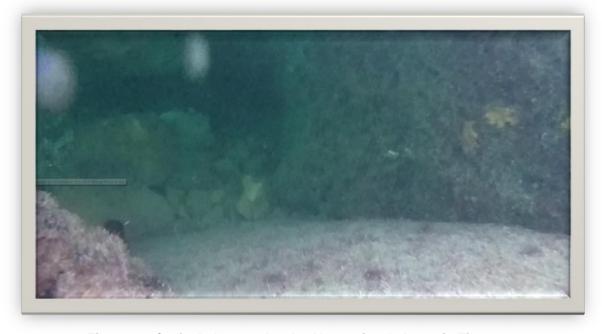
Figure 16: Cavity below sea level. Above visual shown in Figure 18.

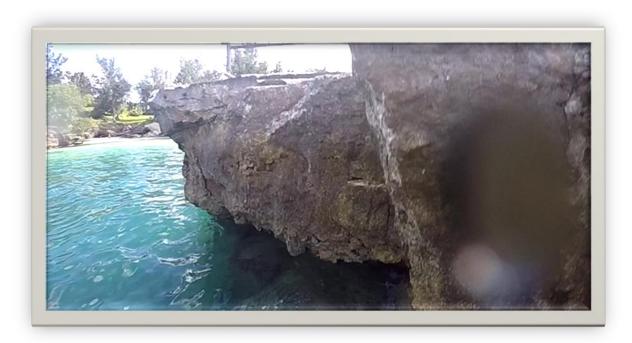
Figure 21: Eastern Face of landing at Clarence Cove.

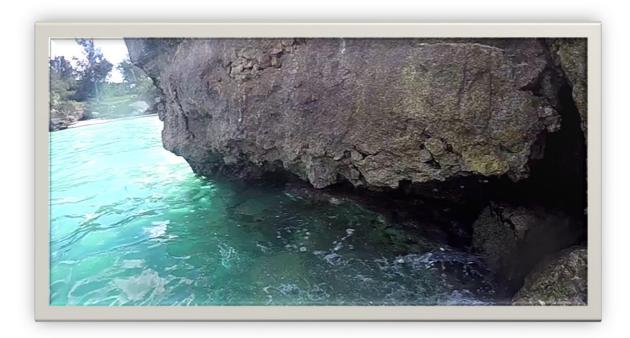
Figure 22: Eastern Face showing erosion of concrete due to wave action.

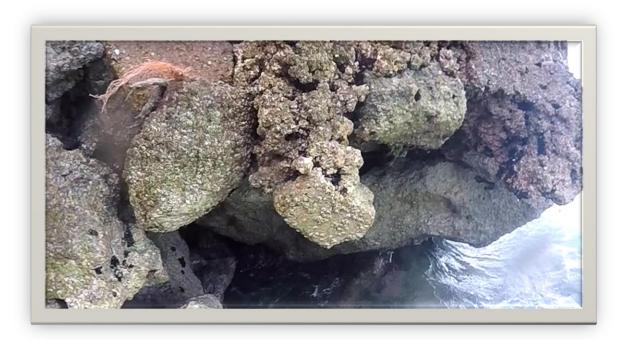
Figure 17: Typical erosion of concrete.

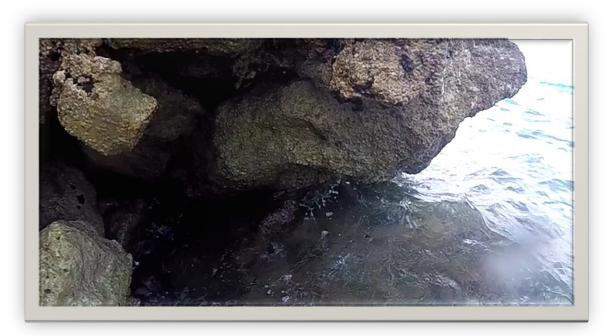
Figure 24: Cavity on Eastern Face of Landing.
