**HAMON CUSTODIS-COTTRELL
 (CANADA) INC.**
 23 West Beaver Creek Road
 Richmond Hill, Ontario, L4B 1K4

INSPECTION REPORT

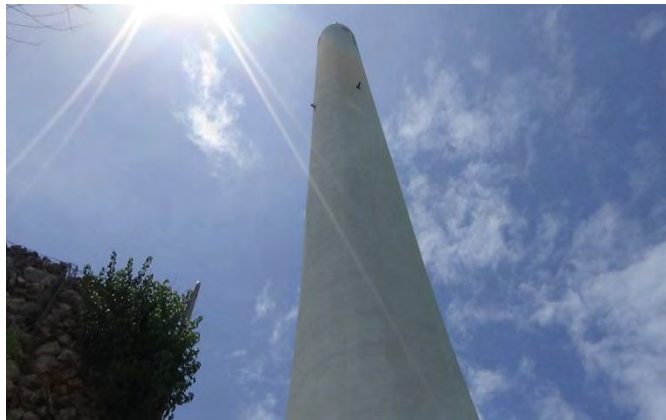
Hamon Custodis performed a complete set of inspections on the 246'-0" concrete chimney (units #1 & #2) in May of 2017. The purpose of these inspections was to determine current conditions of the unit. Plant personnel expressed a slight concern regarding the loss of steel thickness within the carbon steel liners.

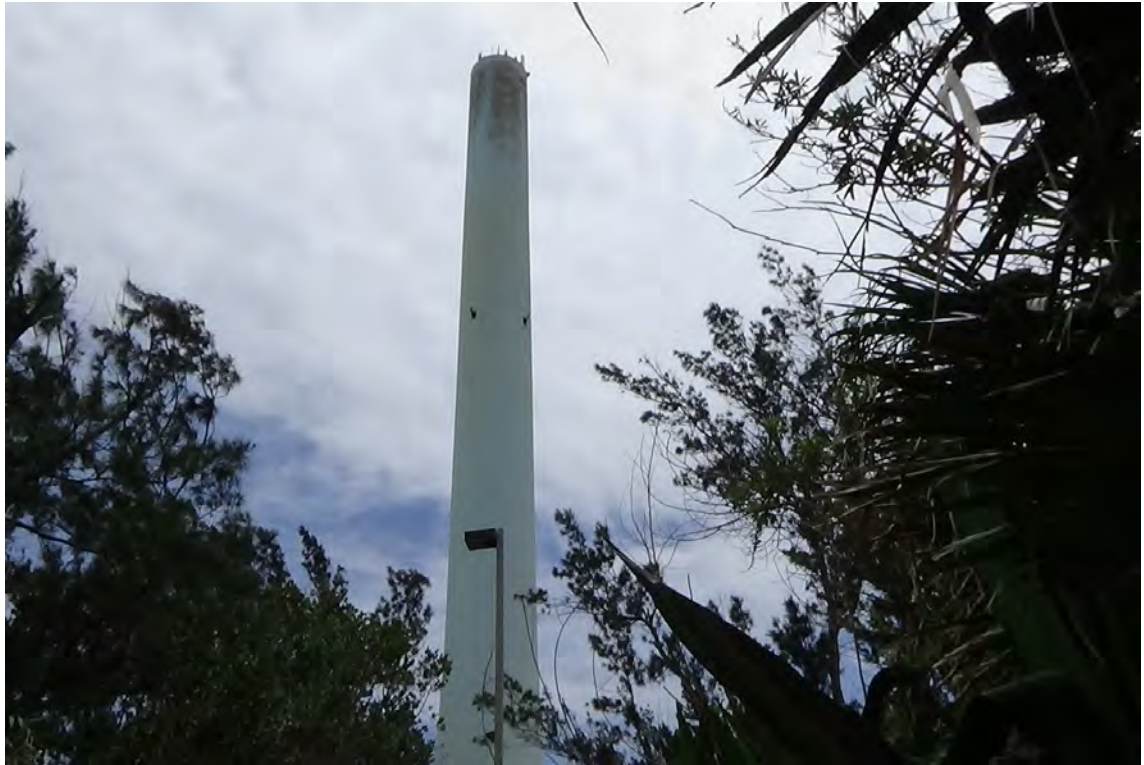
Overview of Tynes Bay 246' chimney. Inspections were performed inside both liners, ultrasonic thickness measurements were taken throughout the height of both liners. Exterior inspections were conducted on the north & south sides from a boatswain's chair. One annular inspection was performed from the access ladder.

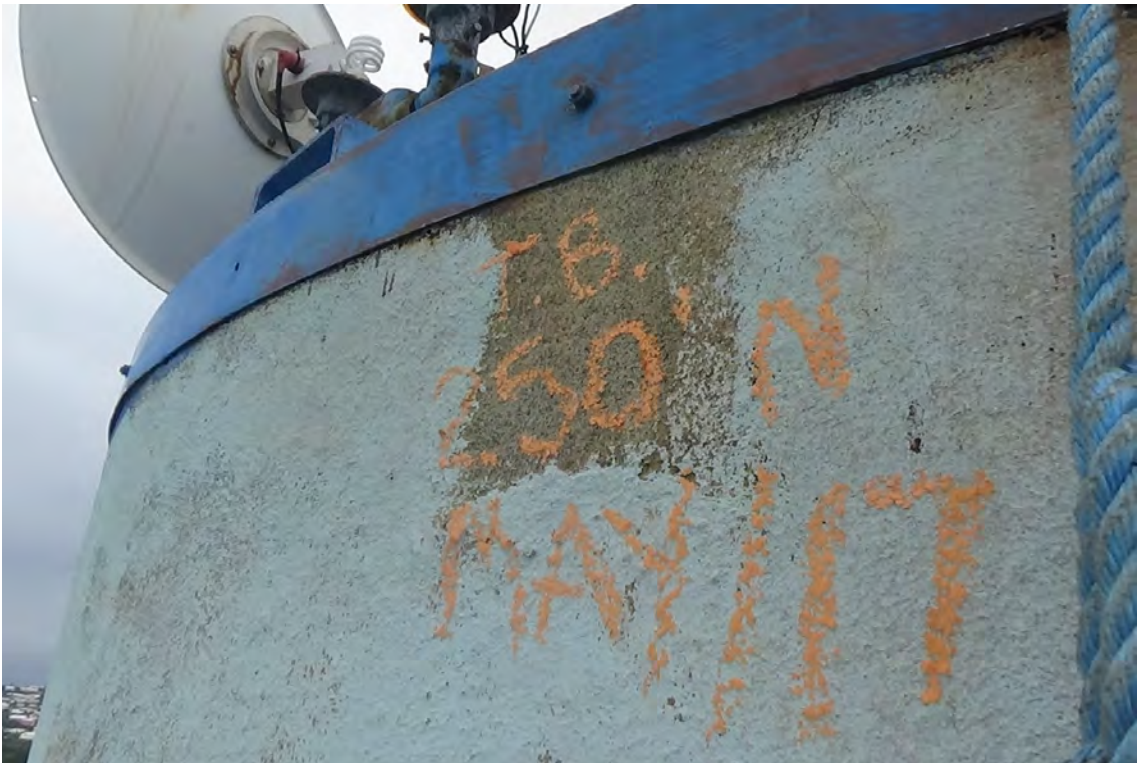
250' N—Area of bare concrete is visible where rigging would have been placed during original painting of column. The protective coating is badly worn throughout the top 50' of the chimney.

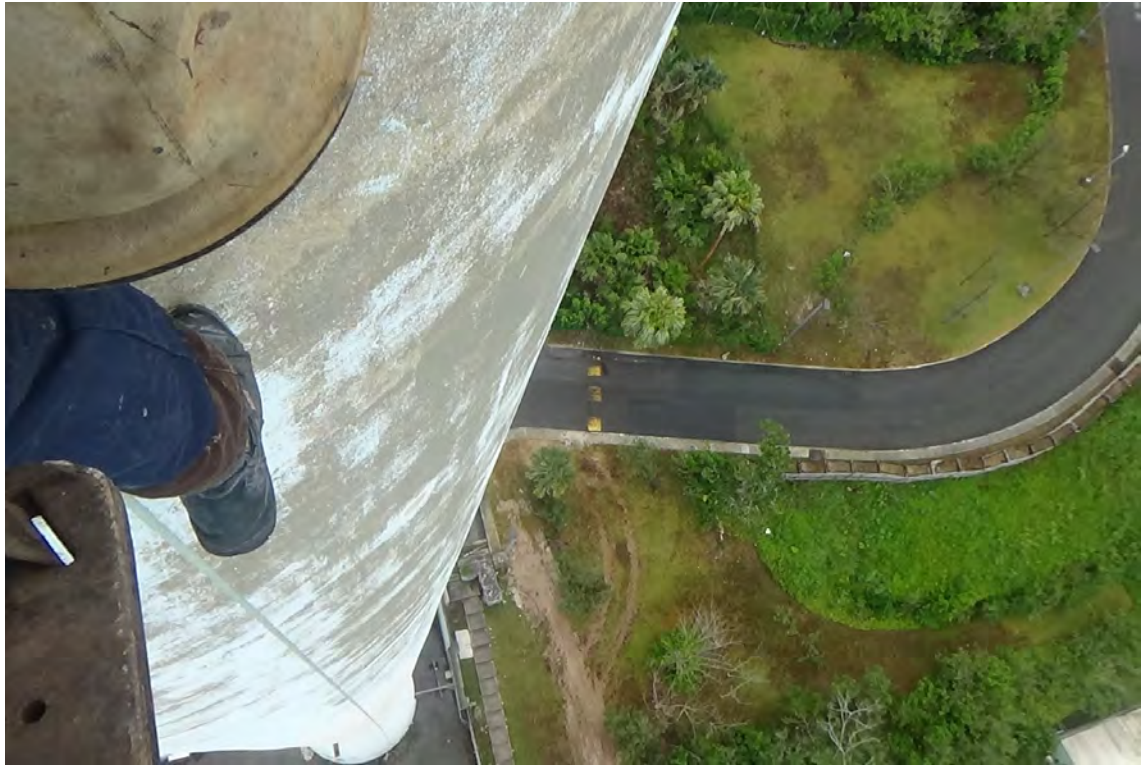
250' N—View looking down the exterior of the concrete column displays significant paint deterioration. Paint coverage within the top 50' was estimated to be 30% in tact.

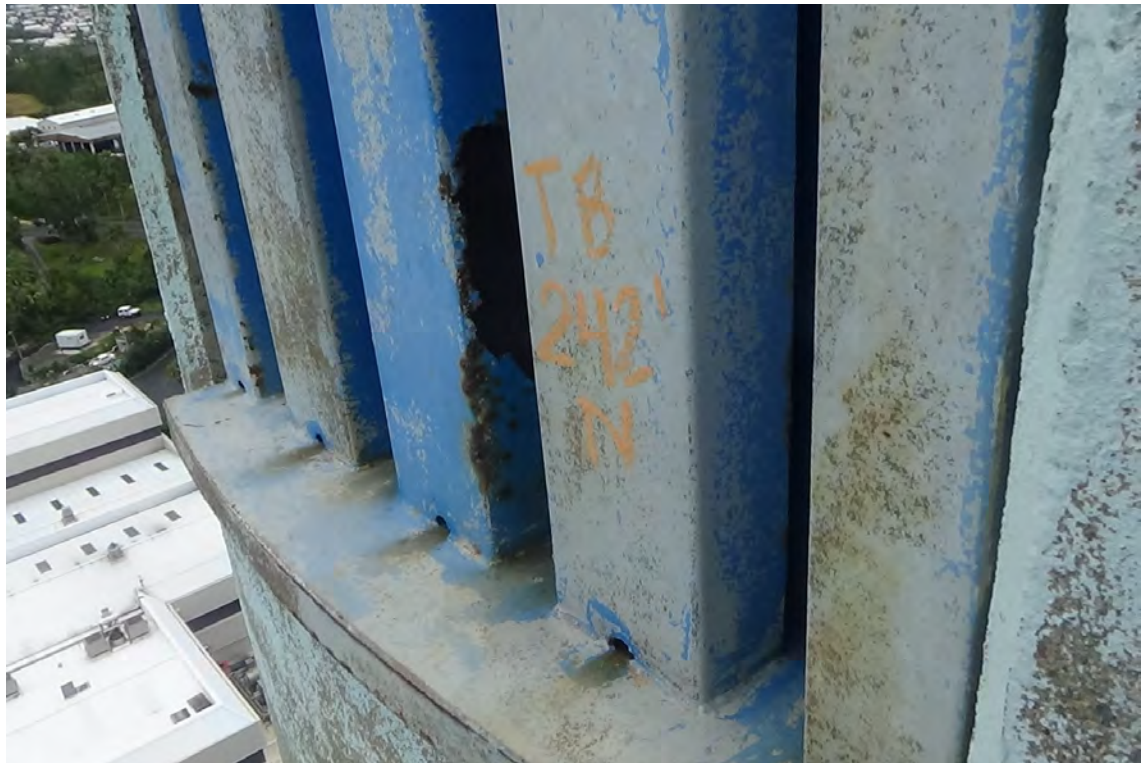
242' N—The blue paint protecting the steel vent cover appears severely weathered. Paint coverage on the steel cover was estimated to be 50% in tact. Areas of significant rust and pitting are visible on the steel channels.

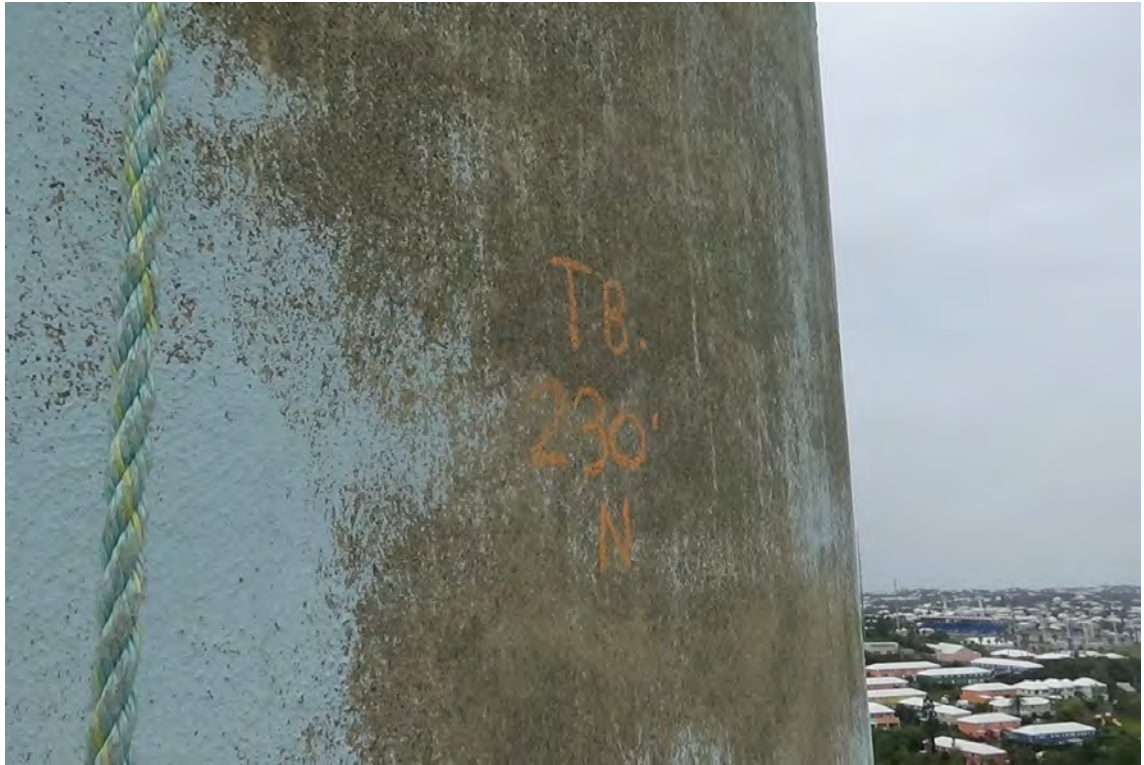
230' N—A large area of bare concrete is visible at this elevation. The remainder of the coating is weathered, the paint appears to be “washing” off the concrete rather than peeling.

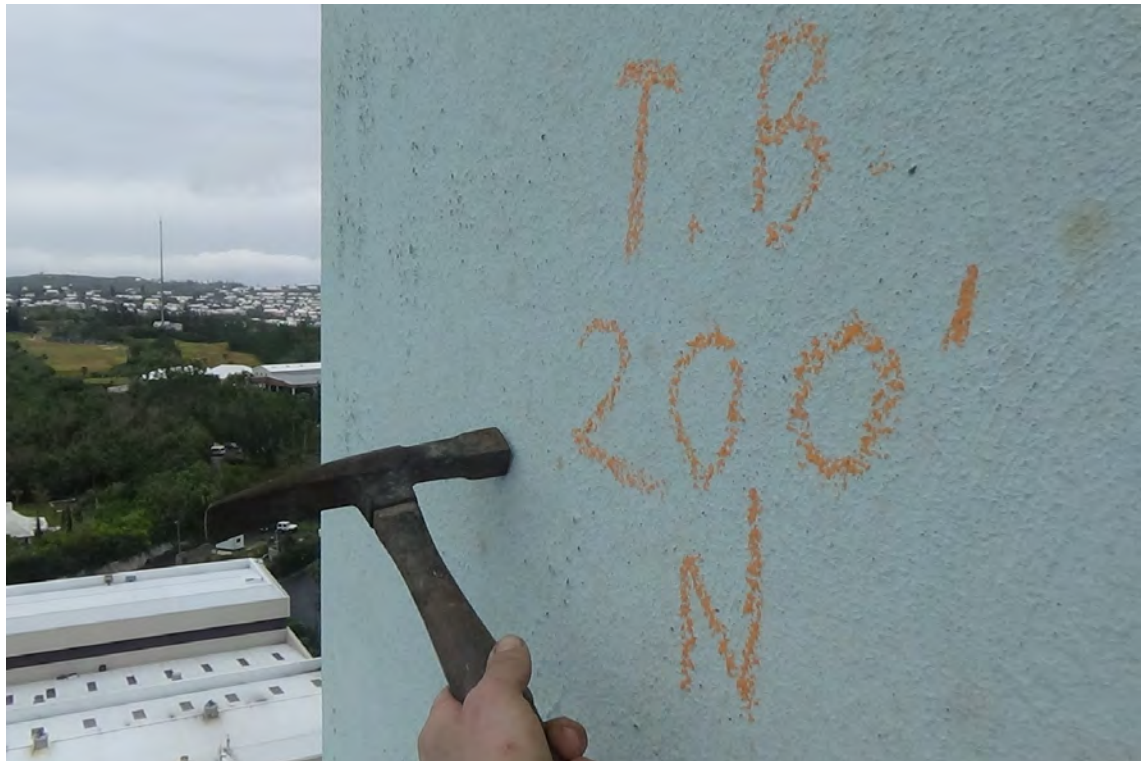
200' N—The protective coating below 200' is more consistent. Paint coverage was estimated to be 85% intact between the 150' to 200' elevations. The concrete was hammer tested throughout the height of the column and was discovered to be in sound condition.

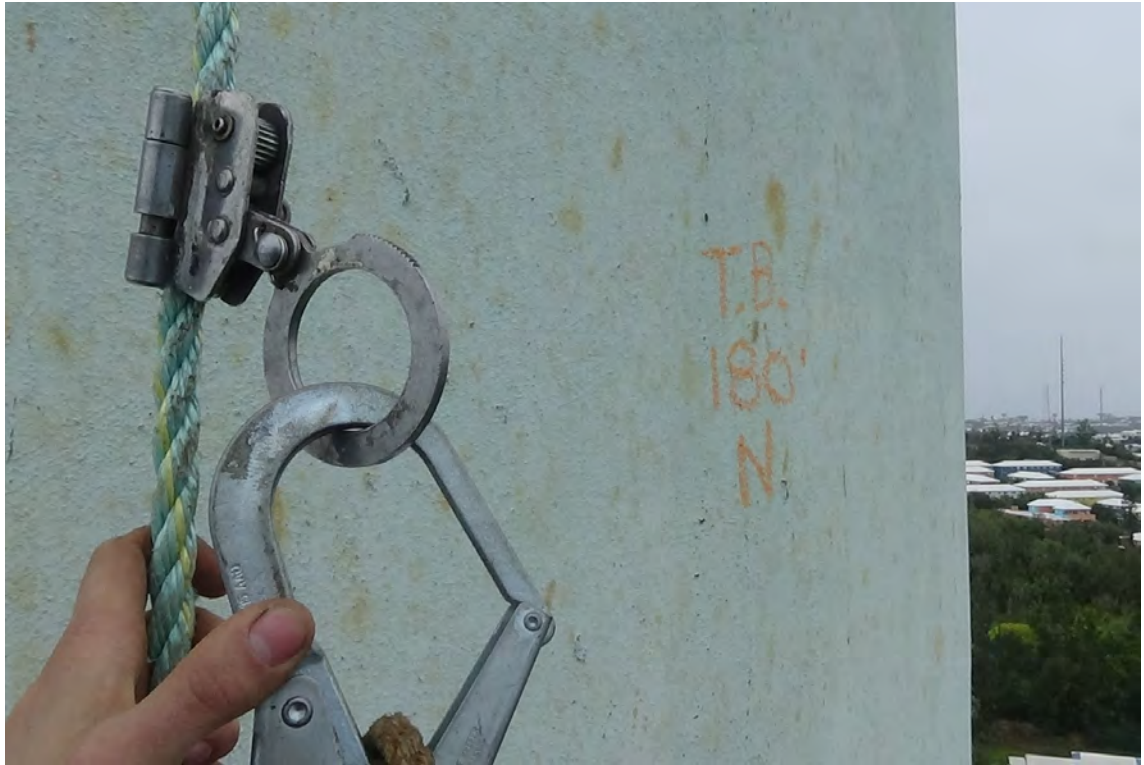
180' N—Below 200' a spotty brown staining is visible throughout the exterior coating. These stains can be attributed to steel scale being blown out the interior of the liners. The staining is more prominent on the north side of the column and diminishes as one descends towards the base.

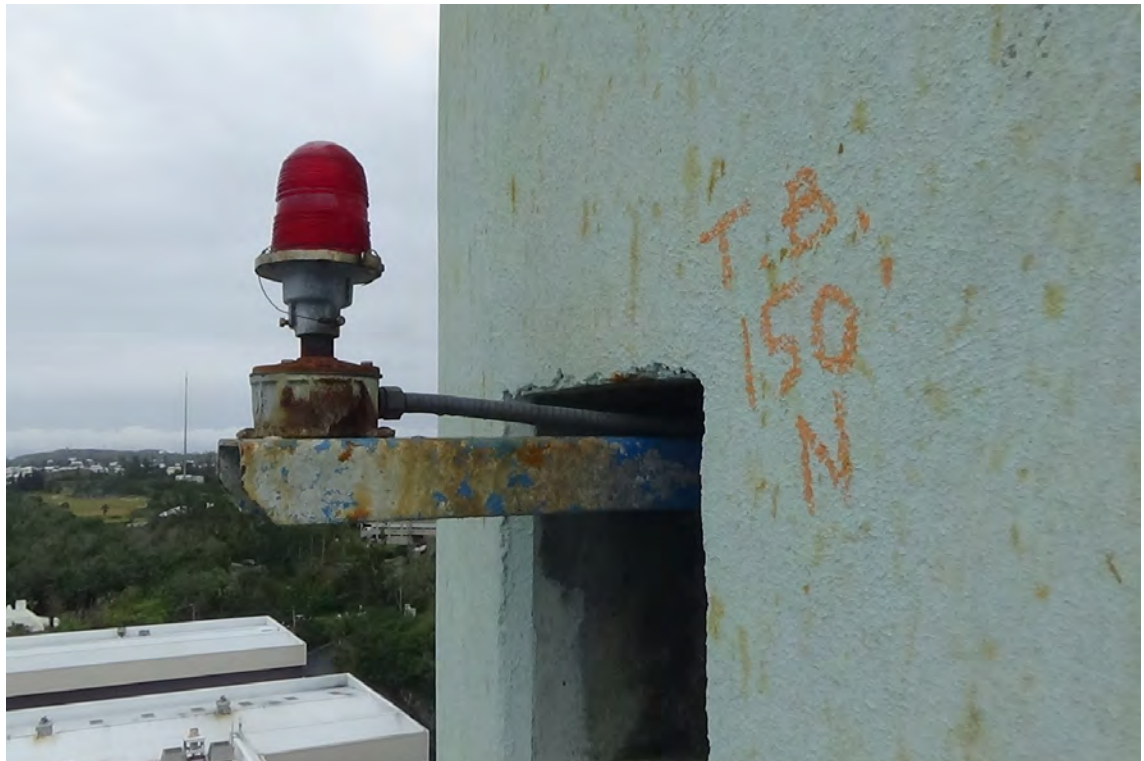
150' N—Aircraft obstruction light is in satisfactory condition. The bottom casing is significantly rusted and showing signs of corrosion. The blue paint covering the mounting channel is approximately 25% in tact. The light appears to be off during the daytime hours.

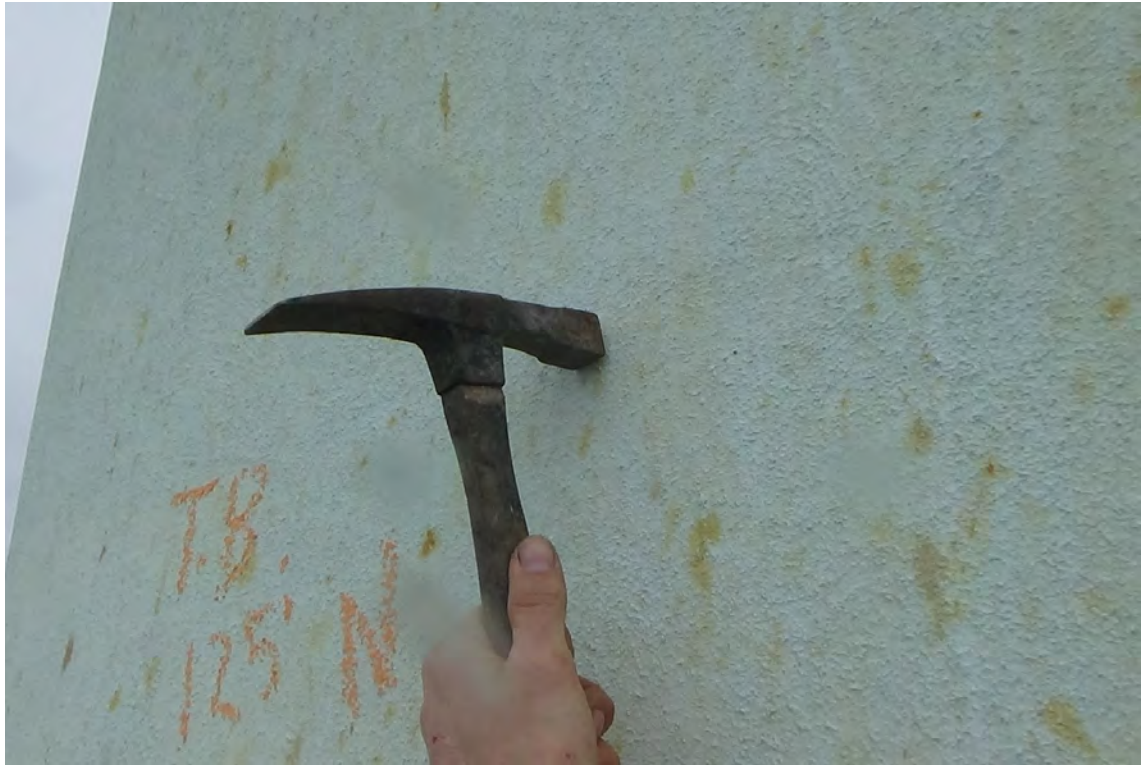
125' N—The exterior of the concrete column was found to be in excellent condition throughout the height of the structure. No cracks or evidence of spalling were observed during the north inspection drop.

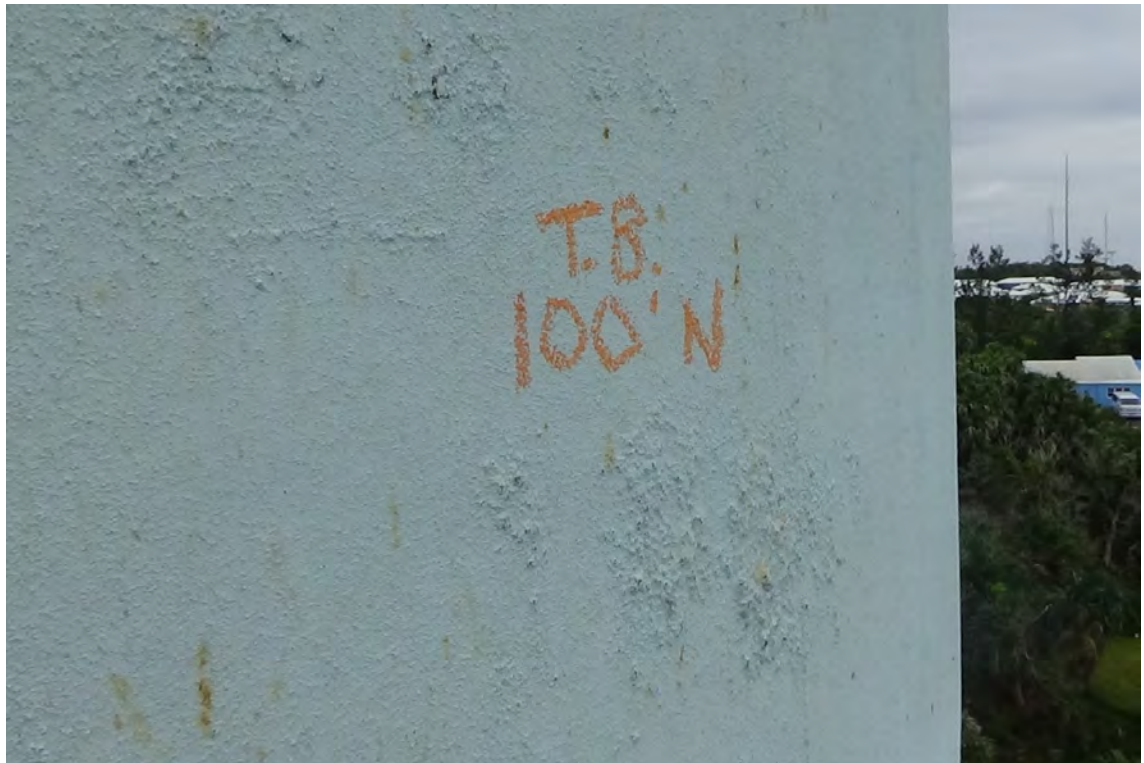
100' N—Areas of rough concrete were observed in this localized area. This minor deficiency can be attributed to concrete sticking to the forms during the original slipforming of the column. These areas were tested with a hammer for hardness and were found to be solid.

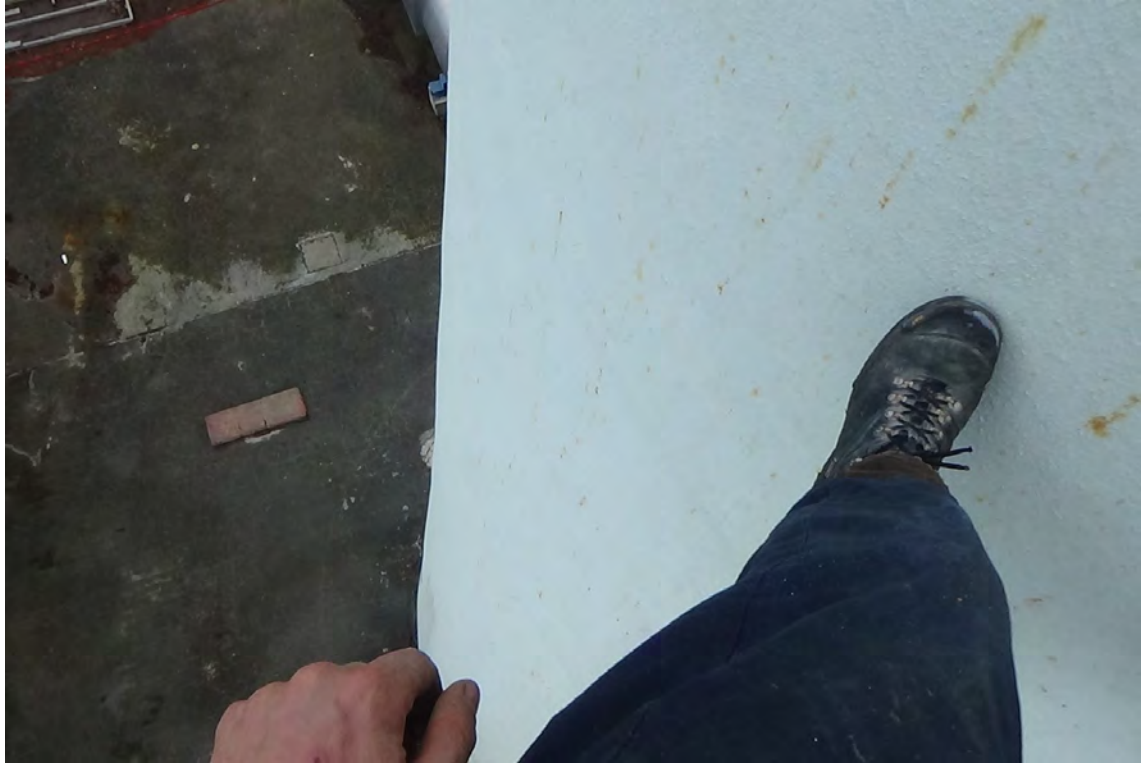
50' N—View looking down towards the base of the chimney displays minimal amount of paint staining at lower elevations. The concrete wall tapers outwards below this elevation

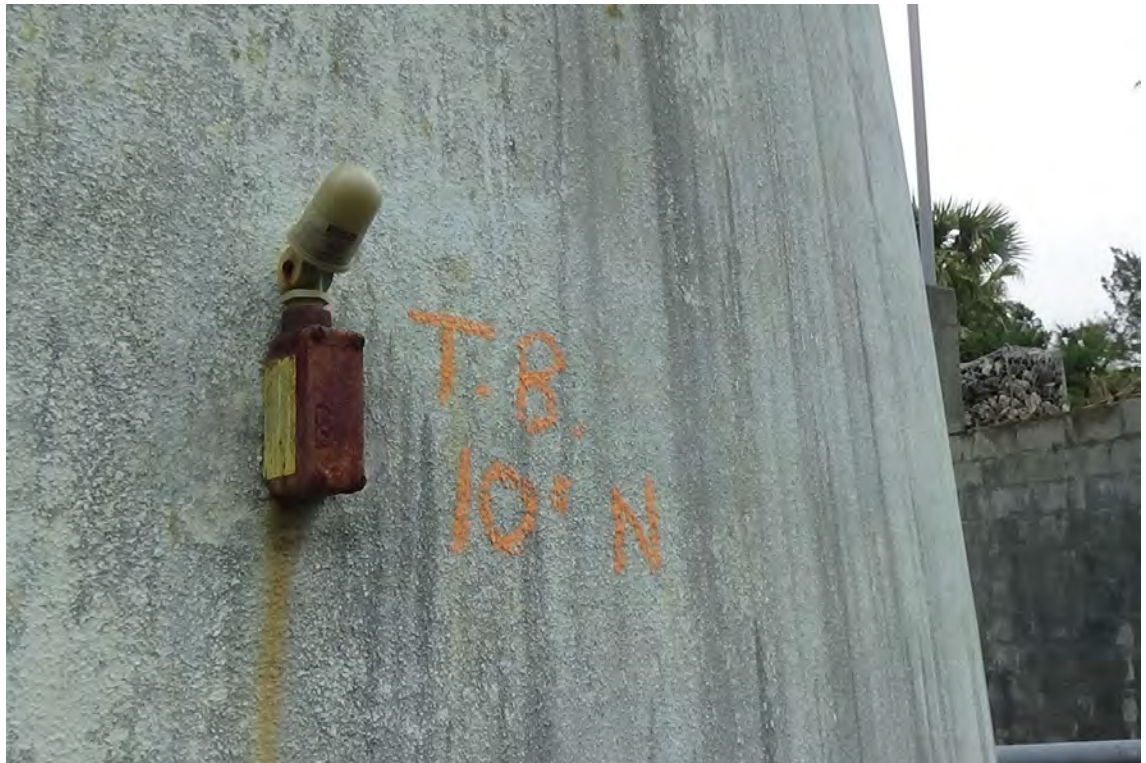
10' N—A small electrical junction box appears as though it once housed an exterior light or intended to. The junction box is moderately rusted and pitted, the pivot head was found to be damaged.

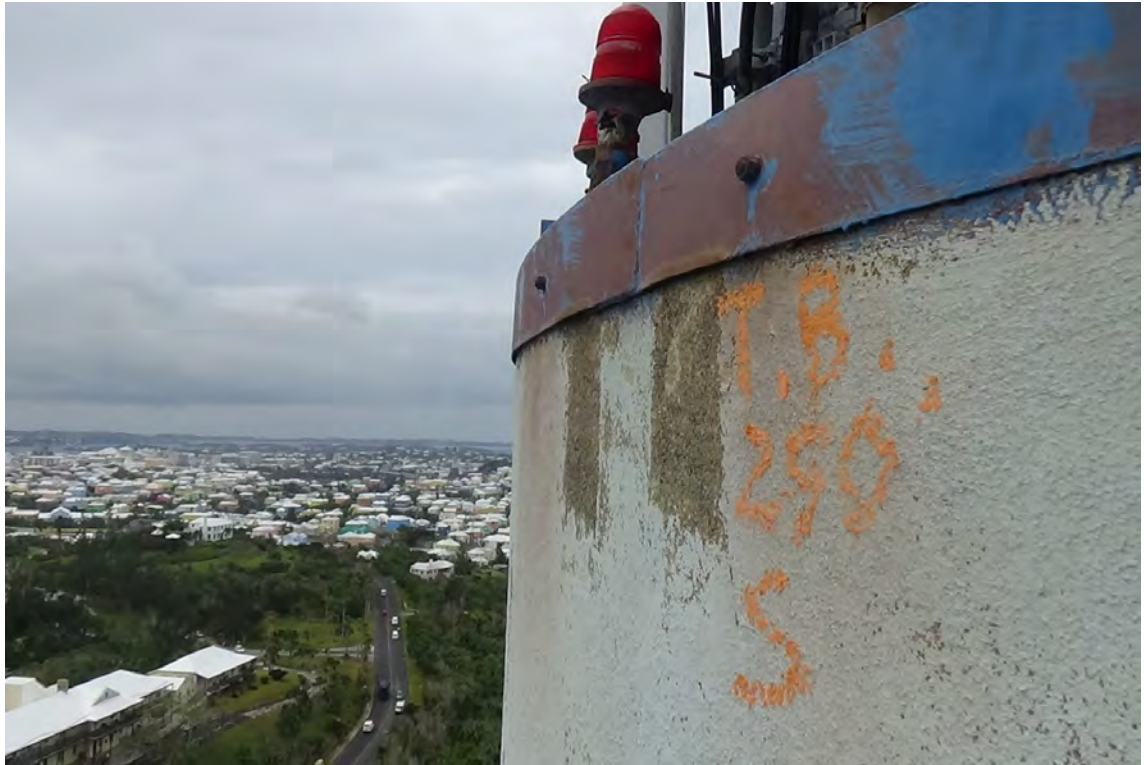
250' S—Two small areas of bare concrete are noticeable below the rain cap. Paint on the cap is badly worn, red primer is visible beneath blue top coat. Aircraft obstruction light casing appears cracked and severely deteriorated.

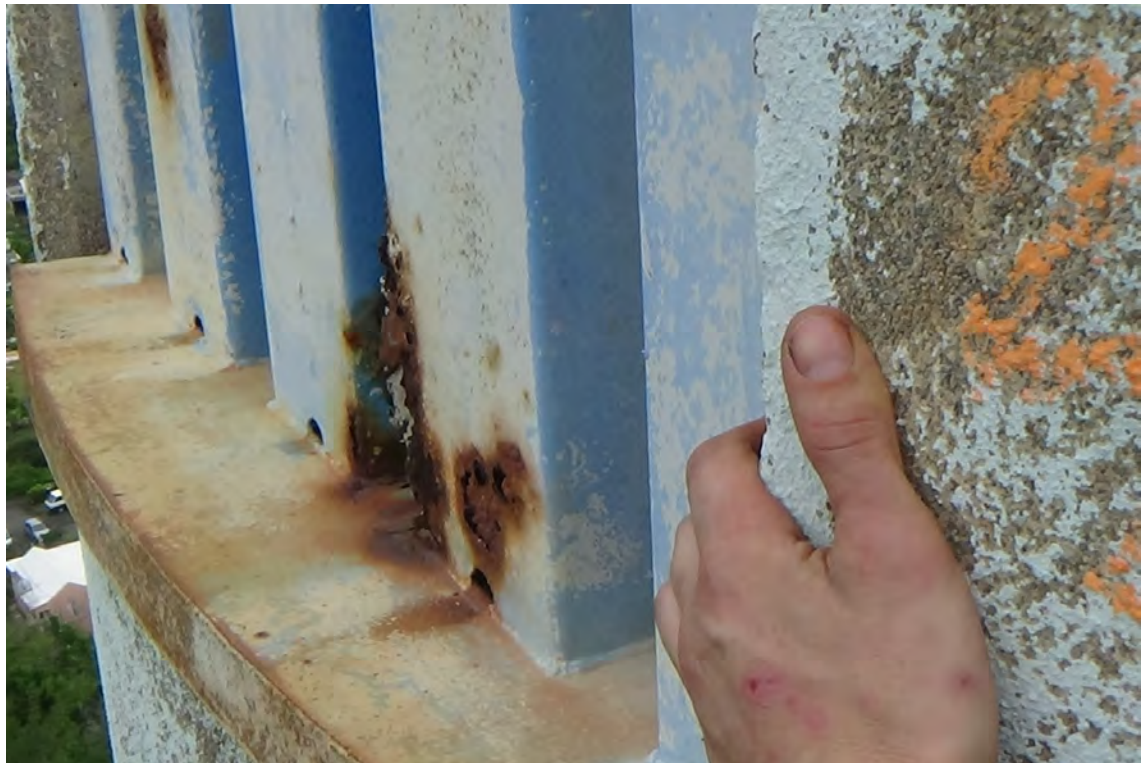
242' S—The paint on the vent cover is weathered. The paint on the vents displays approximately 15% coverage. In areas where the primer coat has deteriorated rust, scaling and corrosion holes are visible.

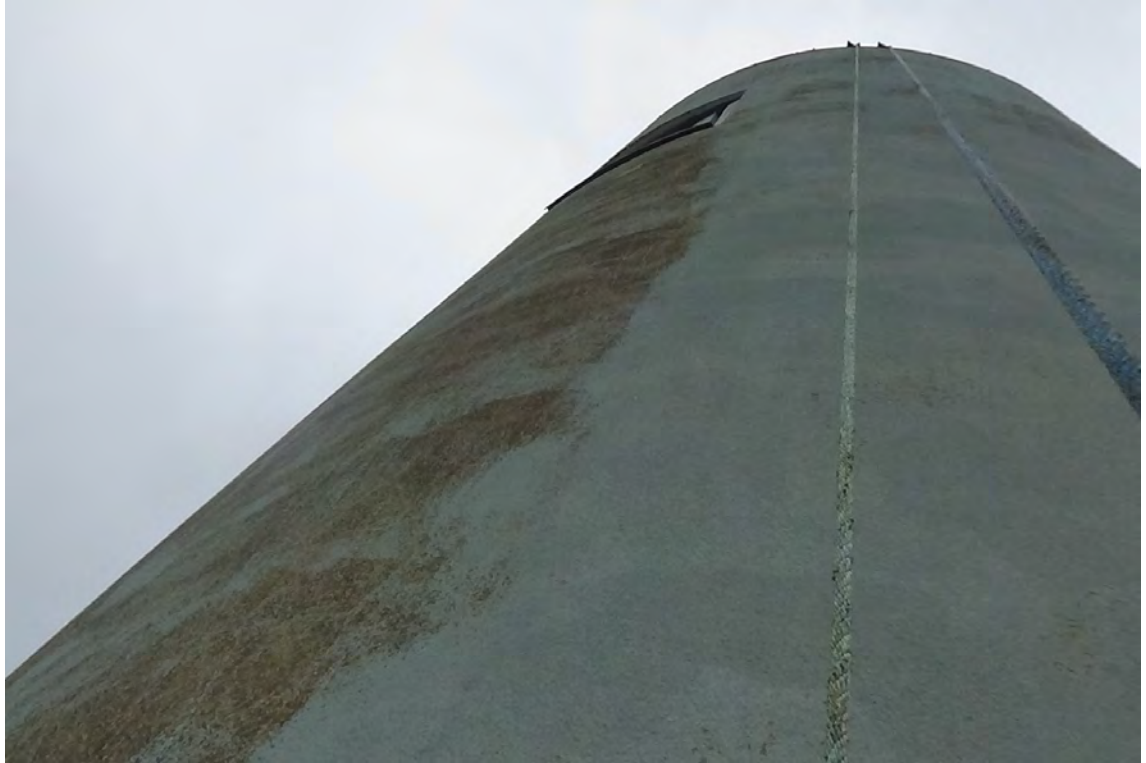
225' S—The protective coating directly beneath the annular vent has completely deteriorated for approximately 25'. The paint to the right of the vent displays a much more consistent finish.

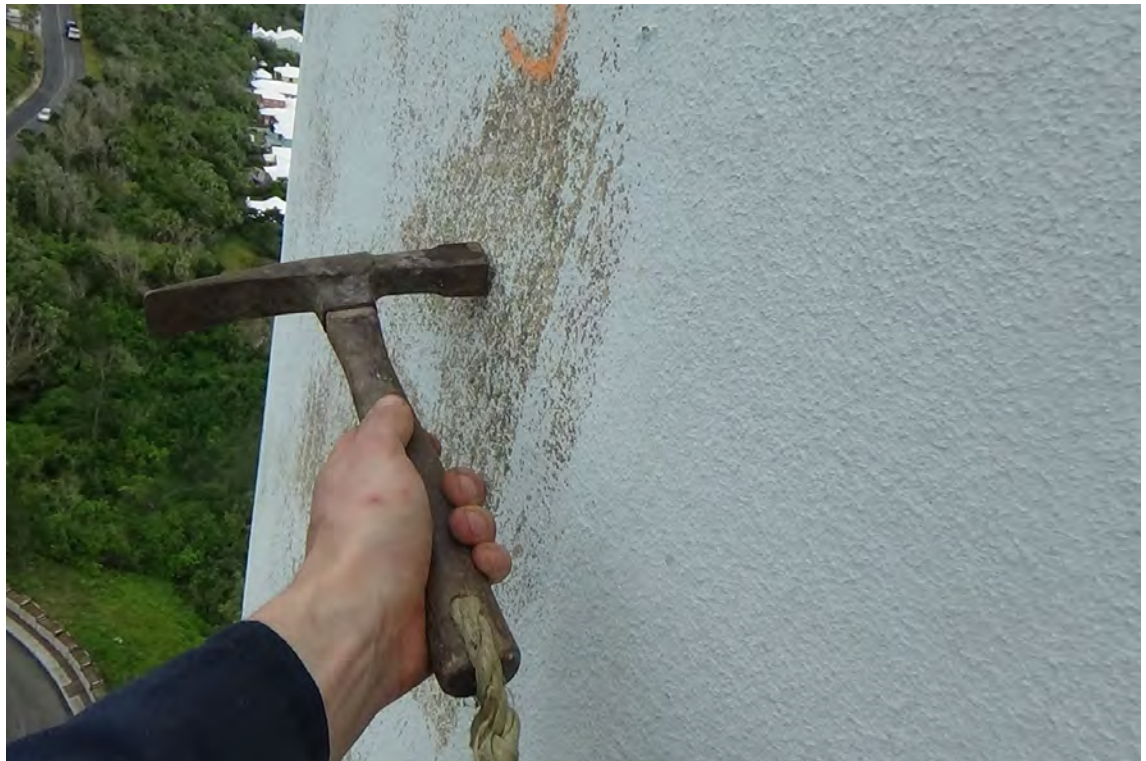
225' S—The concrete wall was hammer tested at various elevations to determine the composition and the hardness of the concrete. All the square footage which was observed and tested during the two exterior inspection drops, proved to be intact and solid.

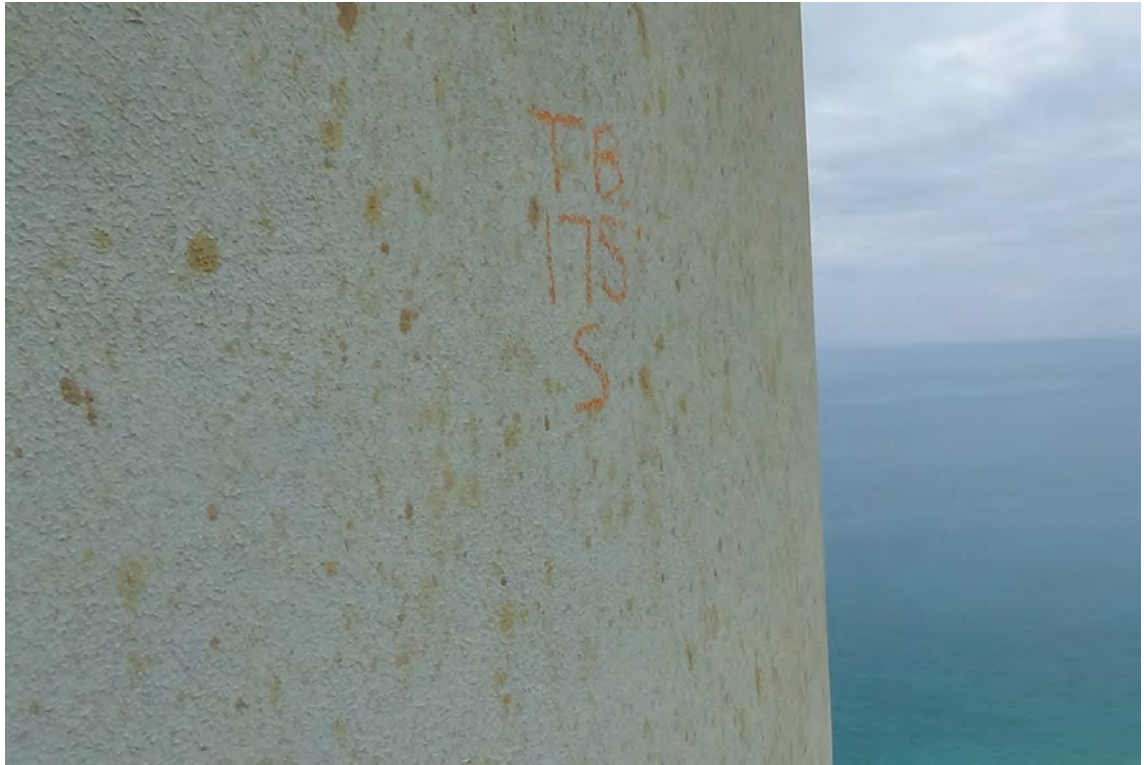
175' S—Paint staining is widespread throughout the height of the column. The staining is most noticeable towards the east side of the structure and diminishes as one descends towards the base.

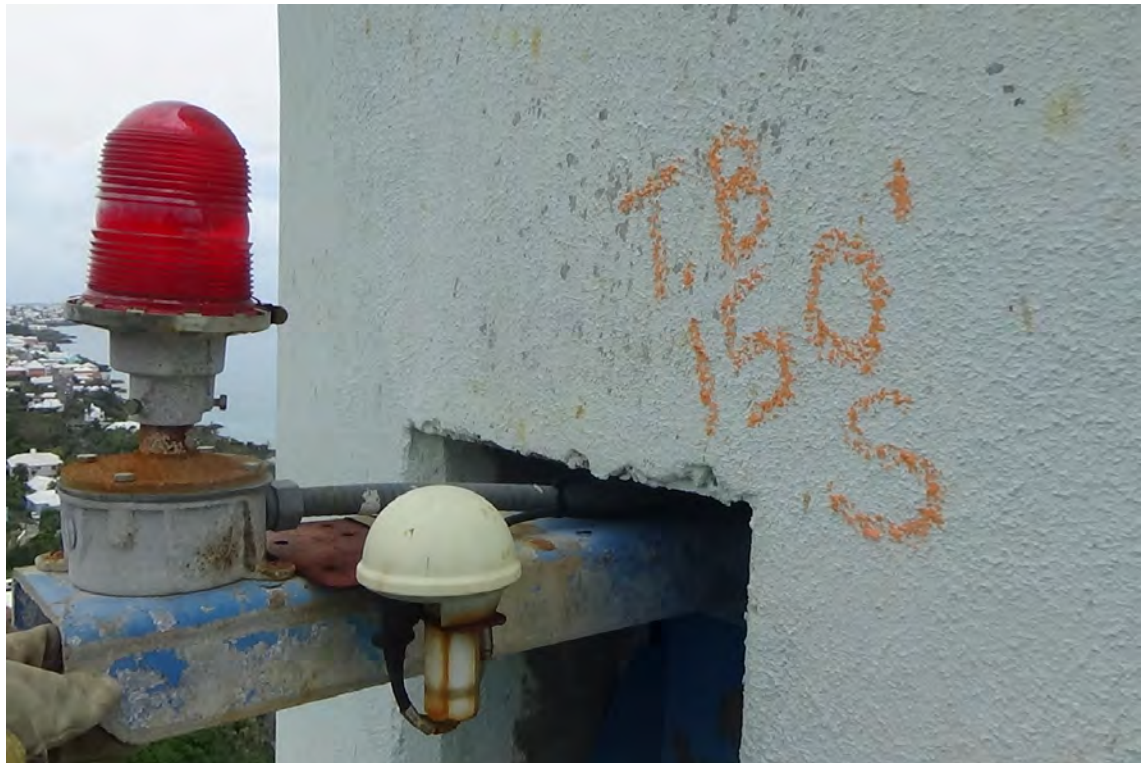
150' S—Aircraft obstruction light and components are all in satisfactory condition. The paint on the mounting bracket is badly worn.

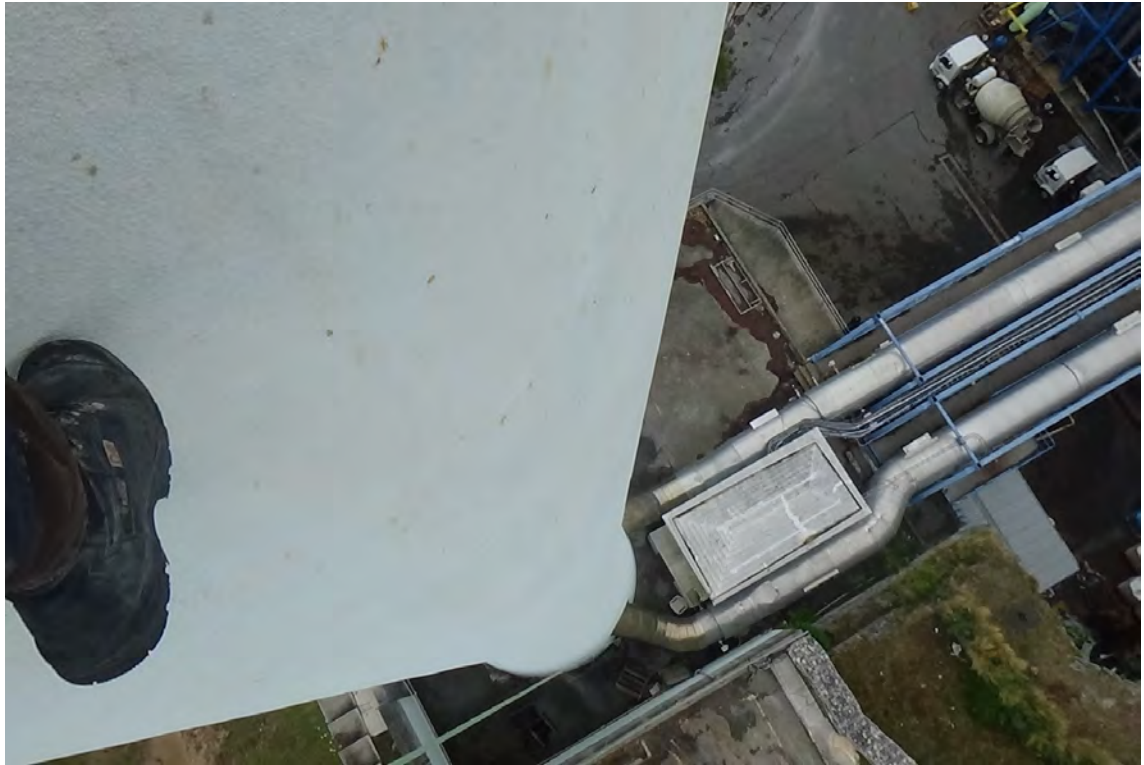
125' S—View looking down the wall shows significantly less staining to the paint than at higher elevations. Breeching ducts enter the concrete column on the east and south east sides of the structure.

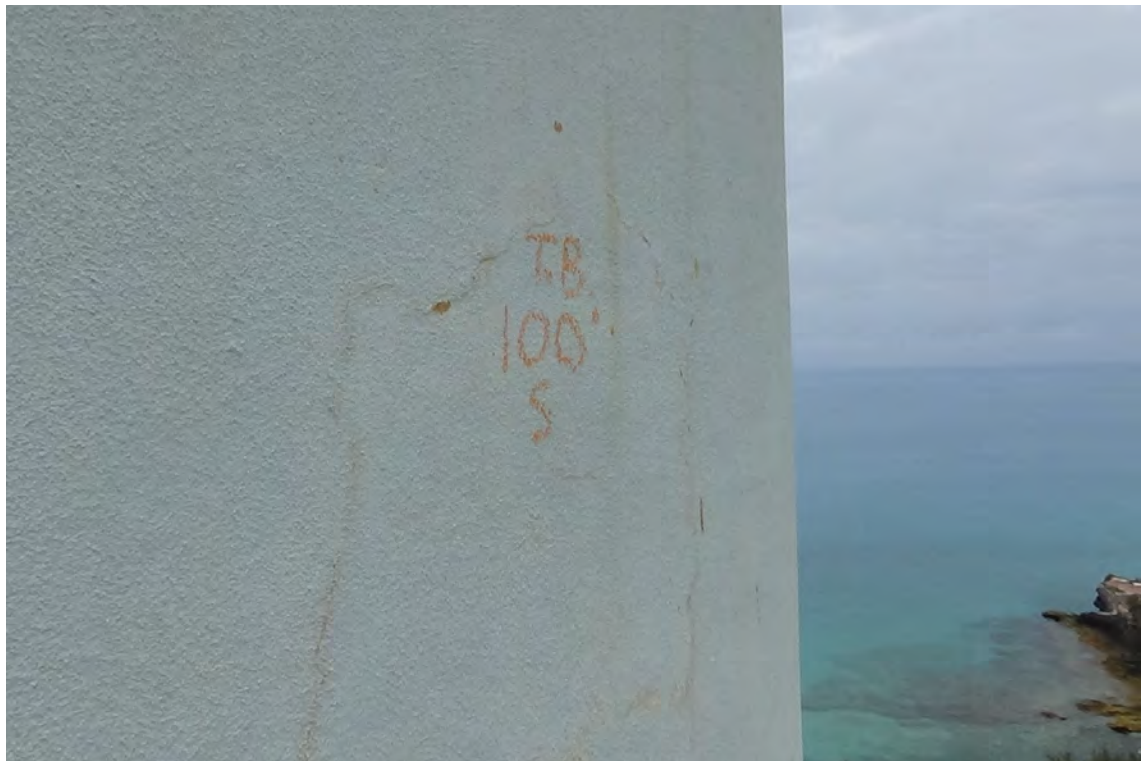
100' S—A series of hairline cracks are visible within the concrete. These minute cracks form a circle approximately 2'-0" by 1'-6" in size. The concrete inside and around the defect was tested with a hammer and found to be solid.

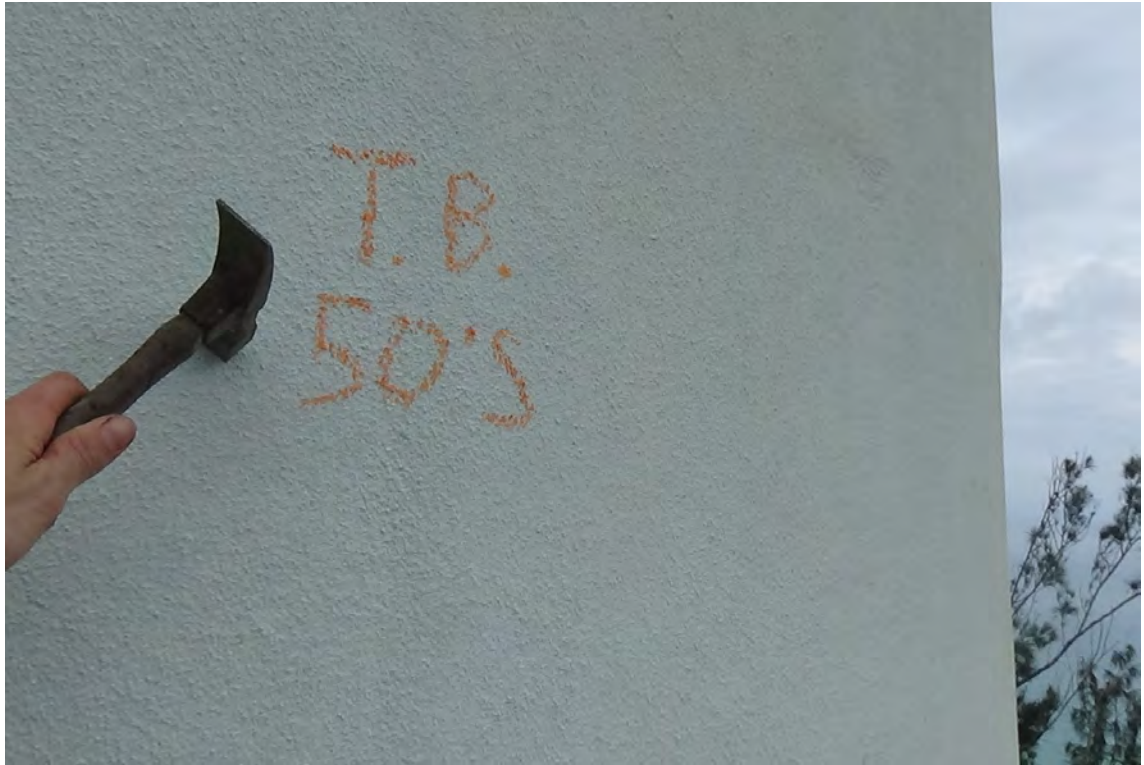
50' S—The concrete wall was hammer tested at various elevations to determine the composition and the hardness of the concrete. All the square footage which was observed and tested during the two exterior inspection drops, proved to be intact and solid.

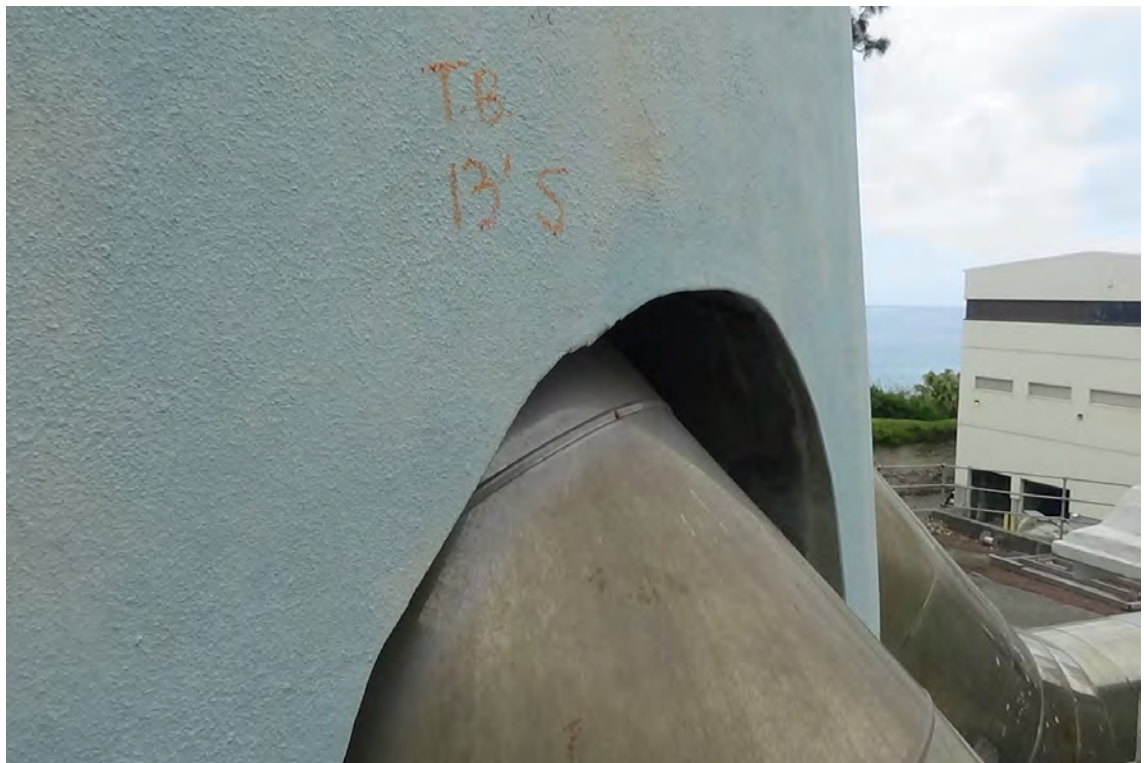
13' SE—Flue #1 enters the concrete column. No deficiencies were noticed around the opening or on the duct cladding.

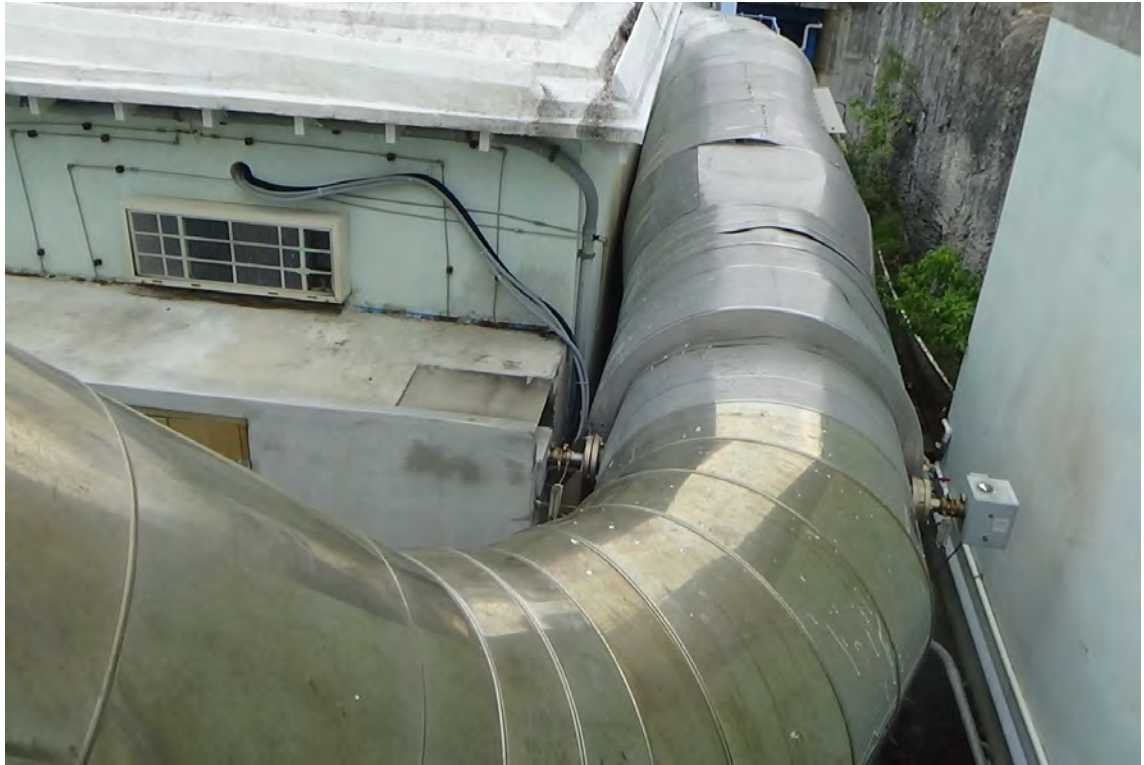
13' SE—View looking at the top of flue #1 ductwork displays no major damage or deficiencies. A small void can be seen on the top of flue duct where the two overlapping sections of cladding have separated exposing the insulation underneath.

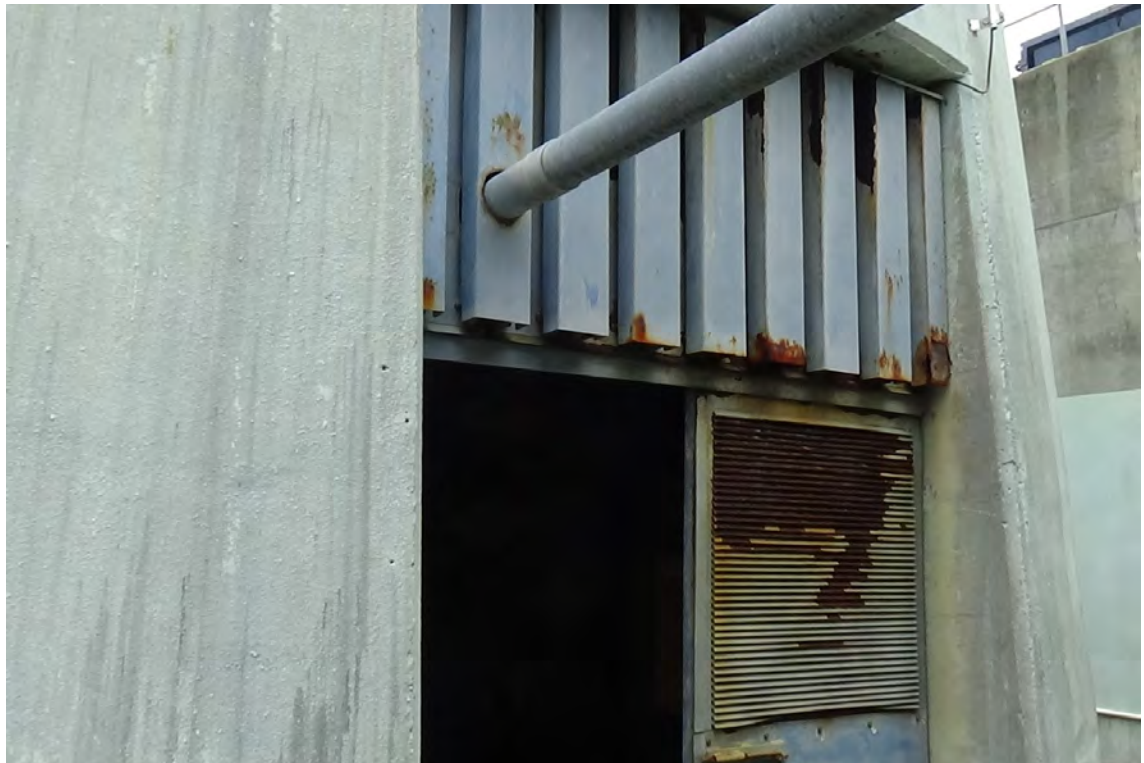
0' W—The two man doors providing access to the annular space were found to be in good working order. The blue paint over the vent portion of the doors is badly deteriorated, exposing significant rust and scale beneath.
