**HAMON CUSTODIS-COTTRELL
 (CANADA) INC.**
 23 West Beaver Creek Road
 Richmond Hill, Ontario, L4B 1K4

INSPECTION REPORT

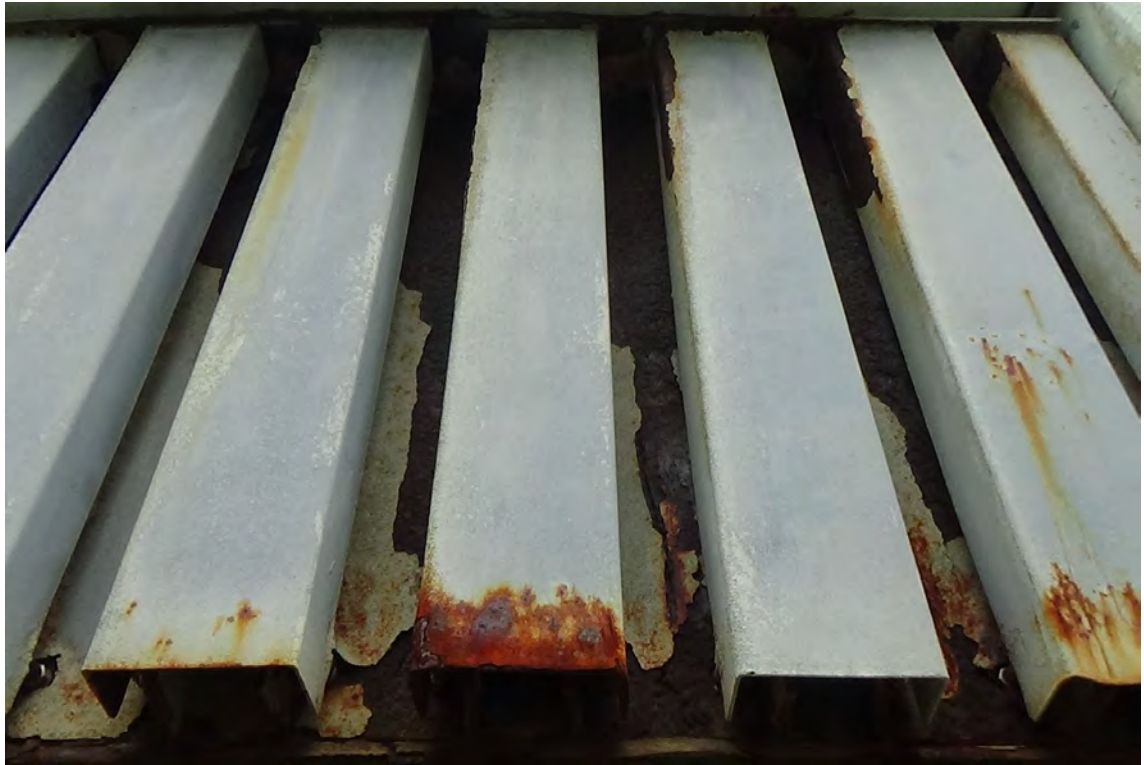
8' W—The vent covering over the annular space access door displays significant amounts of peeling paint, exposing rusted and pitted steel beneath. Corrosion holes are visible towards the bottom of the steel channels.

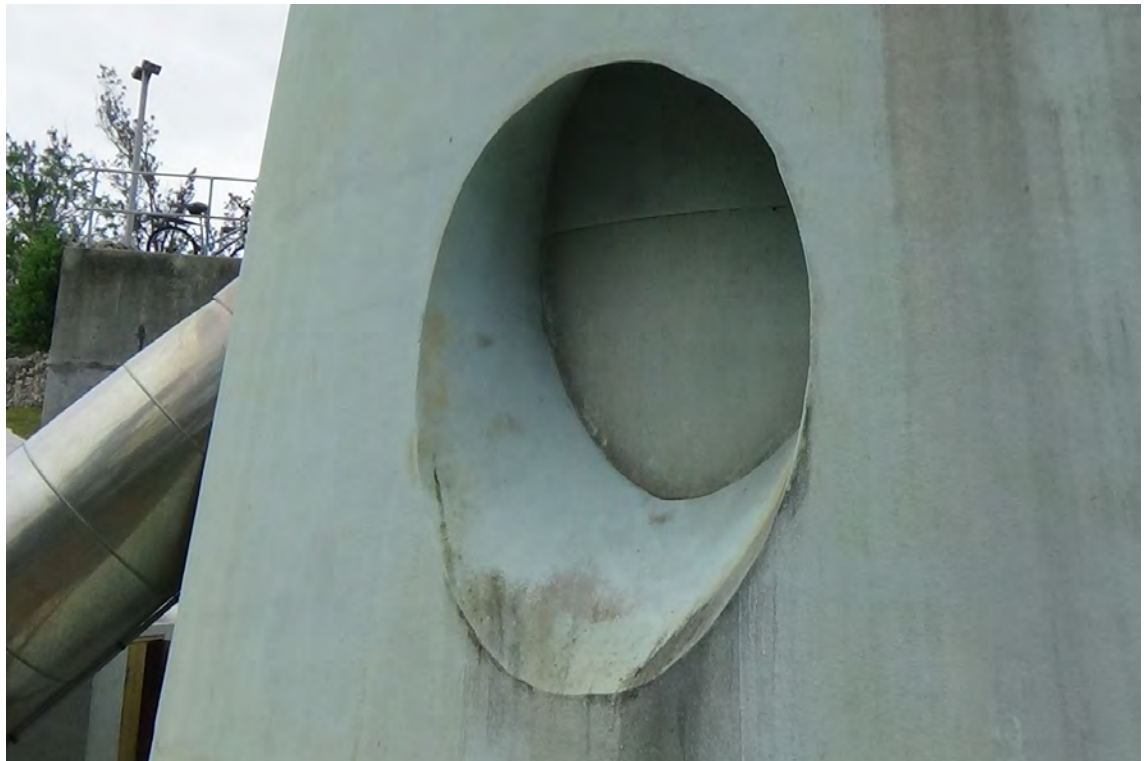
10' NE—Provisions have been made for a third flue to enter the column in this location. A cover plate has been anchored the interior wall to help keep out the elements and wildlife.

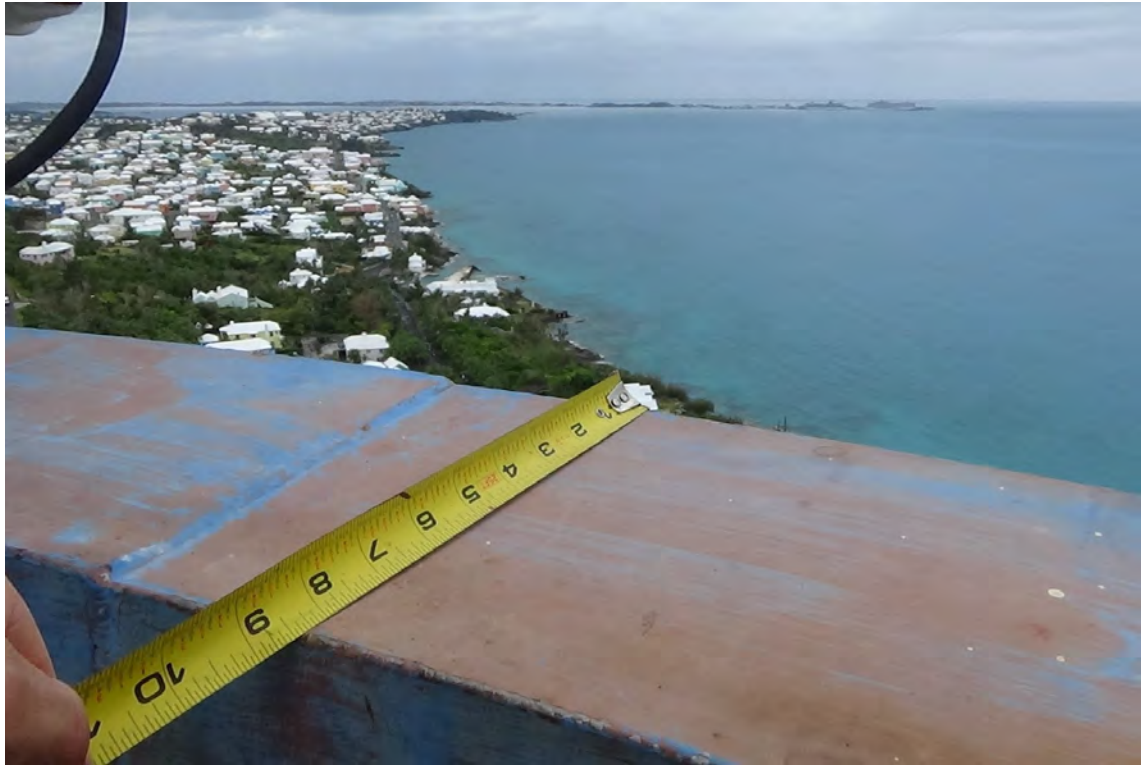
250' NW—The concrete rain cap measures 8 ½" in width. The top coat of blue paint appears weathered throughout the entire rain cap. The red primer is visible beneath the worn paint.

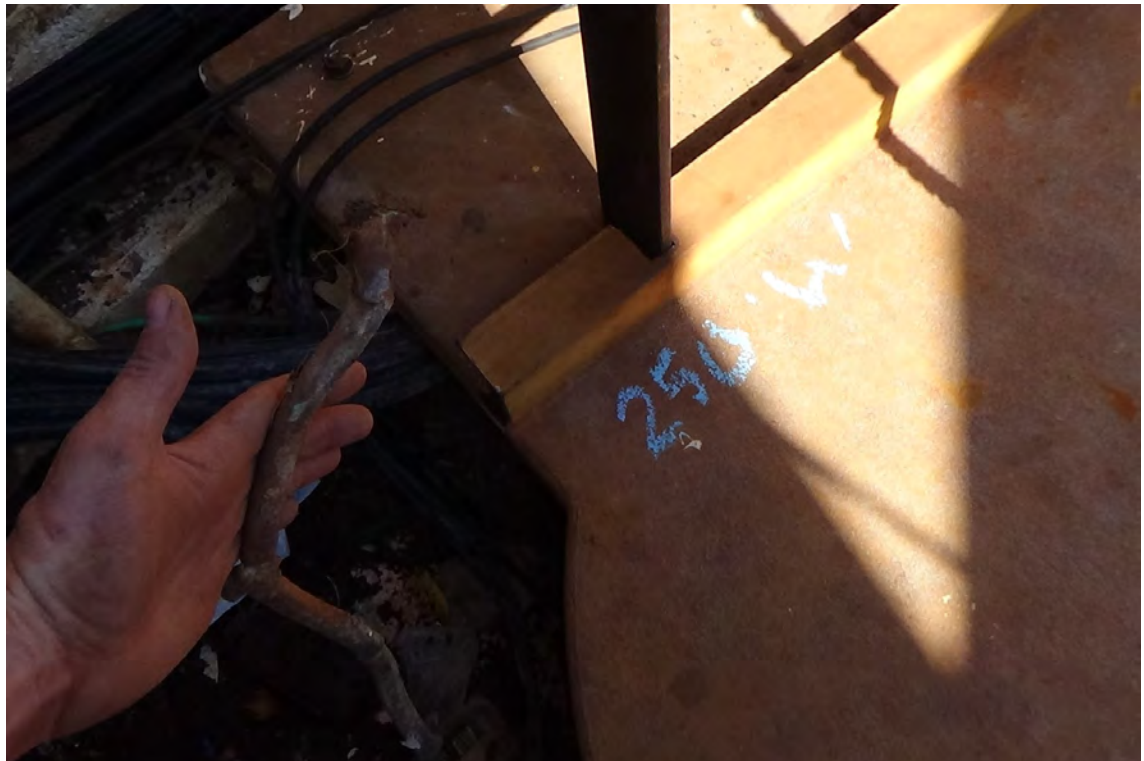
250' W—Photo taken on the roof deck shows that the ground cable connecting the liner grounds to the copper downlead has been sheared.

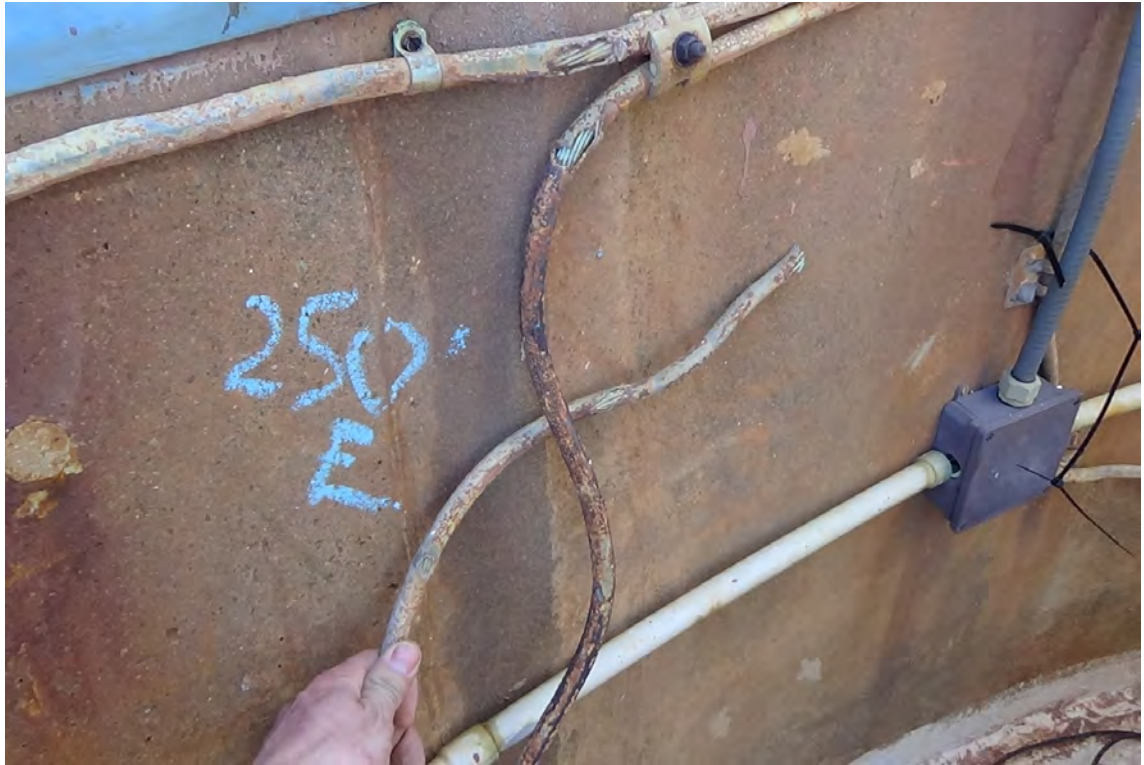
250' E—A disconnected ground cable was found to be tucked behind the electrical conduit. The cable is believed to have serviced flue #2. There was not a ground connection on flue #2 found during the inspection. Notice the wear to the lead casing on the ground and circuit cable.

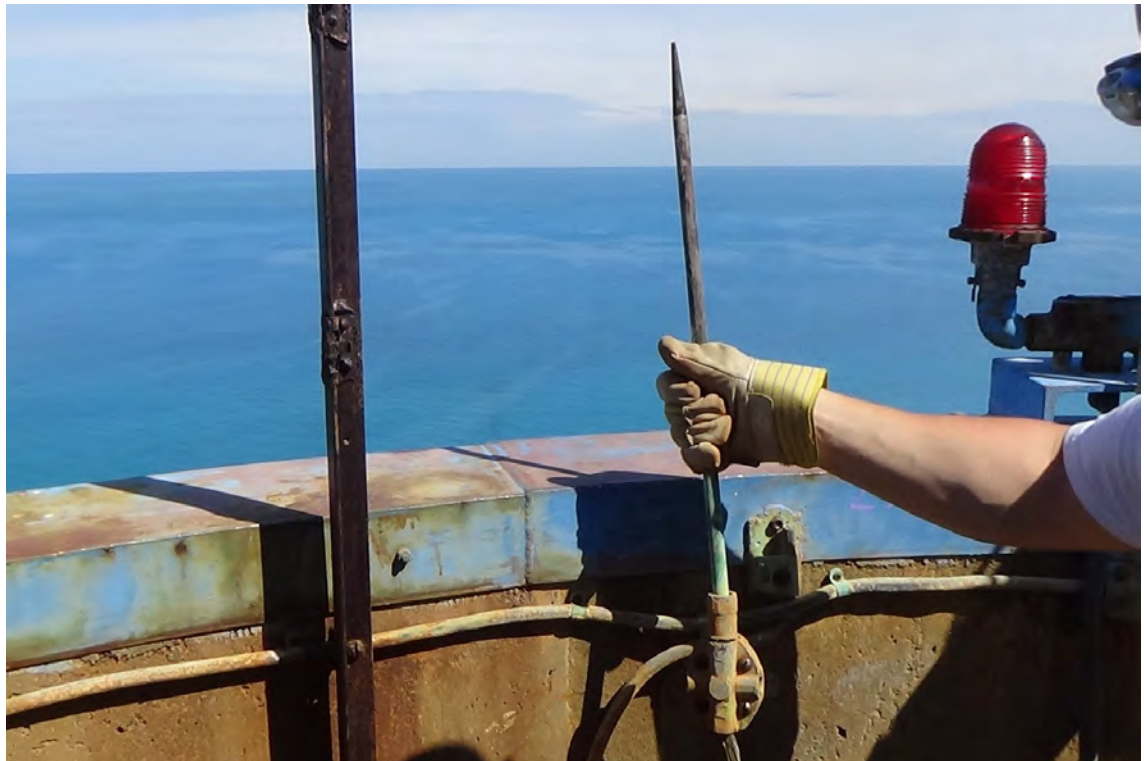
250' N—A stray lightning point was found to be tied into the LPS on the north side. The point is not mounted and was discovered to be tucked in behind the angle iron seen on the left side of the photo.

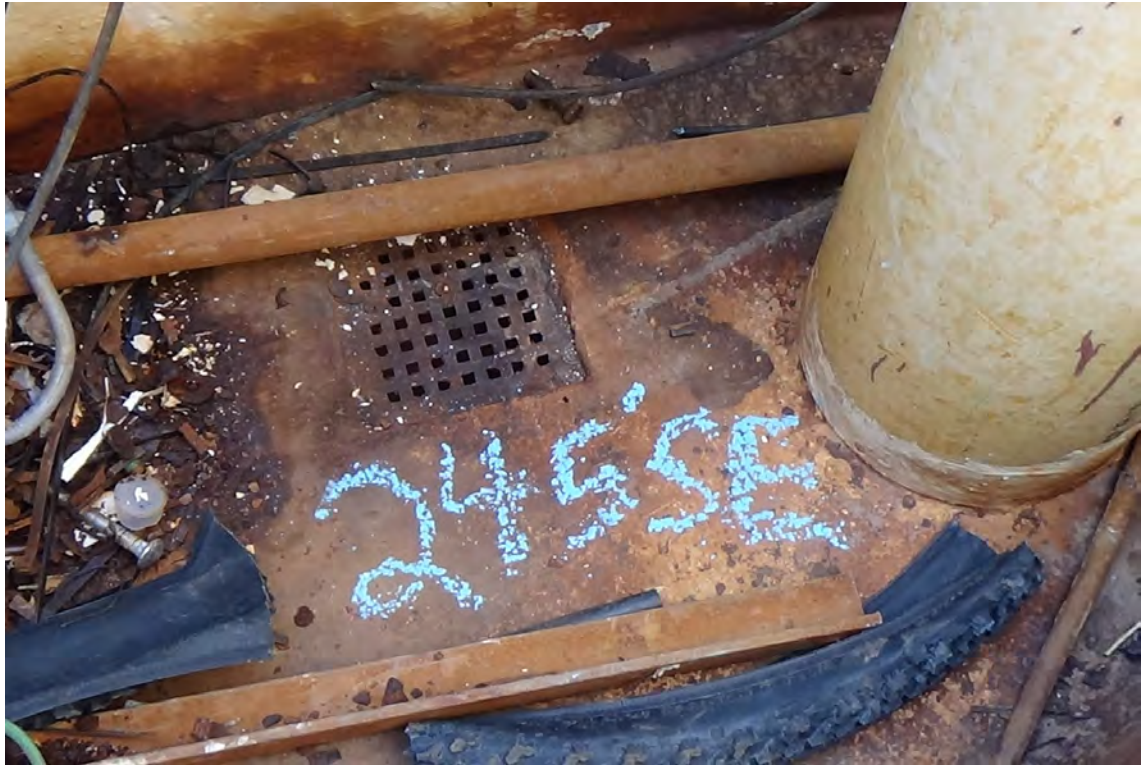
245' SE—The drain cover on the south east side is free of obstructions. The cover plate is level with the concrete floor and appears to be functioning properly. Notice the amount of trash and debris that has accumulated on the roof over the years.

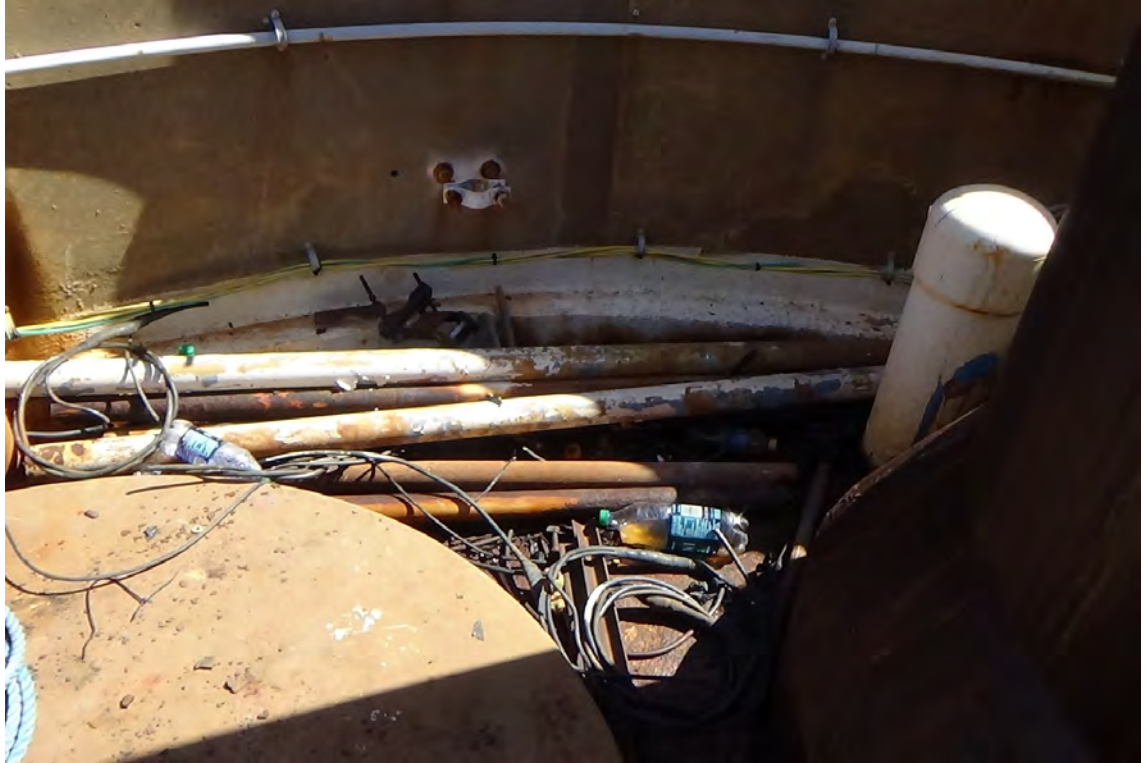
245' N—Trash and scrap material has compiled on the roof deck giving an air of untidiness and creating tripping hazards.

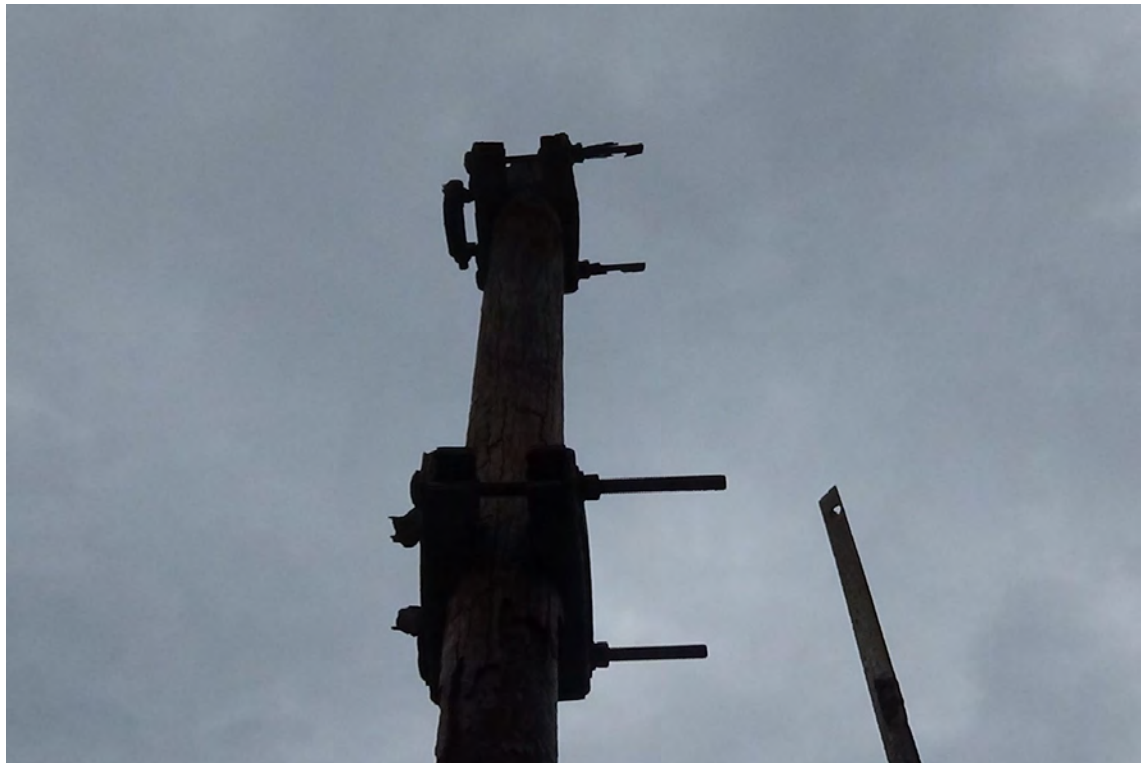
250' NW—An extreme amount of rust and scale are visible on the post and hardware of the obsolete, satellite transmitter mast.

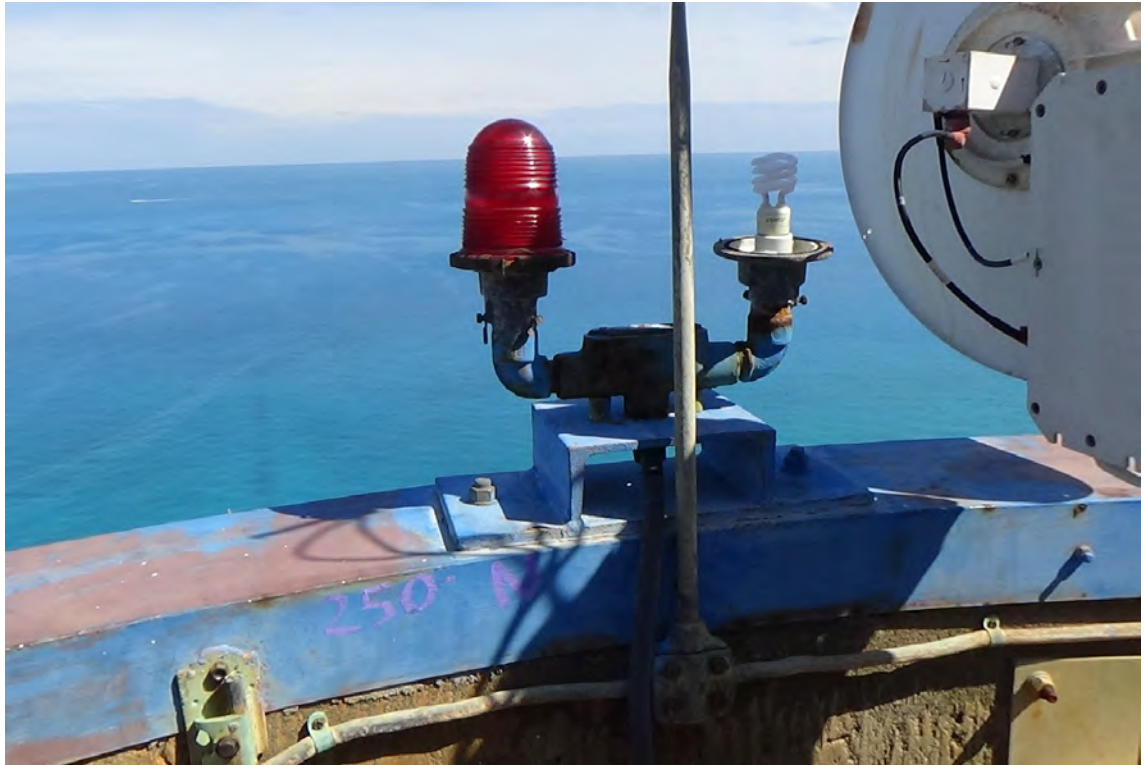
250' N— One red globe on the north side light was found to be missing. Red pieces of glass were discovered on the concrete roof slab, suggesting that the globe fell inwards.

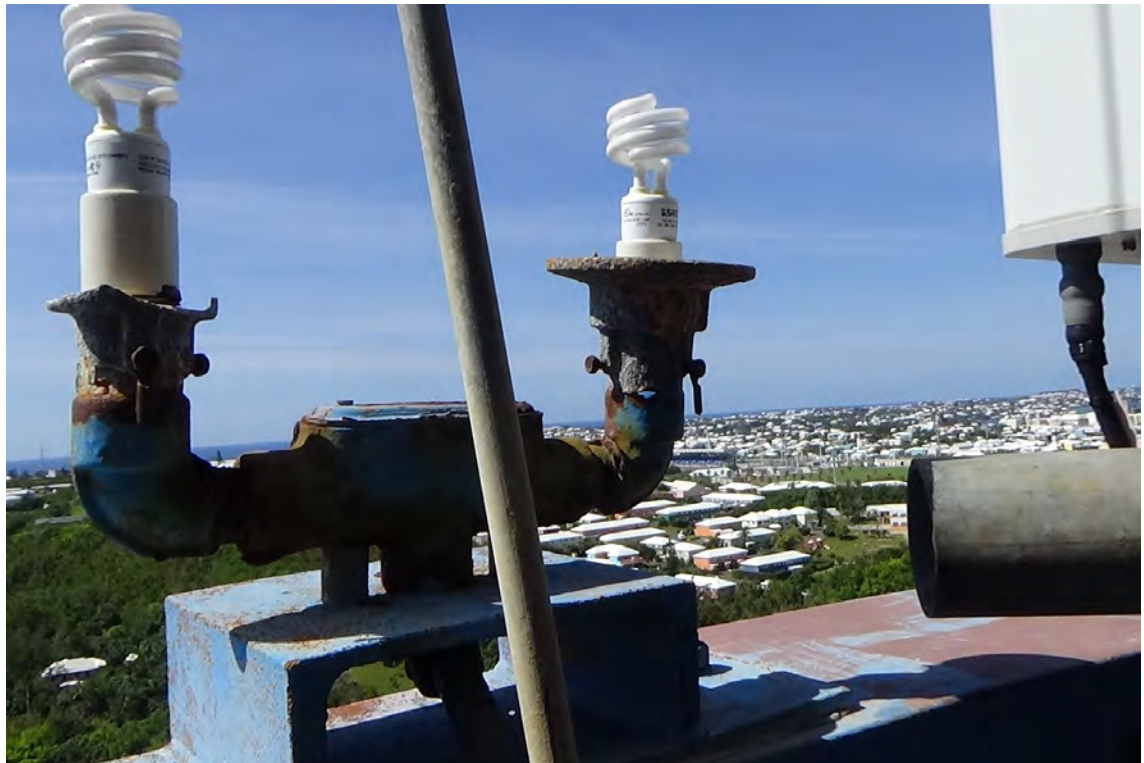
250' S—The red globe on the right side of the AOL was found to be unsecured, the casing on the light on the right was discovered to be cracked 360°. Both globes were removed to eliminate a falling object hazard. They were later replaced and secured with electrical tape as a temporary fix.

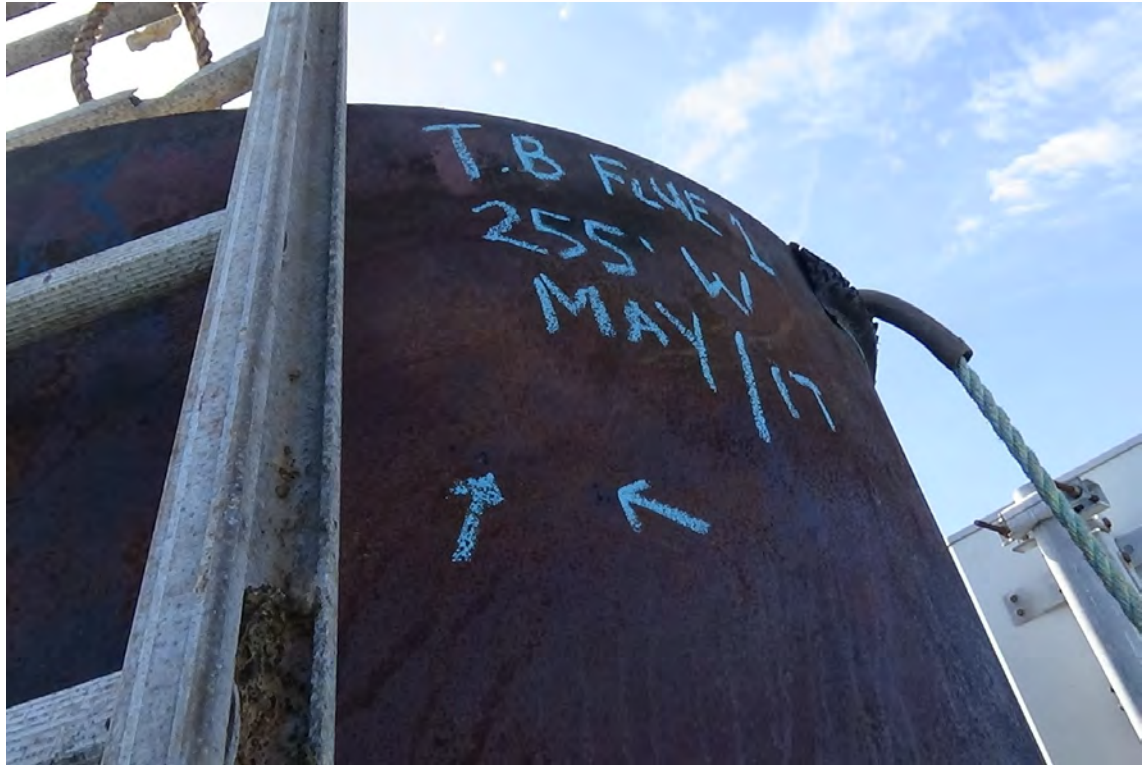
255' W—The top of flue #1 displays a moderate amount of pitting and corrosion within the top 5' of the stainless steel cladding. The blue arrows point to corrosion holes in the cladding.

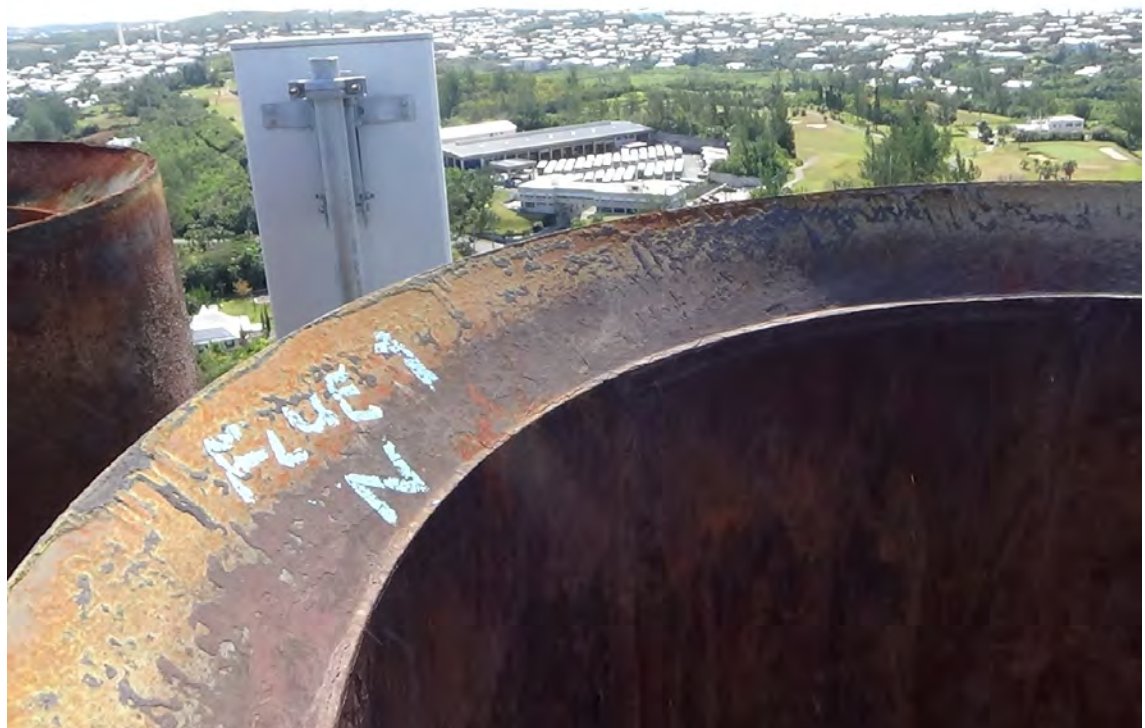
255' N—View looking at the top of flue #1 rain cap. The cap measures 6" in width and displays a moderate amount of deterioration throughout. The top of the liners were at one time painted. That may explain the blotchy appearance as the primer coat has mostly deteriorated.

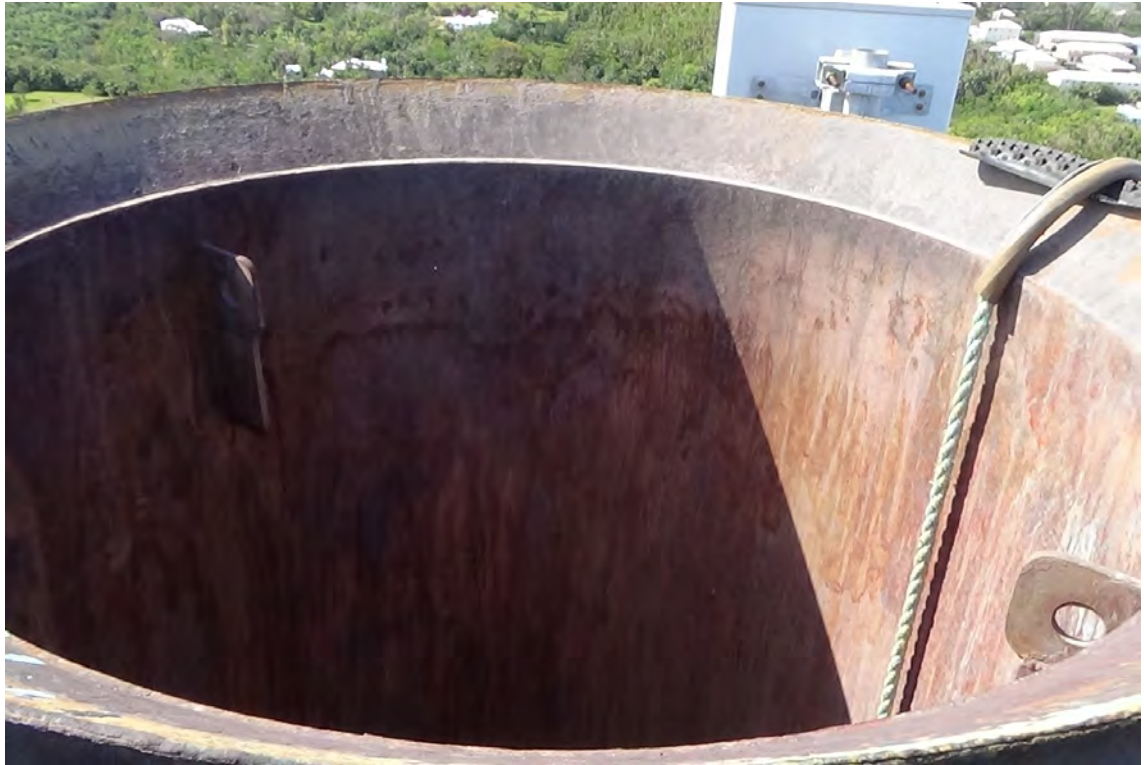
250' S—View looking across to the top of flue #1. A crack in the weld connecting the rain cap to the cladding can be seen in the very bottom right hand corner of the photo.

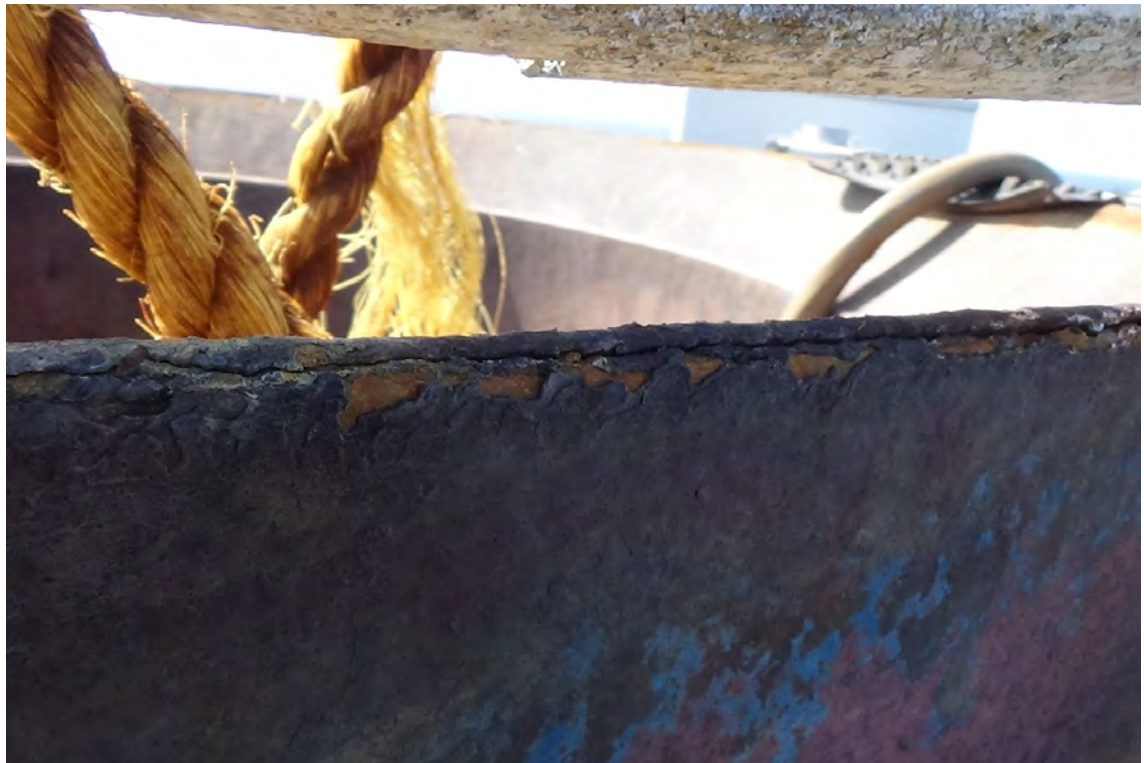
250' NW—Close-up of the cracked weld mentioned in the photo above. The crack continues for approximately 5'-0". The corrosion below the crack appears to be deteriorated paint.

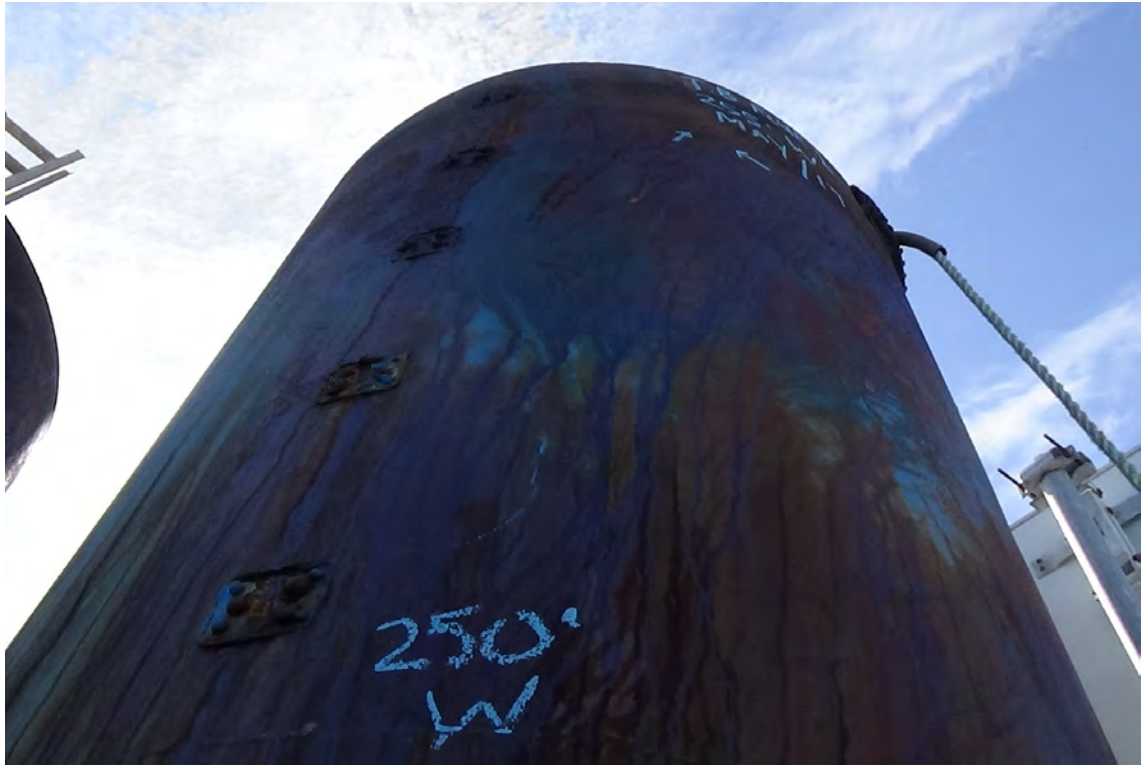
250' W—The exterior cladding of flue #1 was painted blue in the past. A minimal amount of original paint is still visible. The top 5' of the cladding displays a moderate amount of corrosion. Pock marks within the cladding are near penetrating through to the insulation underneath. Corrosion holes are visible near the top.

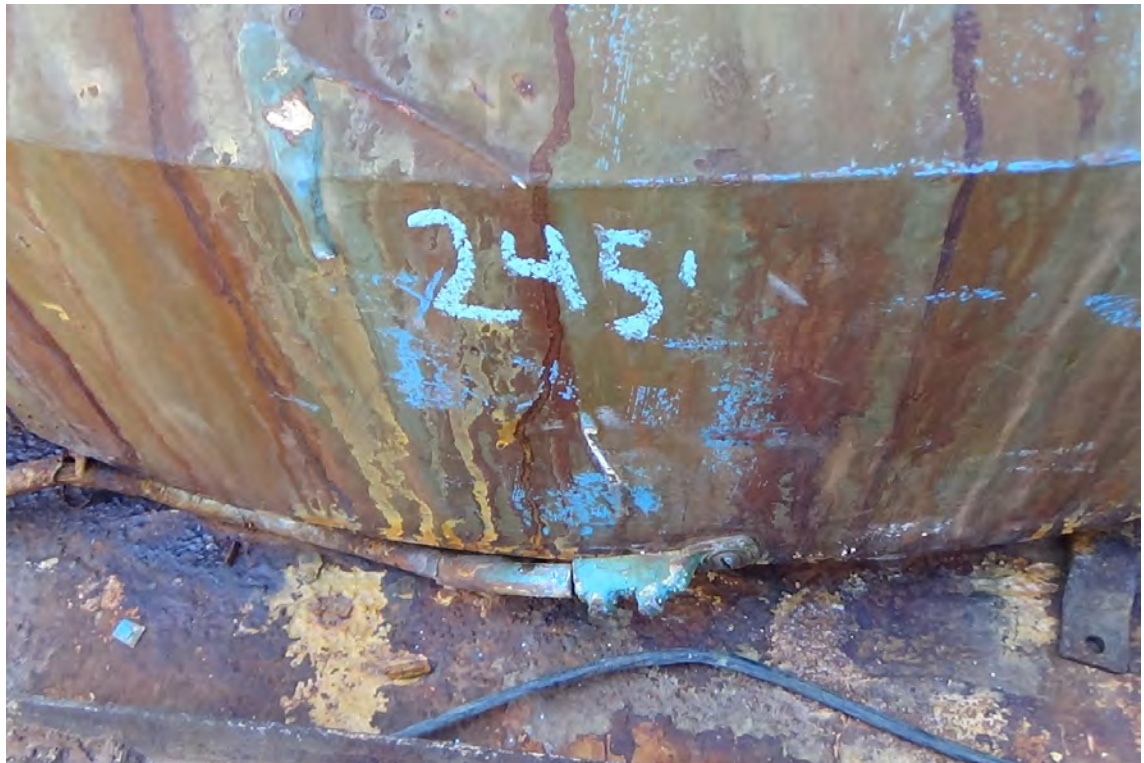
245' W—The ground connection to the skirt of flue #1 is present and intact. The same ground cable was found to be severed near the connection point to the downlead. This appears to be the only location in which the liner is grounded.

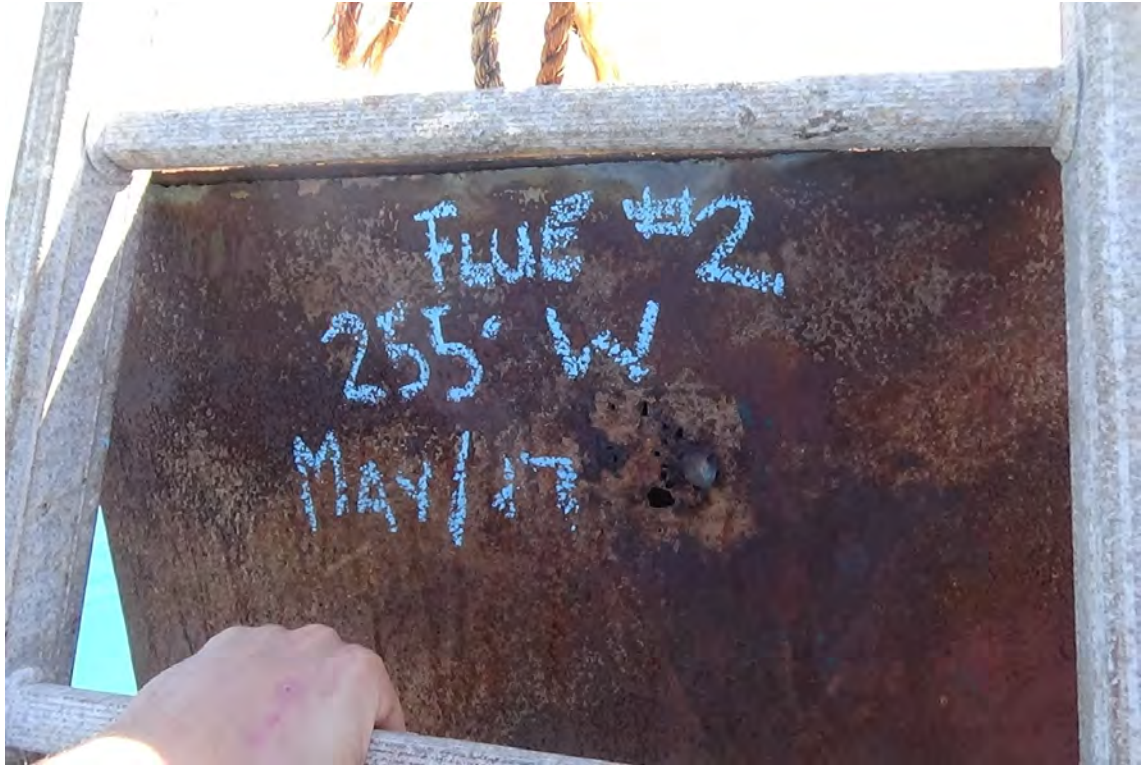
255' W—The top 5' of the stainless steel cladding on flue #2 is severely corroded. Approximately 300° of weld connecting the rain cap to the cladding was found to be cracked causing a large misalignment between the two components.

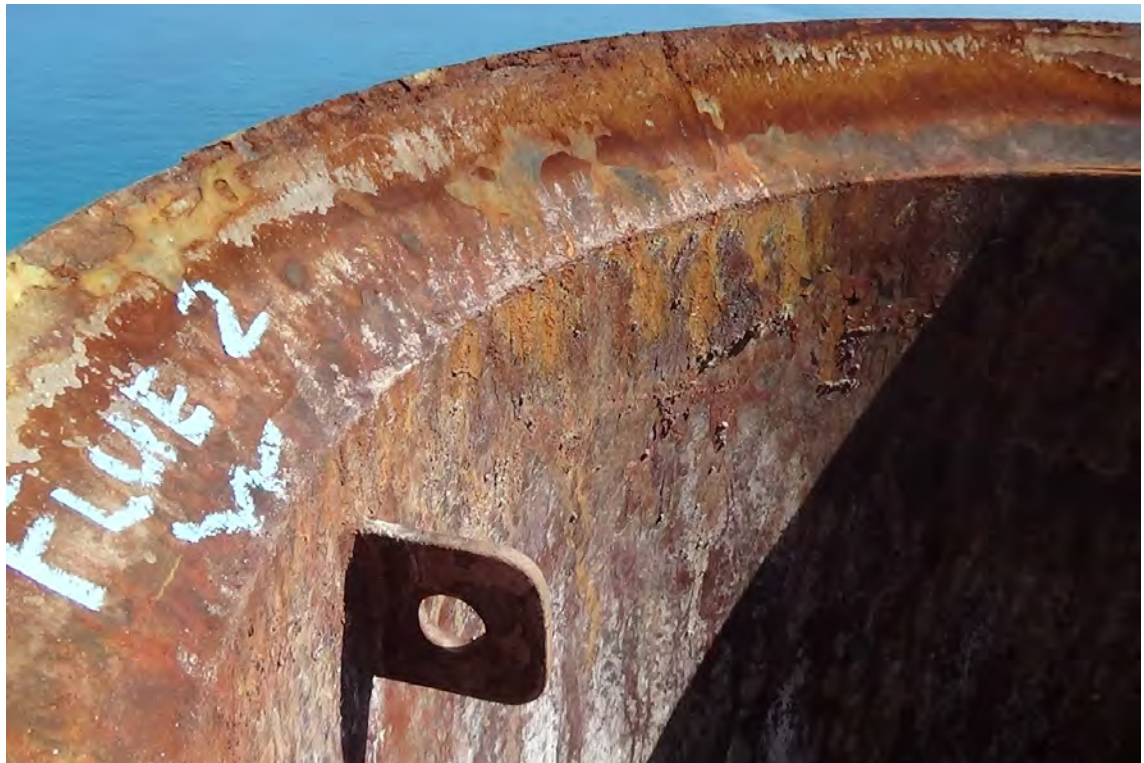
255' NE—A crack approximately 3' long was observed in the weld connecting the cap to the liner wall on flue #2. The corrosion at the top of flue #2 appears to be more profound than that of flue #1.

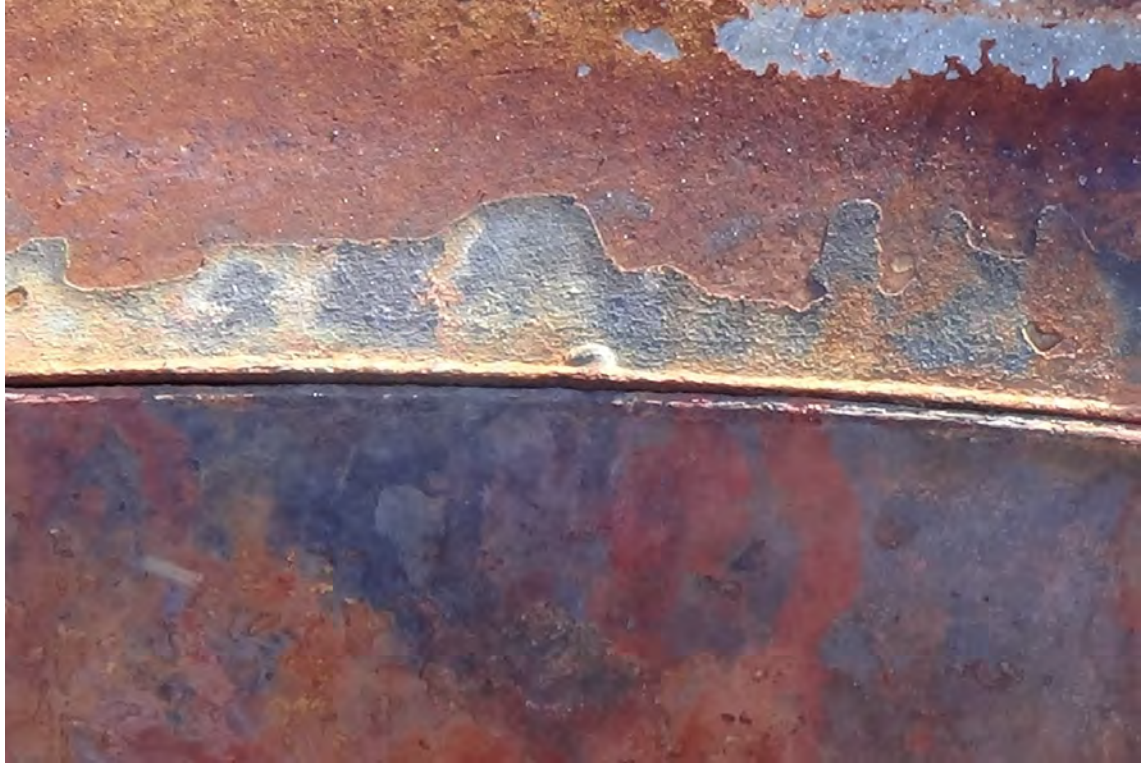
255' E—Close up photos of the cracked weld which attaches the rain cap to the interior flue wall. This particular crack continues for approximately 3'-0".

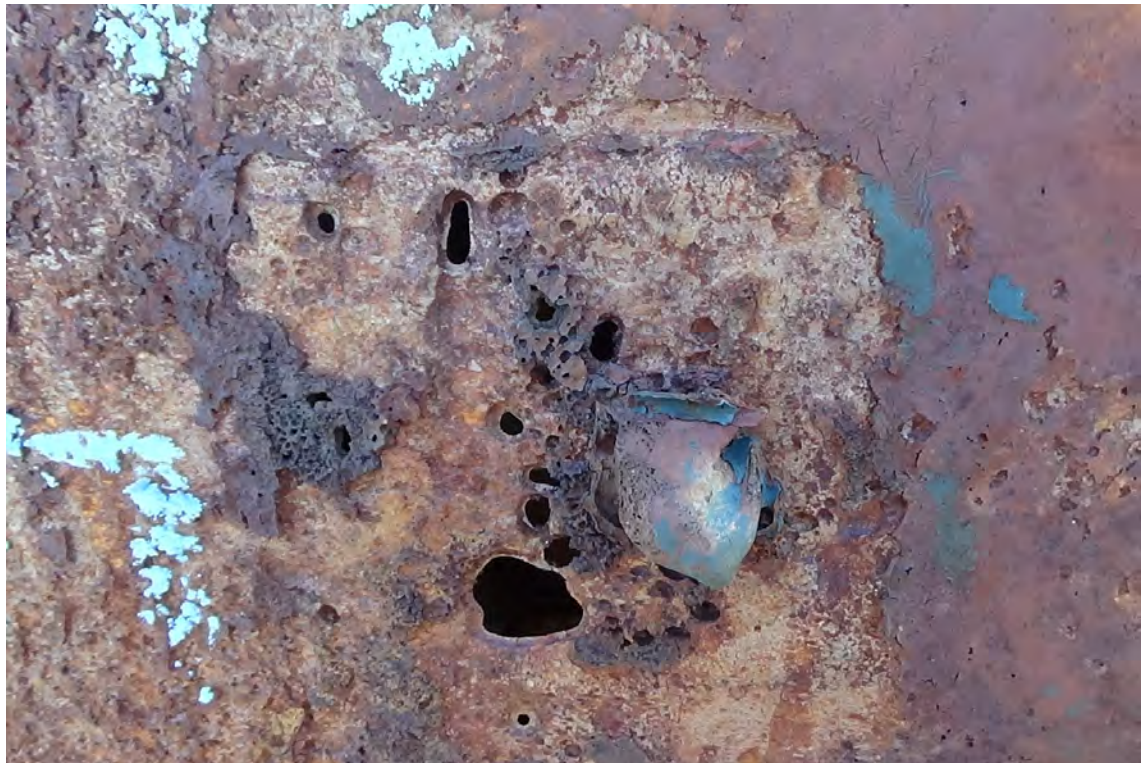
255' W—Small corrosion holes are visible in the stainless steel cladding throughout the top of flue #2. The insulation between the cladding and the liner wall is partially exposed.

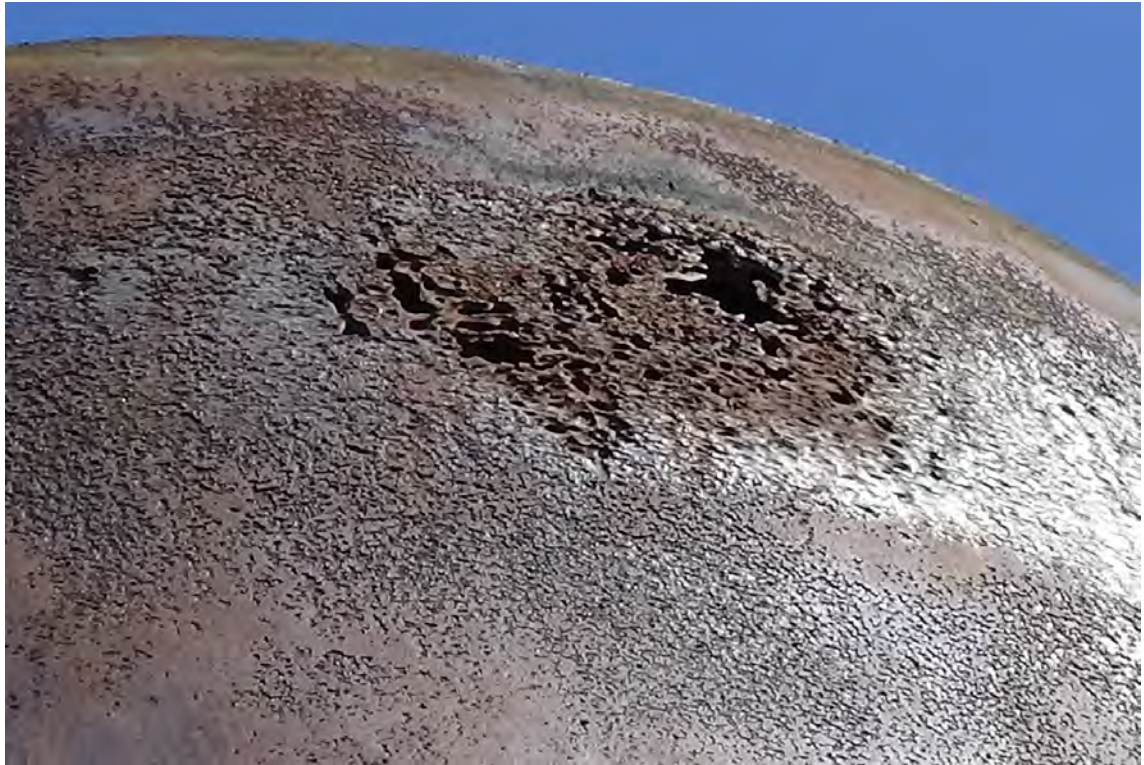
255' S—Large area of corroded cladding on the south side of flue #2. The pitting of the stainless steel is very noticeable in this location.

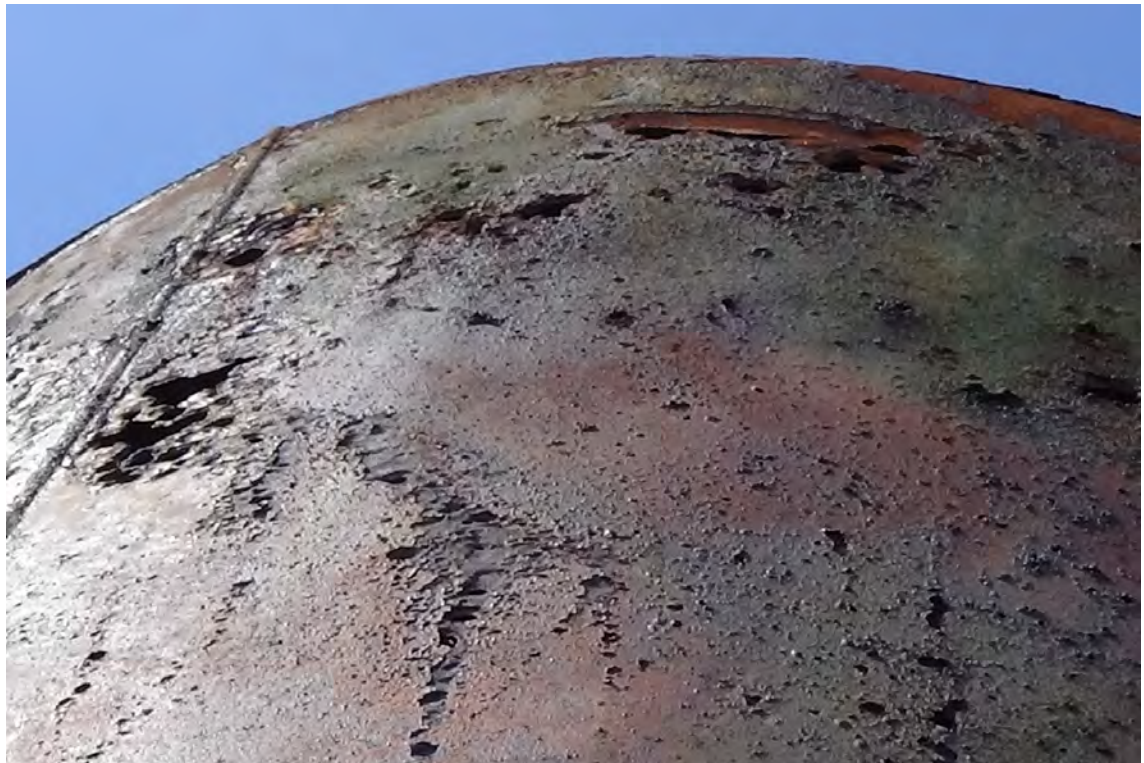
255' NE—More areas of corroded cladding at the top of flue #2. The void in the top right corner of the photo is near 8" in length. The horizontal weld attaching the rain cap to the cladding has cracked in this area. A small amount of overhang is visible which displays the misalignment between the components.

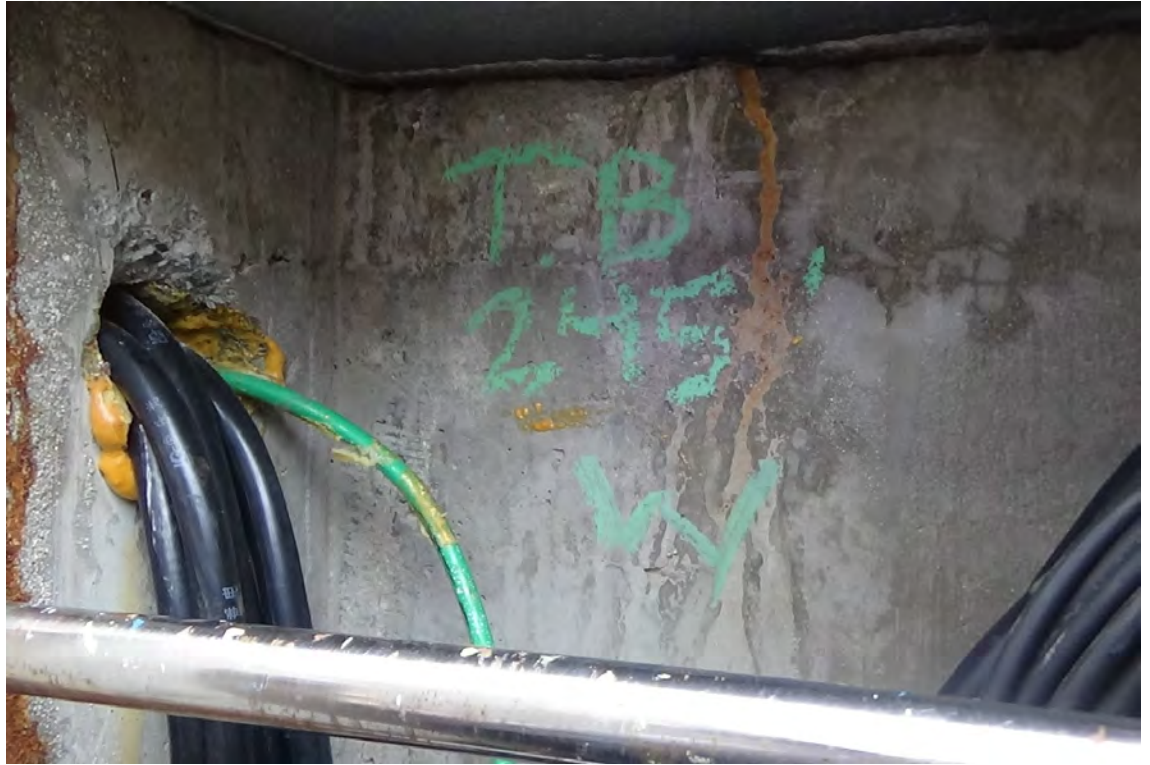
245' W—Expandable foam was used to seal the holes where the electrical and satellite cables exit the concrete column. Much of the foam appears to have deteriorated leaving a slight void behind.

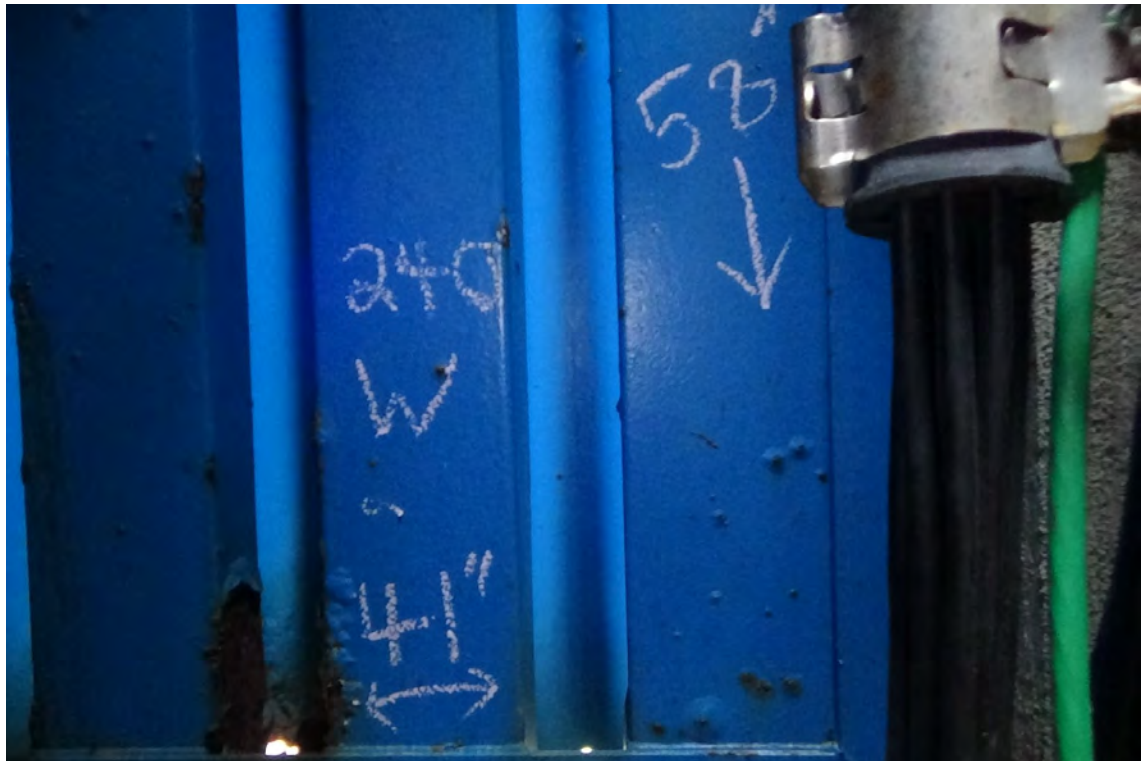
240' W—Field measurements of the vent cover are indicated. The blue paint is peeling towards the bottom of the channels due to rust and scale build-up.
