**HAMON CUSTODIS-COTTRELL
 (CANADA) INC.**
 23 West Beaver Creek Road
 Richmond Hill, Ontario, L4B 1K4

INSPECTION REPORT

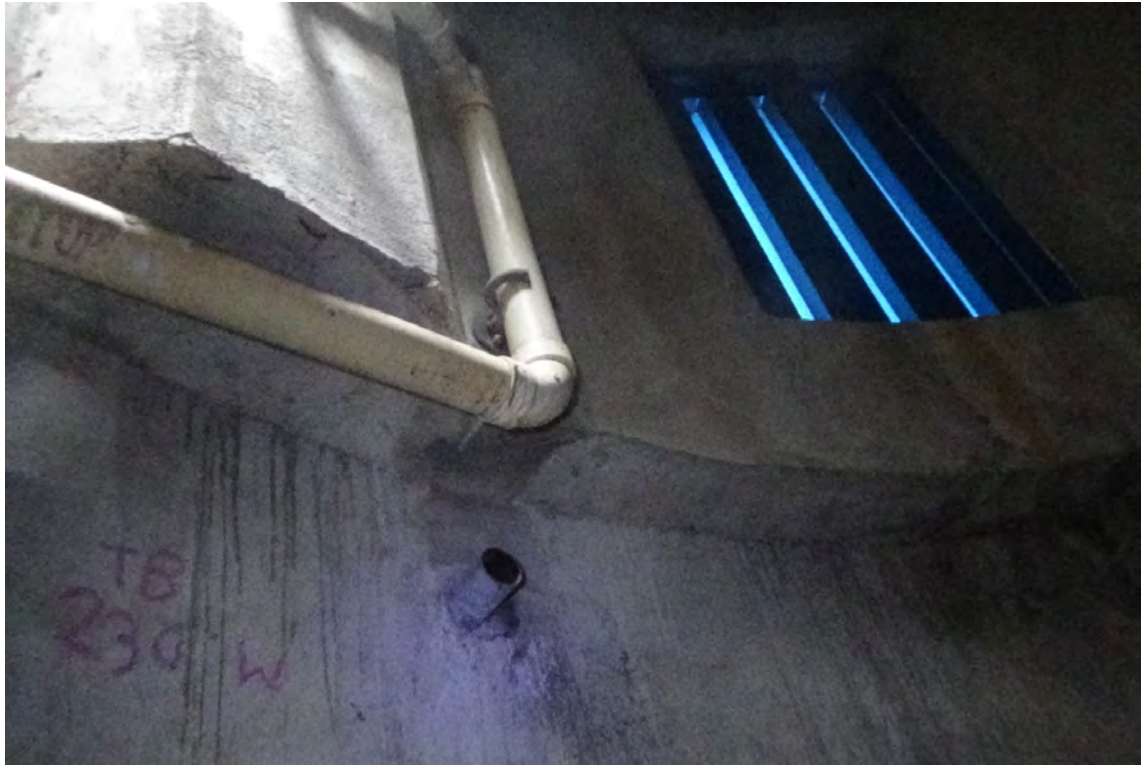
230' W—The drain pipe below the roof elevation is fully intact and properly secured. Notice the interior wall thickness increase of $7\frac{7}{8}$ ". This wall increase is necessary to carry the weight of the roof slab, carrier beam and flues.

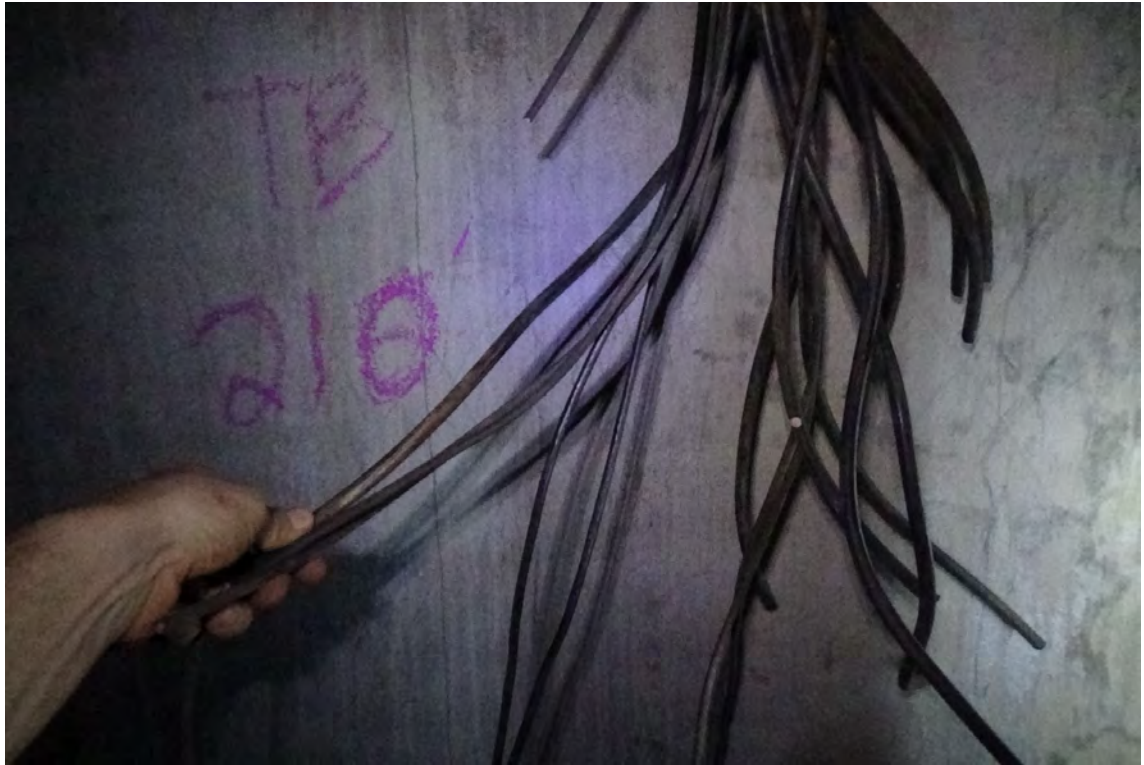
210' W—The wiring for the obsolete satellite transmitters has been severed at this elevation. The loose wires have been left hanging in the annular space.

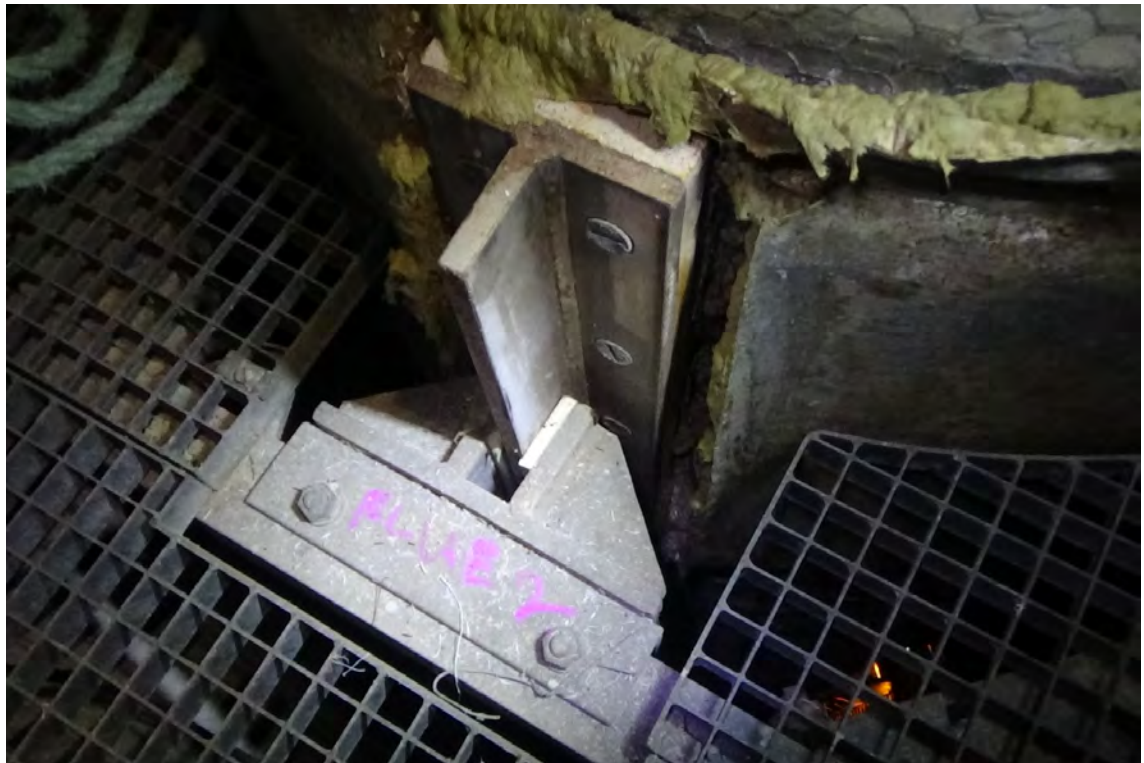
200' E—Each liner is furnished with four horizontal stabilizers located 90° from one another. These stabilizers consist of a system to keep the liners centered and allows for the liners to expand and contract during thermal expansion. All stabilizers were found to be intact, with all components in sound condition.

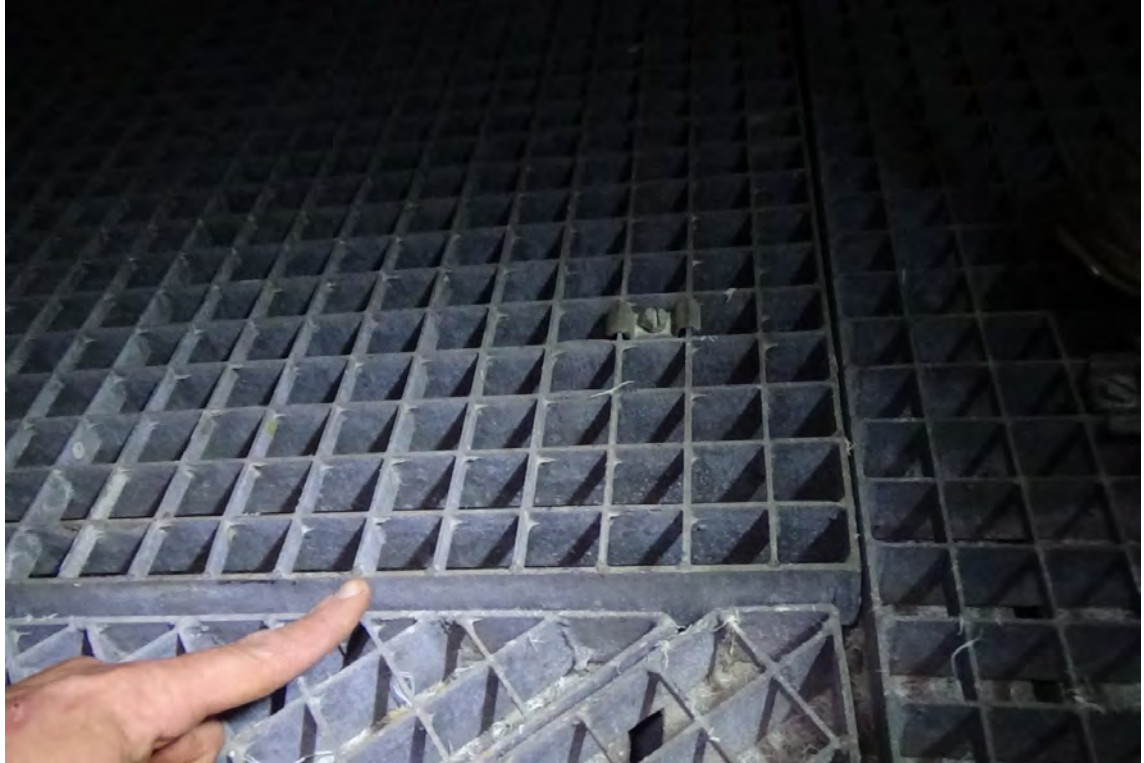
200' N—The grating which is located within the bay allotted for a third flue, appears loose and misaligned with the rest of the grating on the platform. It is believed that this grating is removed from time to time to hoist material to the upper elevations.

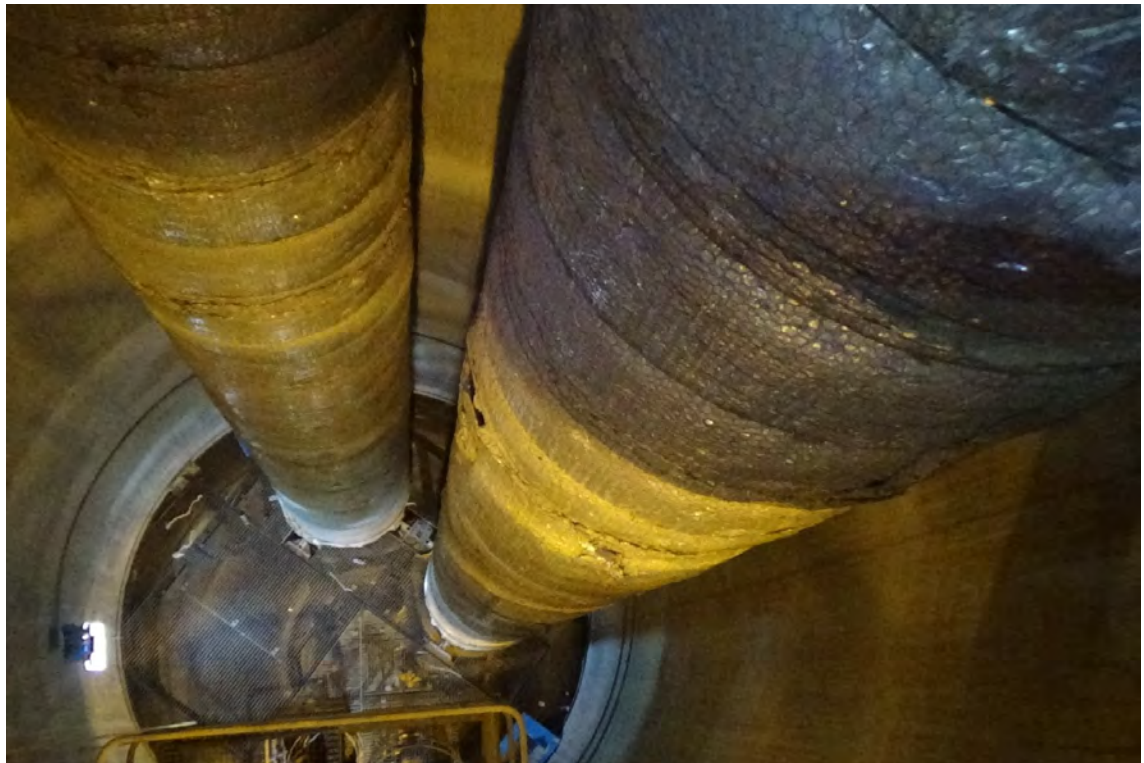
185' E—View looking down shows the the insulation and wire mesh on both flues appears to be fully intact with no sign of damage.

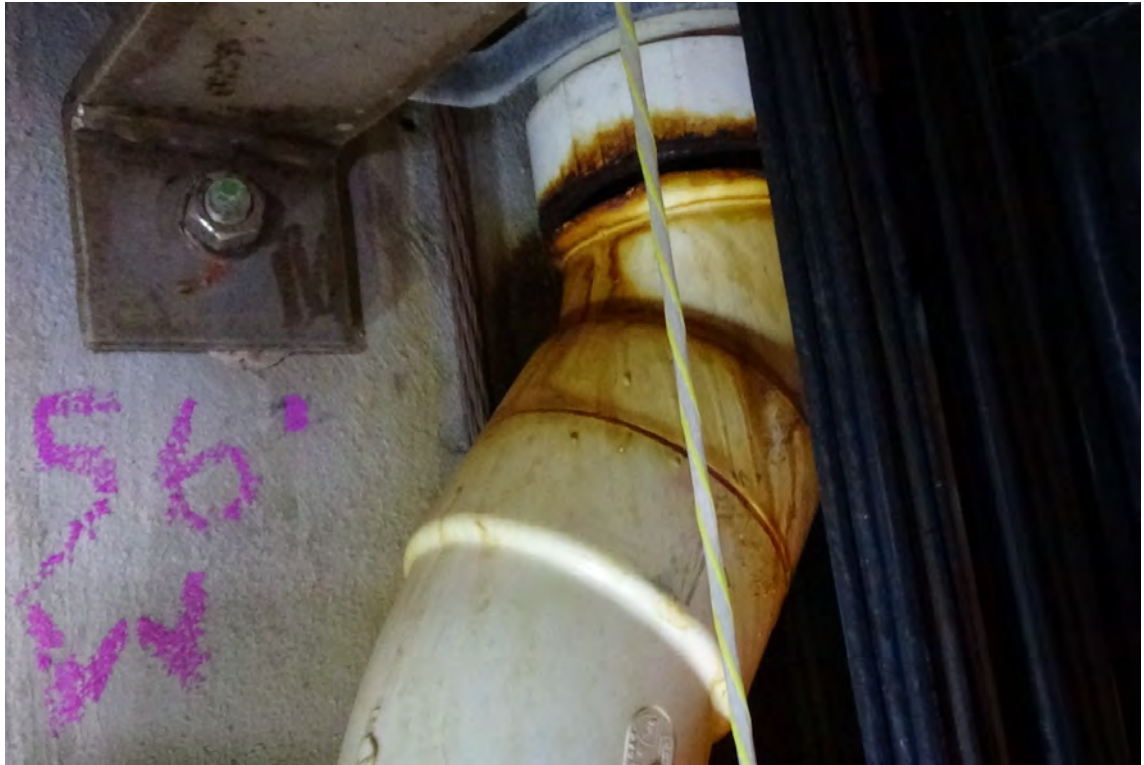
156' W—A break in the drain pipe was visible at this elevation. It appears as though the PVC pipe has cracked at a connection point leaving a $\frac{3}{8}$ " gap, 360° around the pipe.

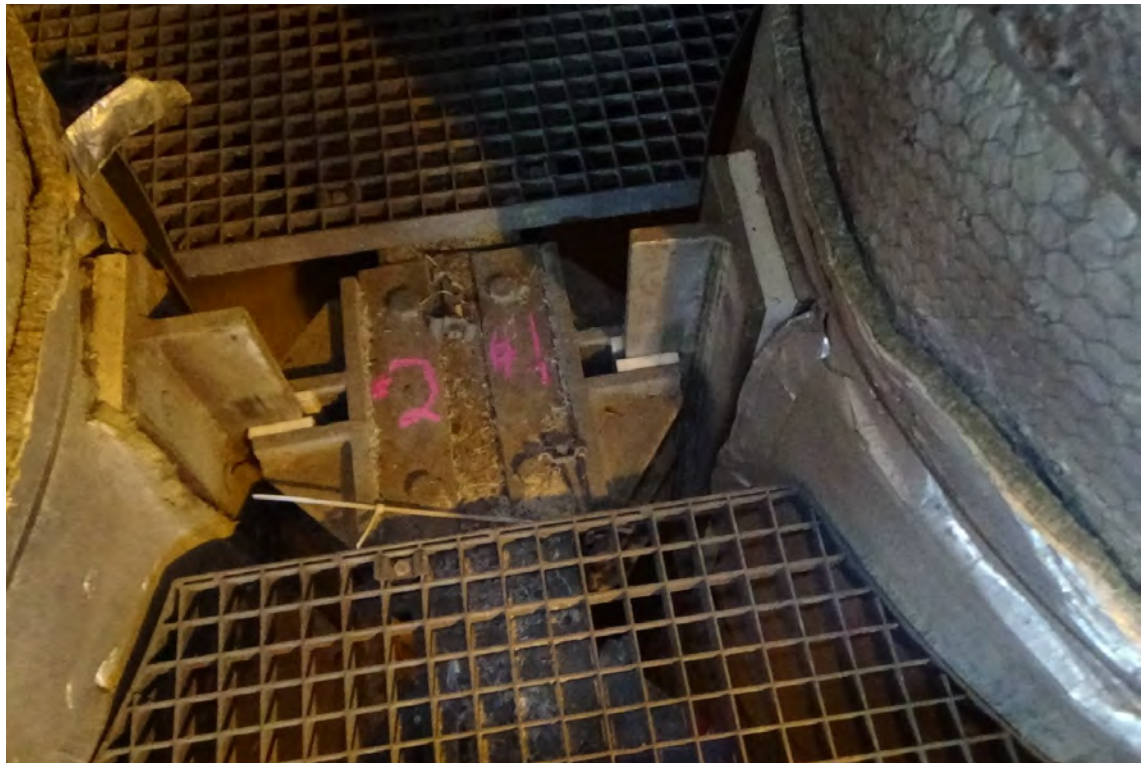
150' E—Horizontal stabilizers were thoroughly inspected during the inspection. All support bolts, welds on the stabilizer plates and teflon pads were all found to be in satisfactory condition.

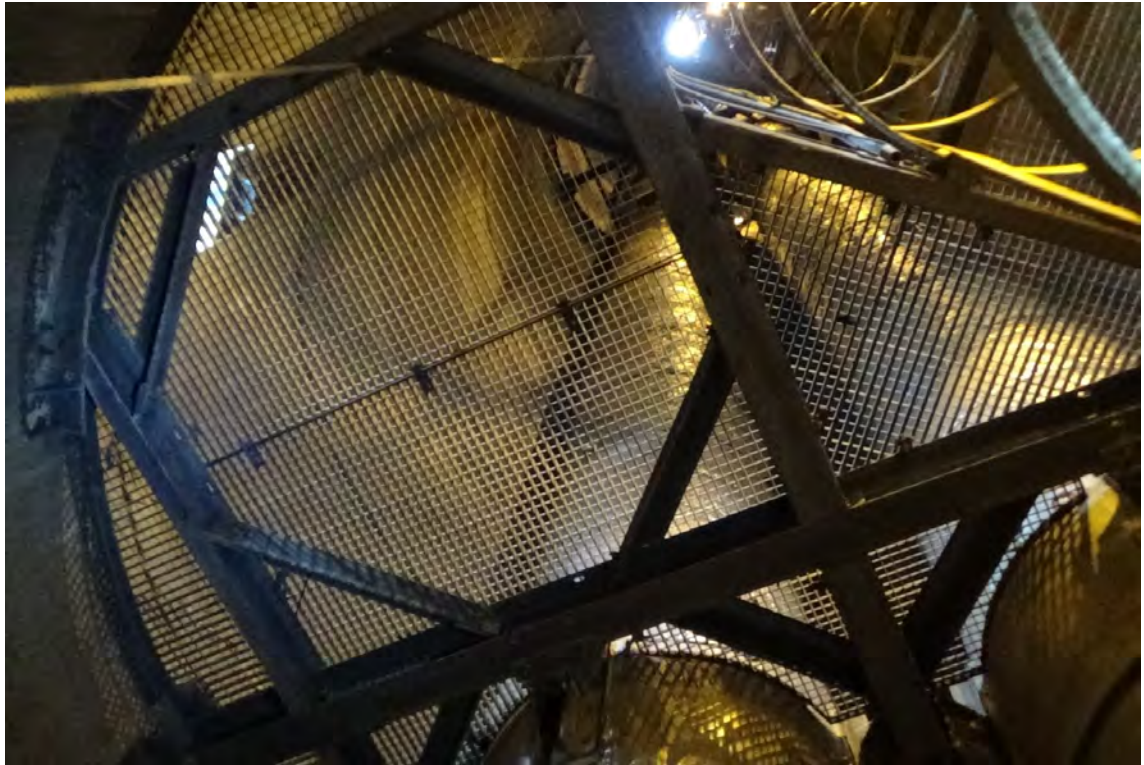
135' N—Provisions have been made in the platform support steel to accommodate a third flue. The amount of support steel is sparse in these areas. Otherwise, the support members are all in sound condition. All platform anchoring is in place and appears to be properly torqued.

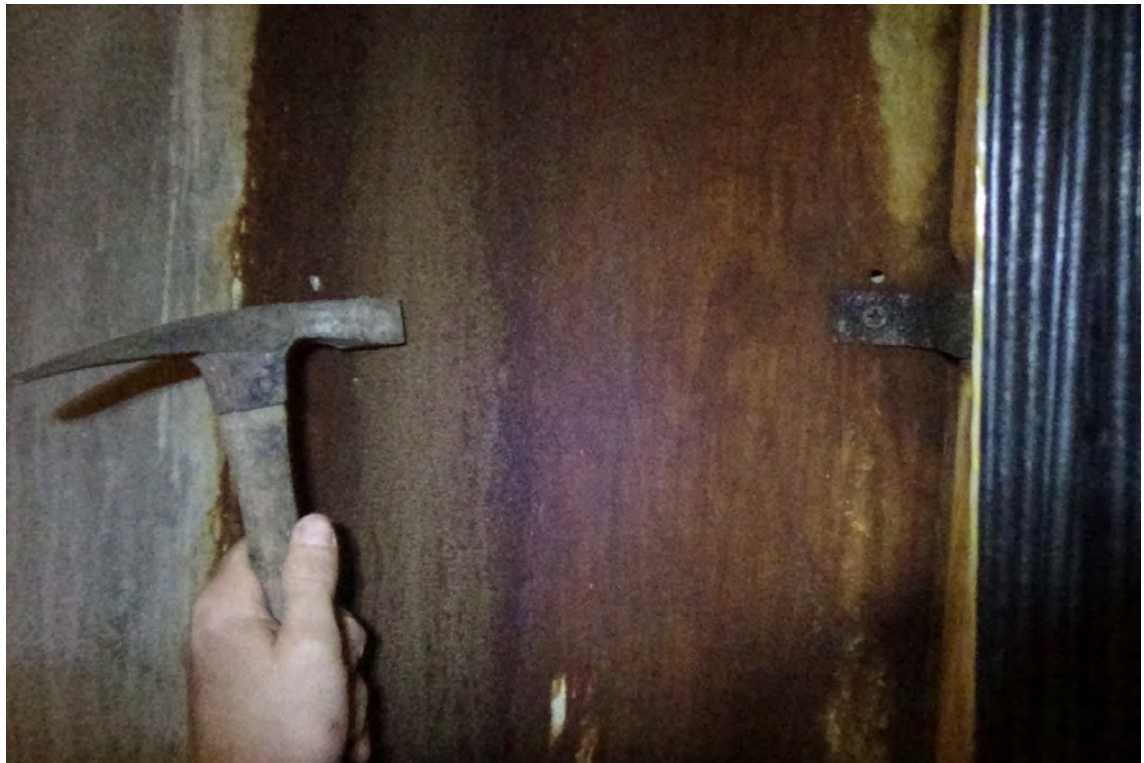
135' W—Substantial staining is noticeable on the concrete below the break in the drain pipe. This staining is visible from approximately the 156' elevation to the ground. The concrete was hammer tested in multiple areas throughout the stain and was found to be intact and solid.

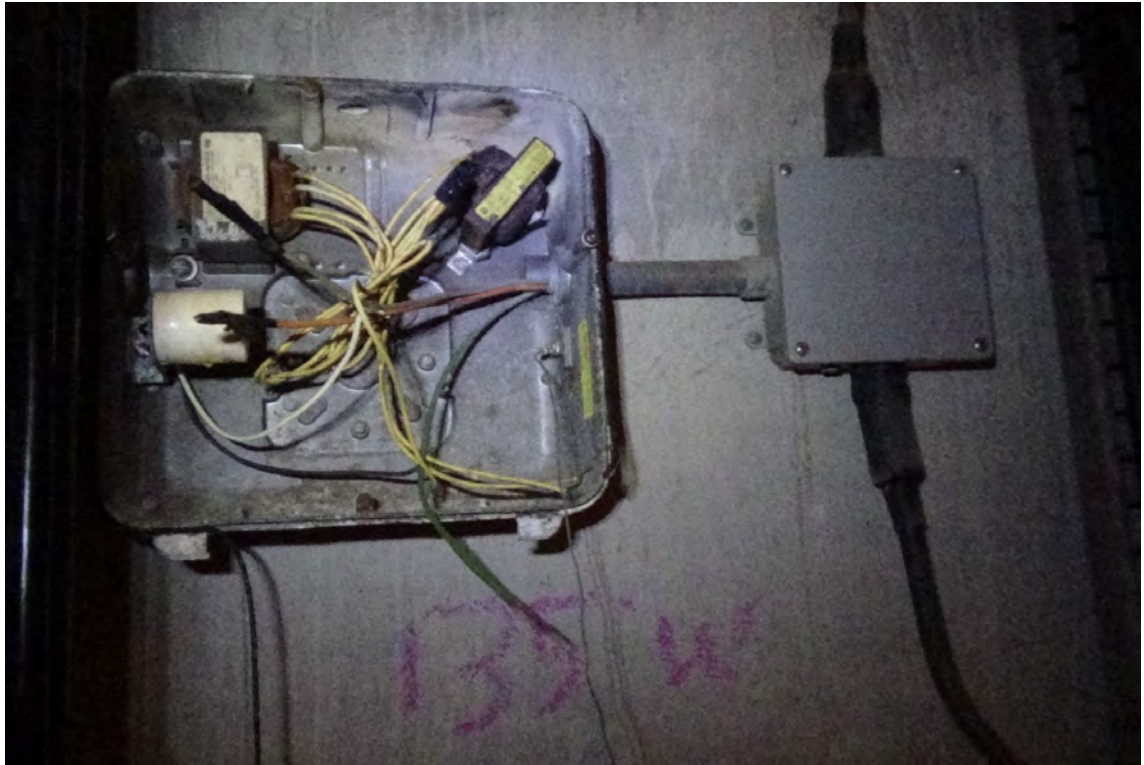
135' W—A single lighting fixture located at approximately 135' was found to be open with the cover and bulb removed. This light is located directly below the leak in the drain pipe. It is likely that moisture penetration into the unit has caused damage inside the light casing.

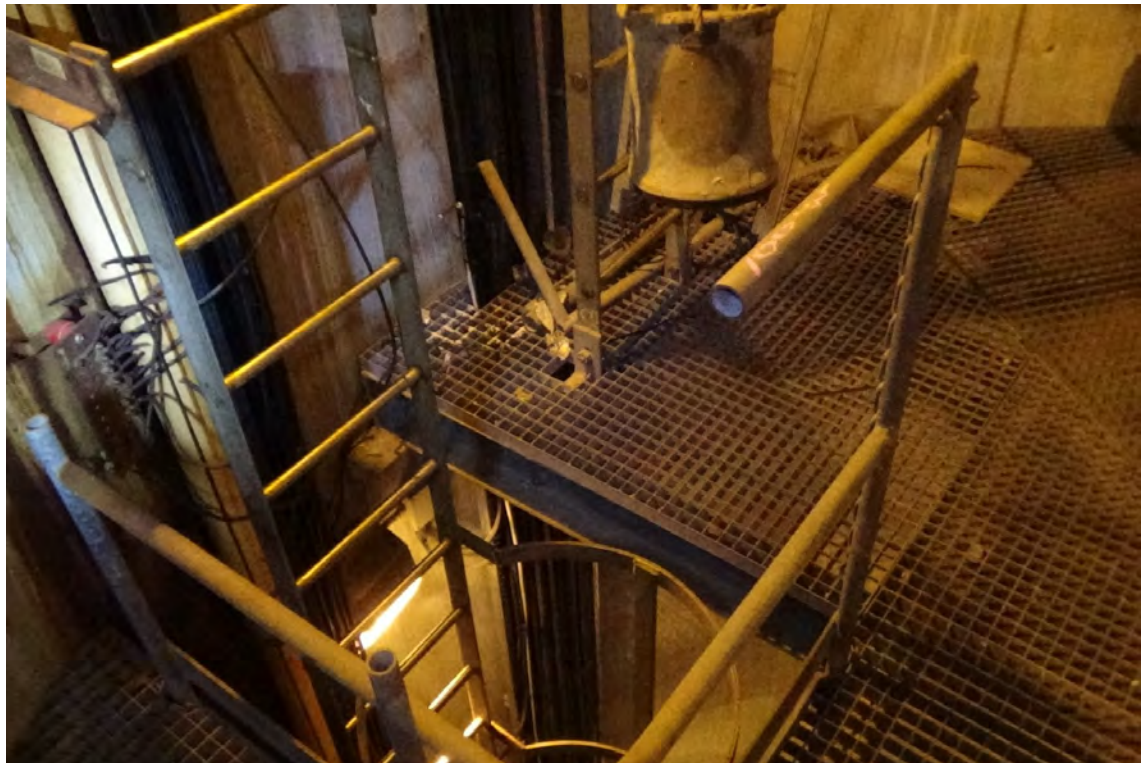
100' W—The handrail around the ladder penetration opening has been cut and removed to accommodate CEMS testing equipment. If these test ports are obsolete the handrail should be welded back into place.

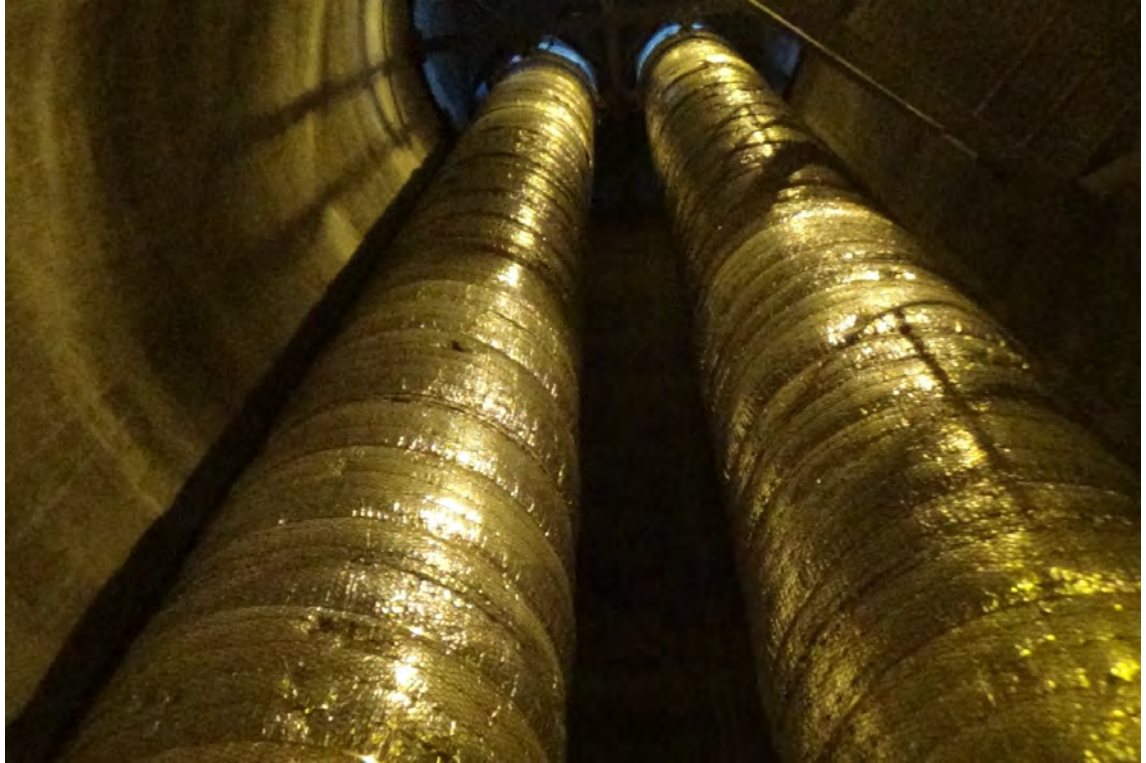
100' E—View looking up at the flues indicates no damage or deterioration to the insulation and wire mesh encapsulating the two flues.

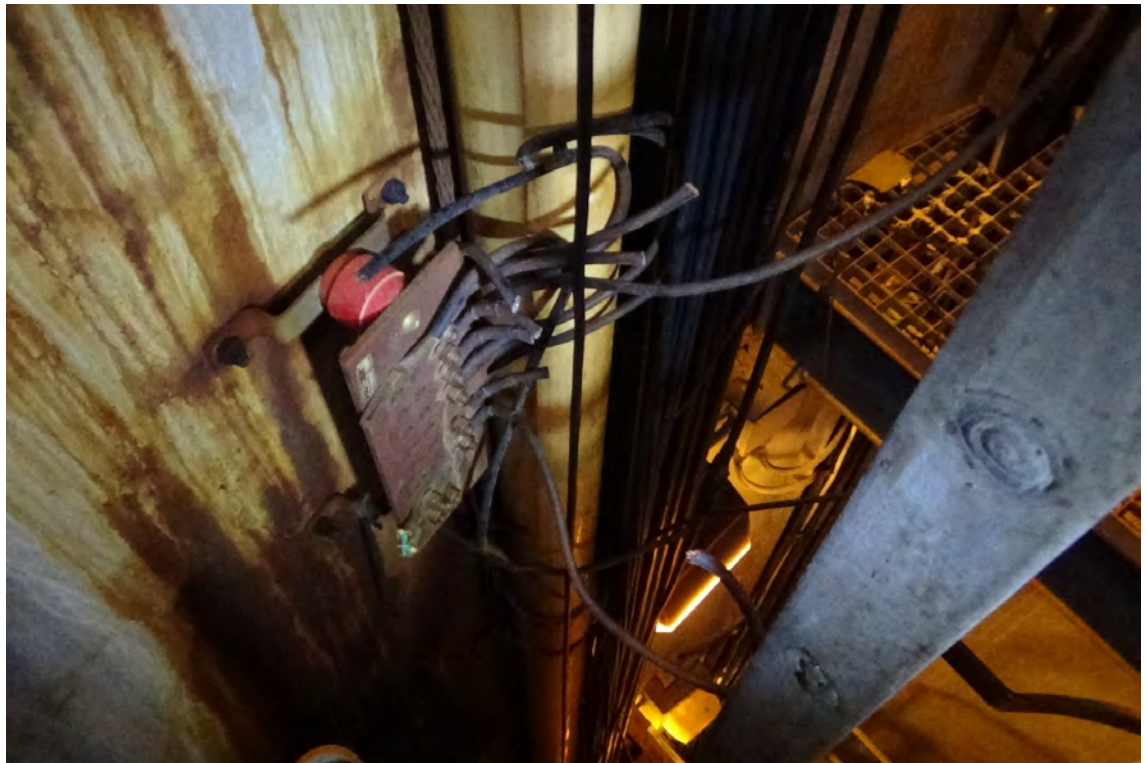
100' W—What appears to be an old termination board for the satellite transmitters is still anchored to the interior wall at this elevation. All the wiring has been severed and the board is obsolete.

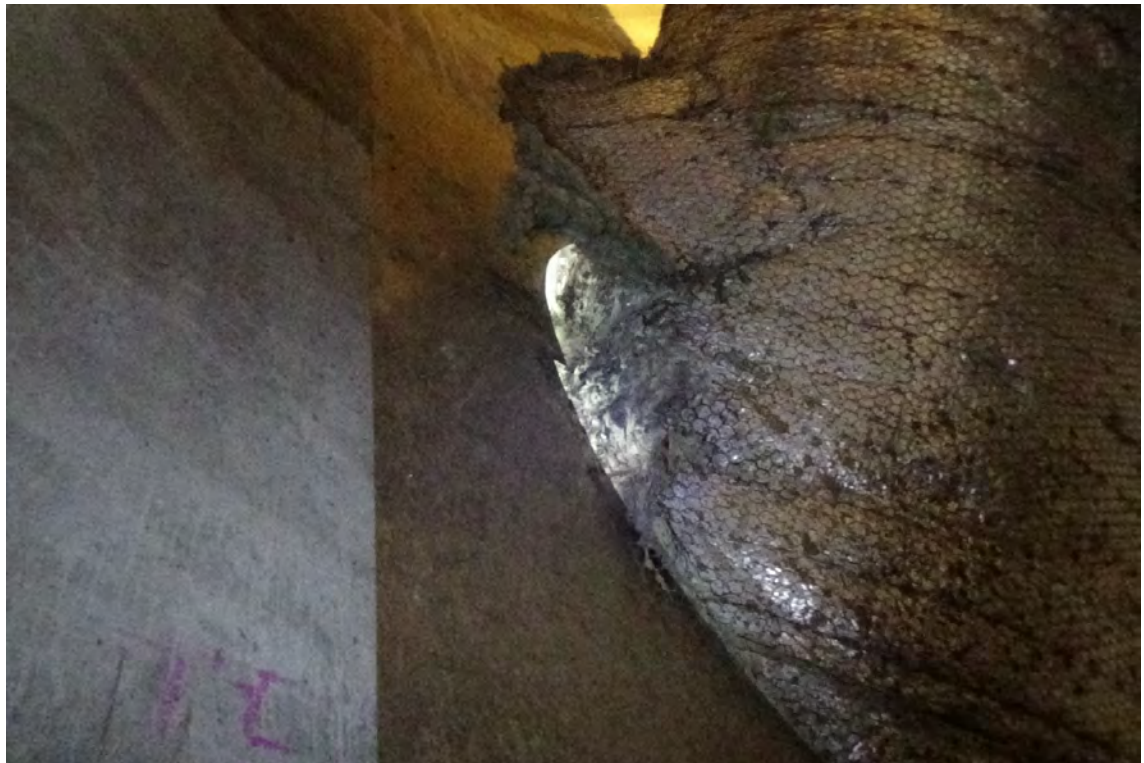
10' SE—Flue #1 breeching duct enters the concrete column on the south east side of the structure. A stainless steel plate is anchored to the concrete in order to minimize moisture penetration into the base. It appears as though the insulation has snagged on the cover plate at some point in time, tearing a small piece.

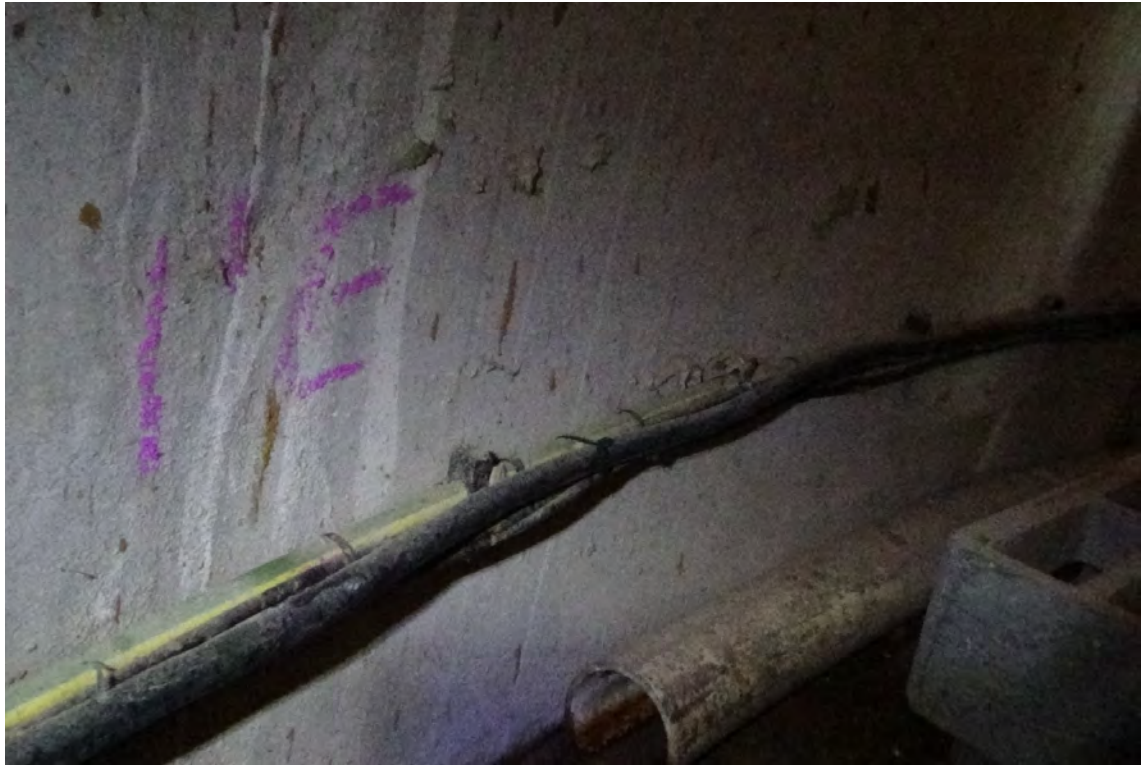
1' E—The circuit and electrical cables are properly secured to the concrete column in a tidy fashion .

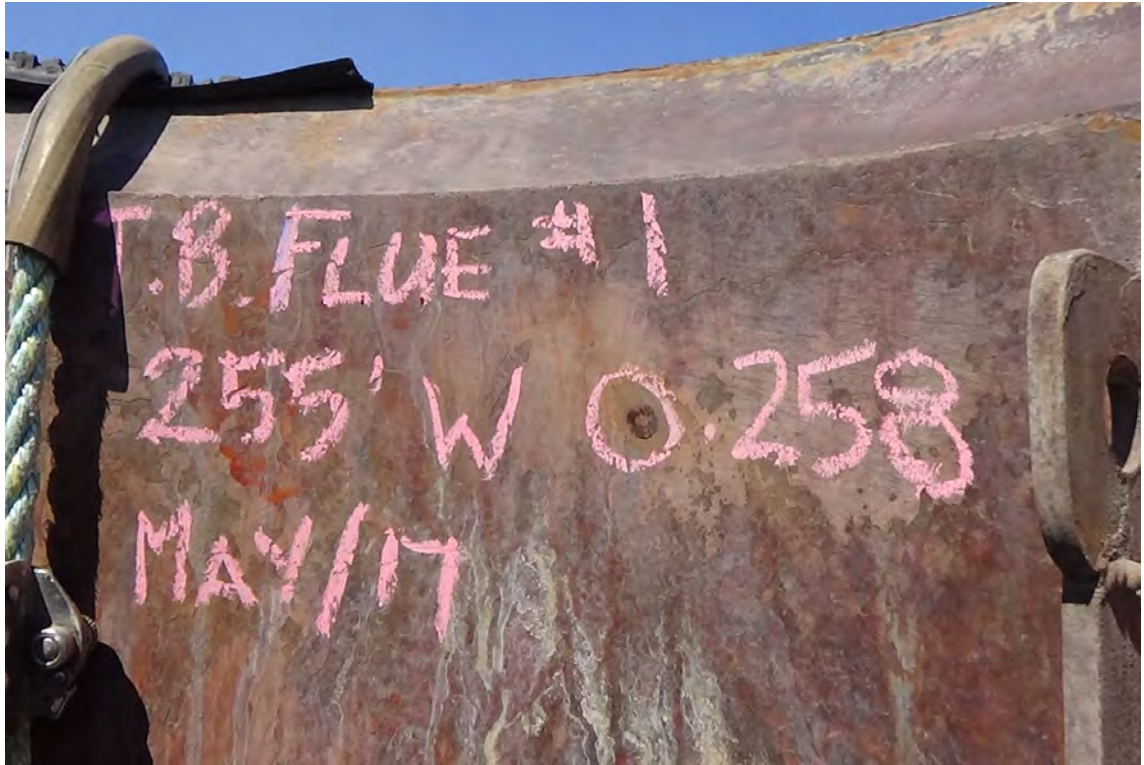
255' W/F1—UT measurements were taken at 5' intervals within the top 15', stainless steel portion of the liner. The measurement at the top elevation (.258) corresponds with ¼" plate thickness.

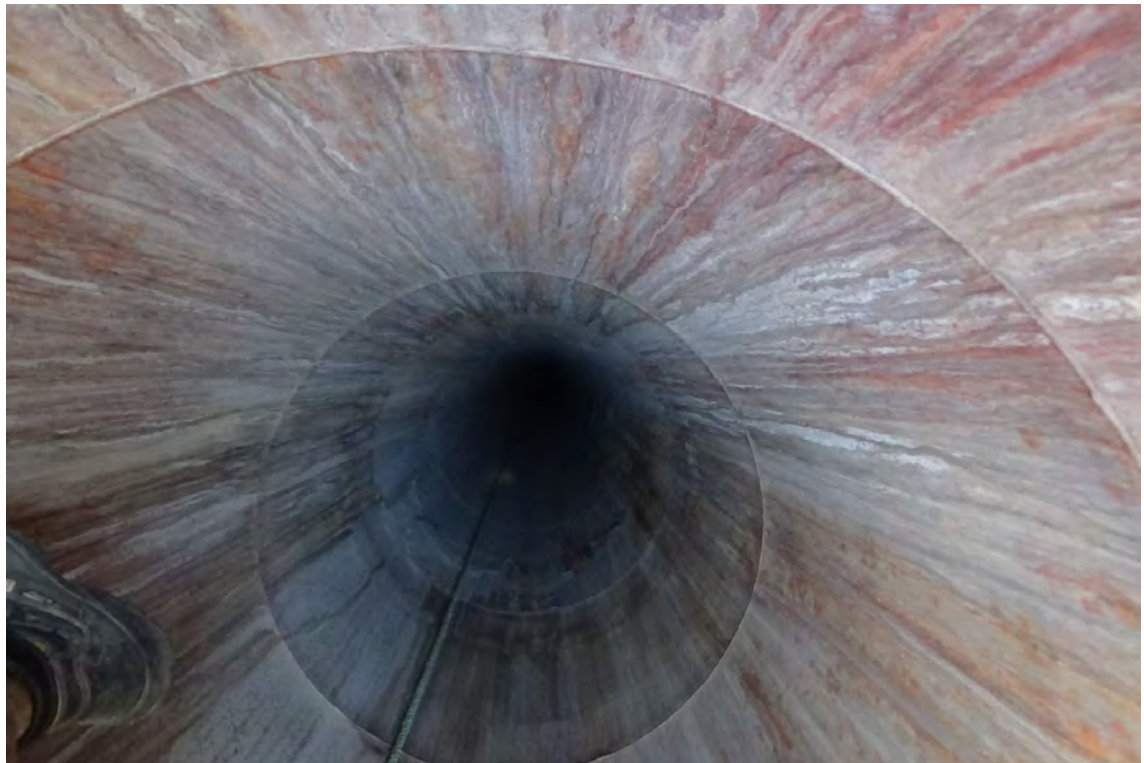
255' W/F1—View looking down at the stainless steel portion of flue #1. Other than the water stains which are clearly visible, the top 15' of the flue appears to be in sound condition.

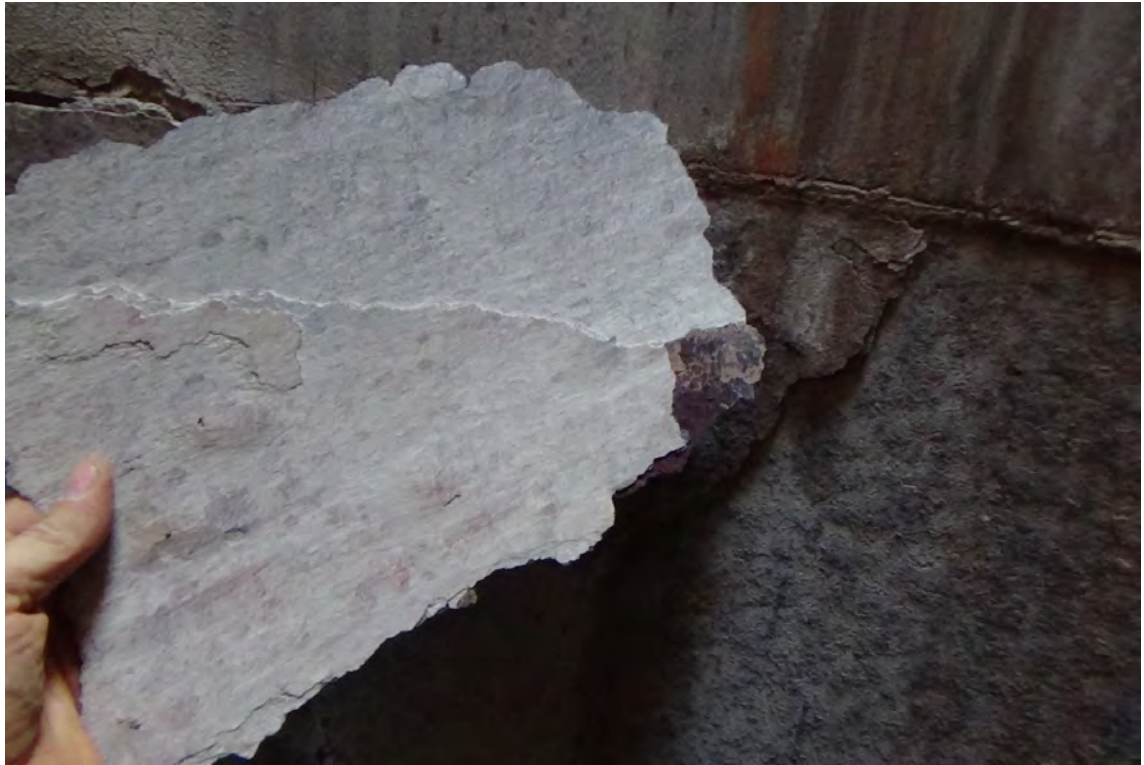
240' W/F1—Heavy scaling is visible to the carbon steel wall beneath the carbon to stainless steel transition. The scale was easily removed from the liner wall as is evidenced from the large piece being displayed by the inspector. The heaviest amount of scale was found near the top of the carbon steel portion of the flue.

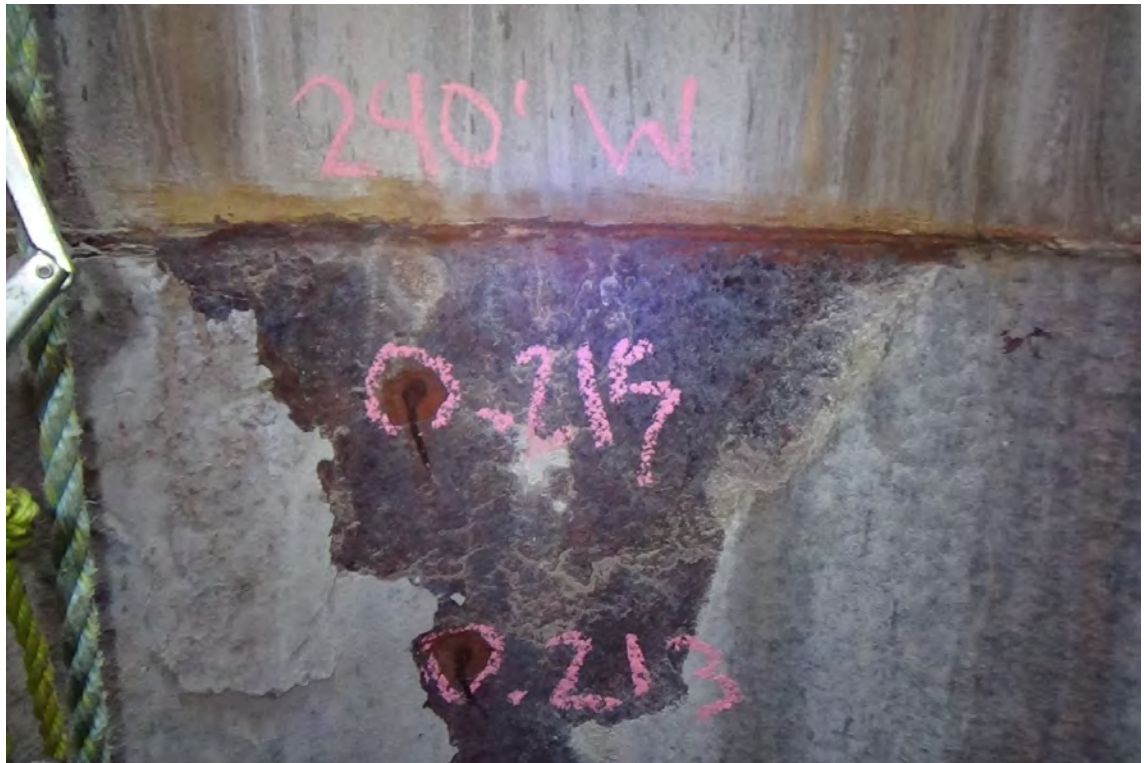
240' W/F1—Ultrasonic thickness measurements were taken at 1' intervals below the carbon to stainless transition. The measurements directly below the transition weld indicate approximately 15% steel thickness loss in the region.

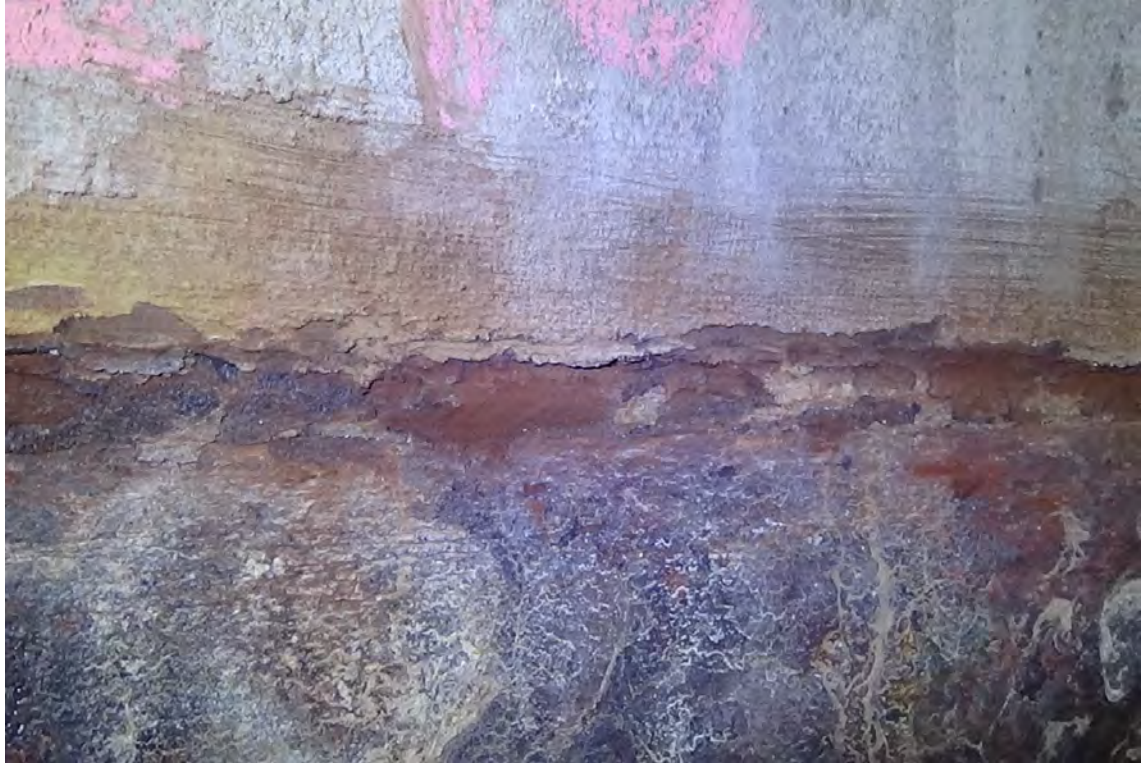
240' W/F1—Heavy scale needed to be removed from the transition weld in order to perform a visual inspection. The weld is extremely rusted and pitted, a significant amount of undercut is visible within the stainless steel portion of the liner. No cracks or separation were visible within the weld.

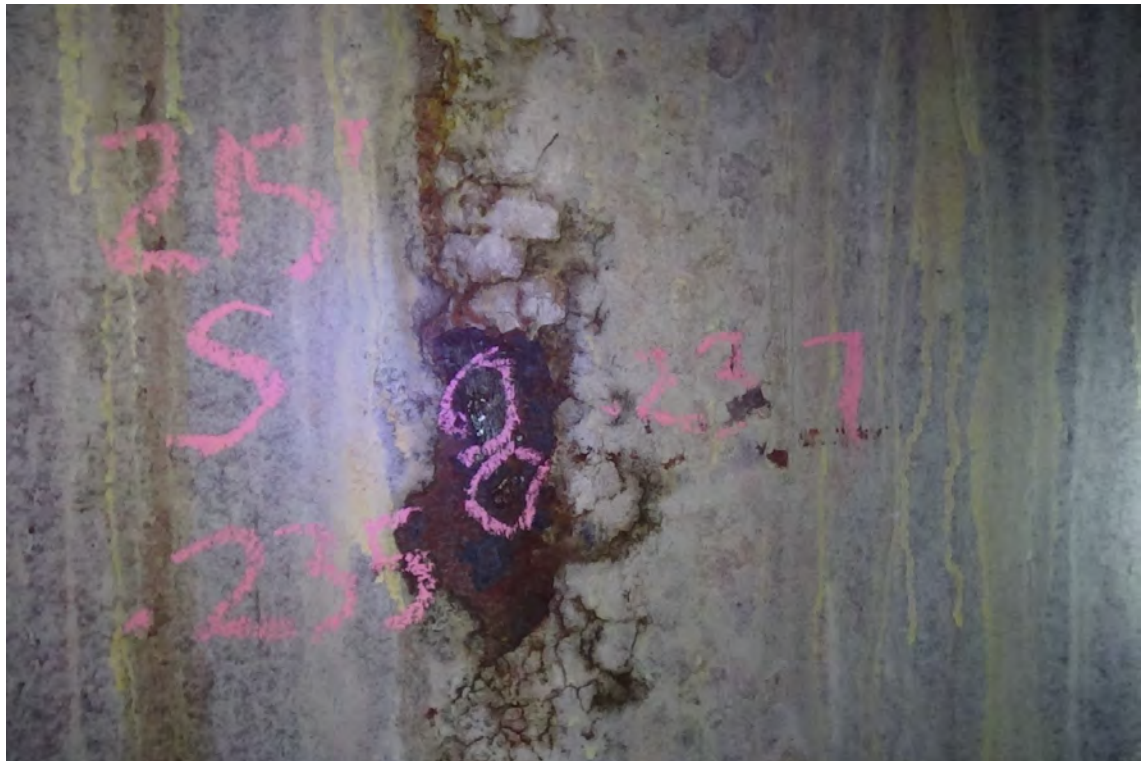
215' S/F1—A small area of scale was removed in order to take an ultrasonic measurement. Multiple layers of scale needed to be removed with a chipping hammer before measureable steel was found. Steel thickness measurements were found to be deteriorated but within acceptable ranges.

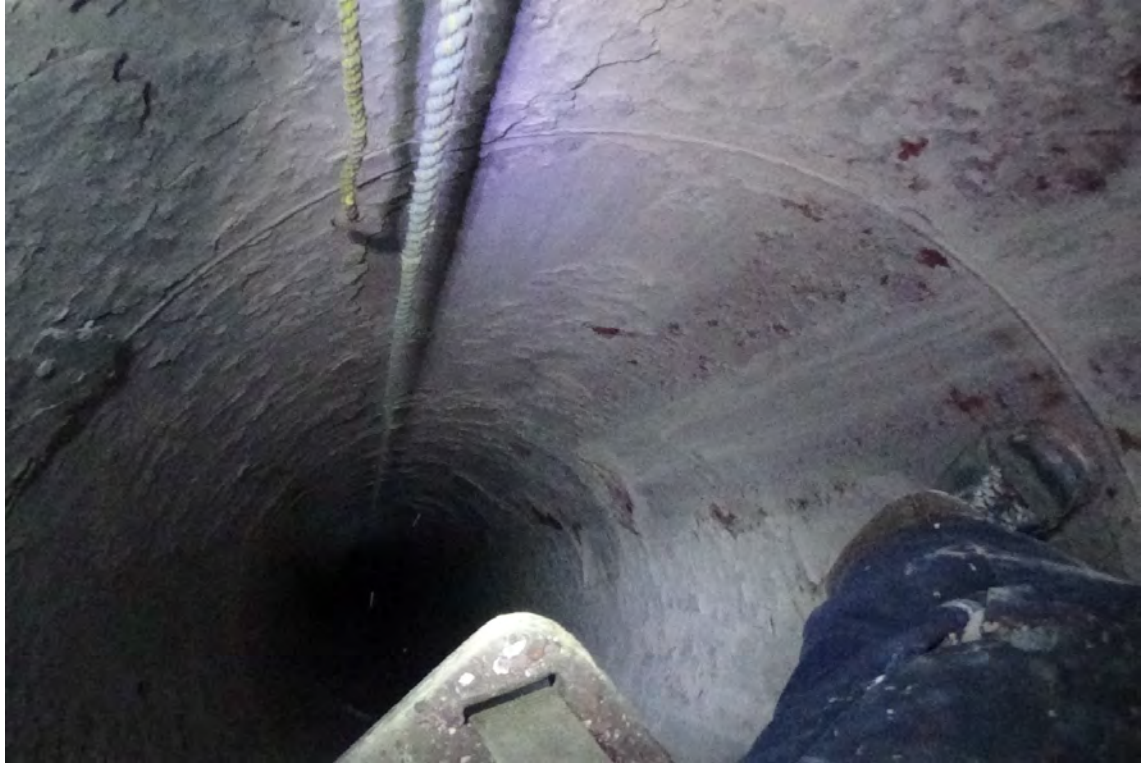
190' W/F1—View looking down the liner displays a consistent amount of scale throughout the height of the liner. The scale is easily removed from the wall in large sheets.

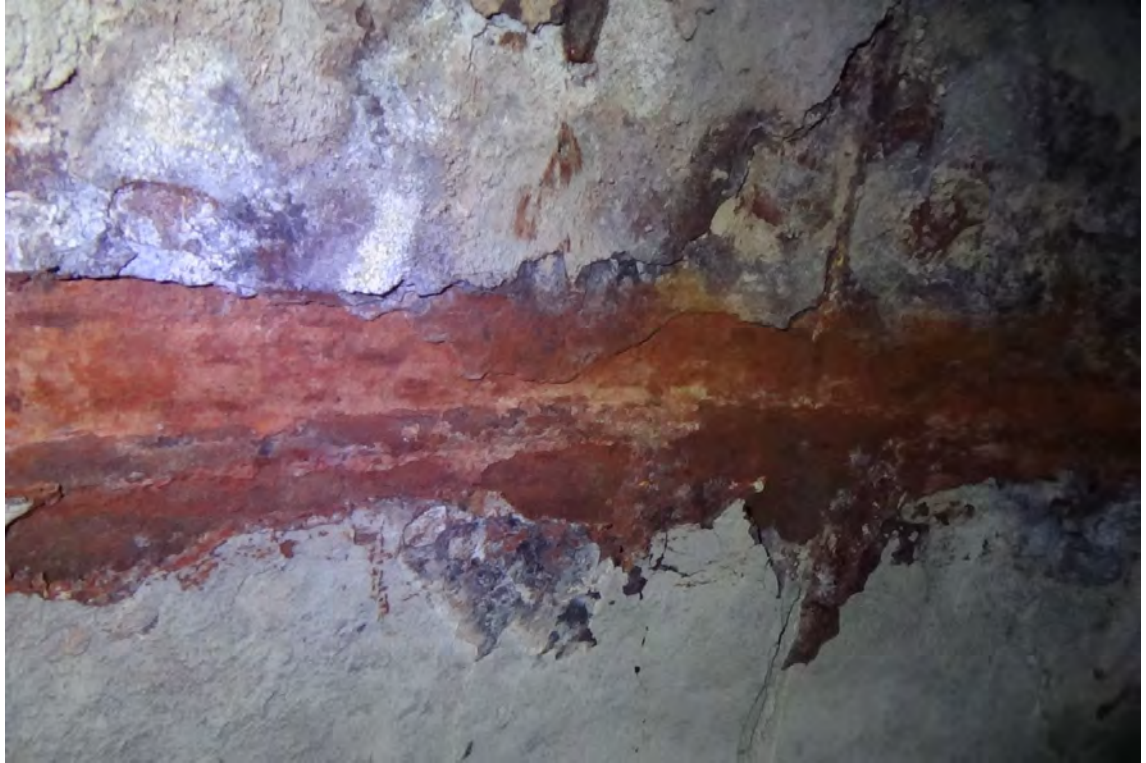
100' W/F1—Vertical and horizontal welds were cleaned and visually inspected at regular intervals. A heavy amount of scale was initially removed to view the weld. As was similar with other horizontal joints, the weld was found to be substantially rusted and pitted. Excess wear can best describe the condition of the weld.

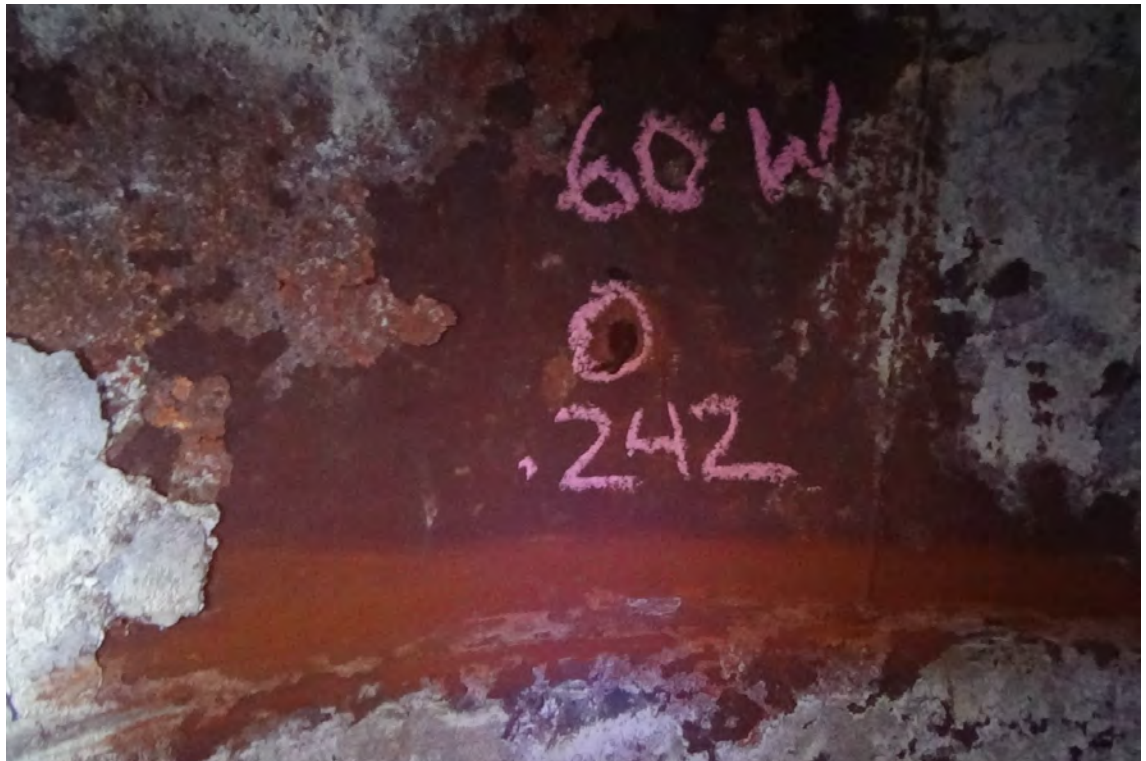
60' W/F1—Scale still needs to be removed to attain a UT measurement. Notice the outline of the scaling steel on the left side of the photo and the rusted surface beneath. The UT measurement taken is consistent with ¼" plate.
