**HAMON CUSTODIS-COTTRELL
 (CANADA) INC.**
 23 West Beaver Creek Road
 Richmond Hill, Ontario, L4B 1K4

INSPECTION REPORT

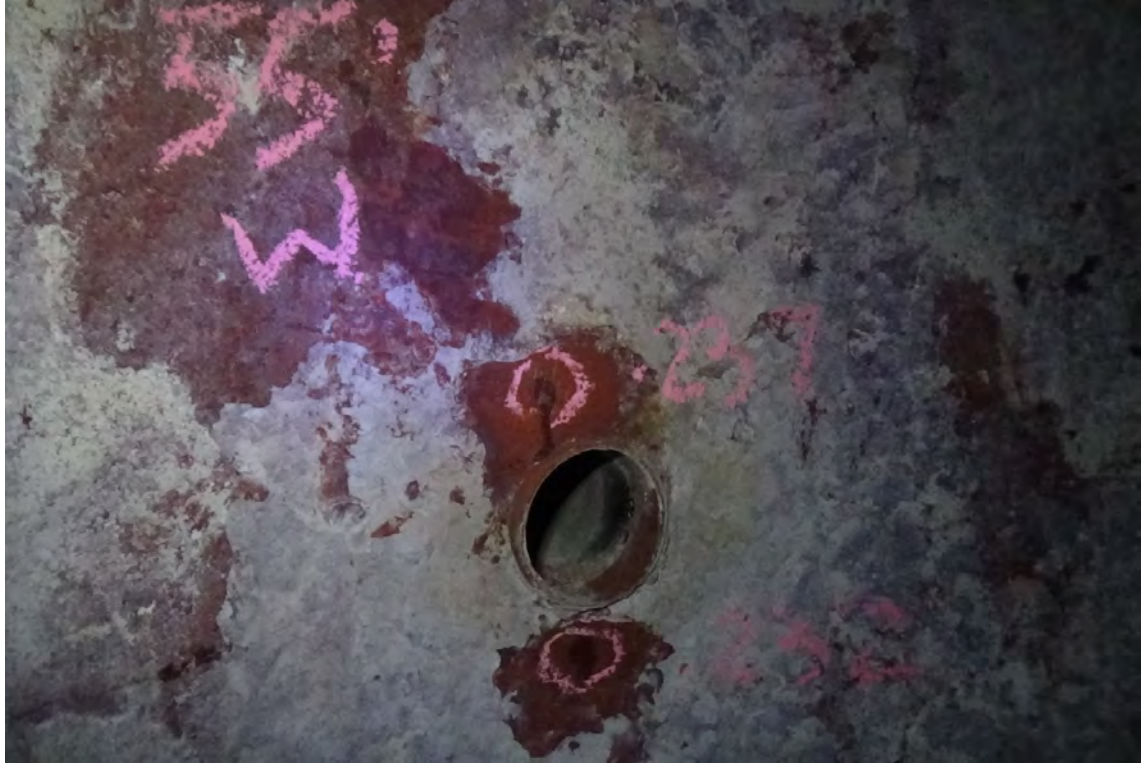
55' W/F1—UT readings were taken around the opacity meter opening. Measurements were a bit lower than other readings taken in the area. However, the measurements are within acceptable levels. No deformities were noticed around the openings.

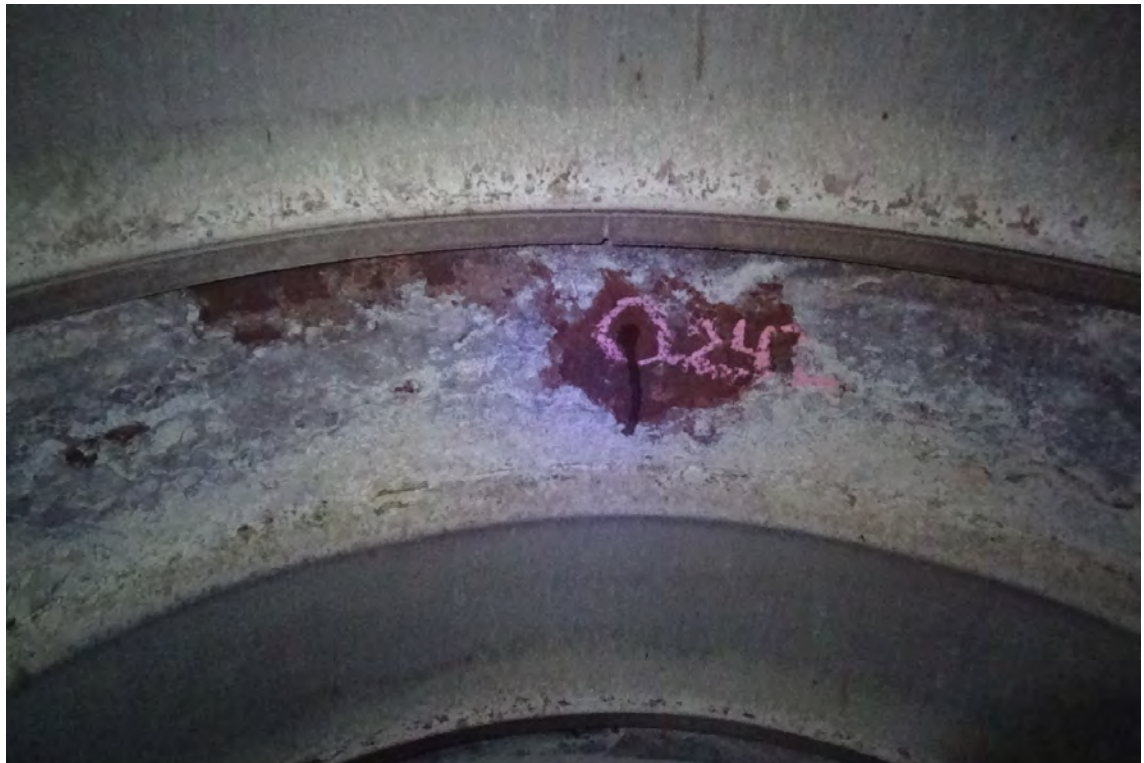
30' W/F1—No observable issues at the expansion bellows. All aspects of the expansion joint appear to be fully functional. As is the case with the rest of the liner, scale and rust are prominent at this elevation.

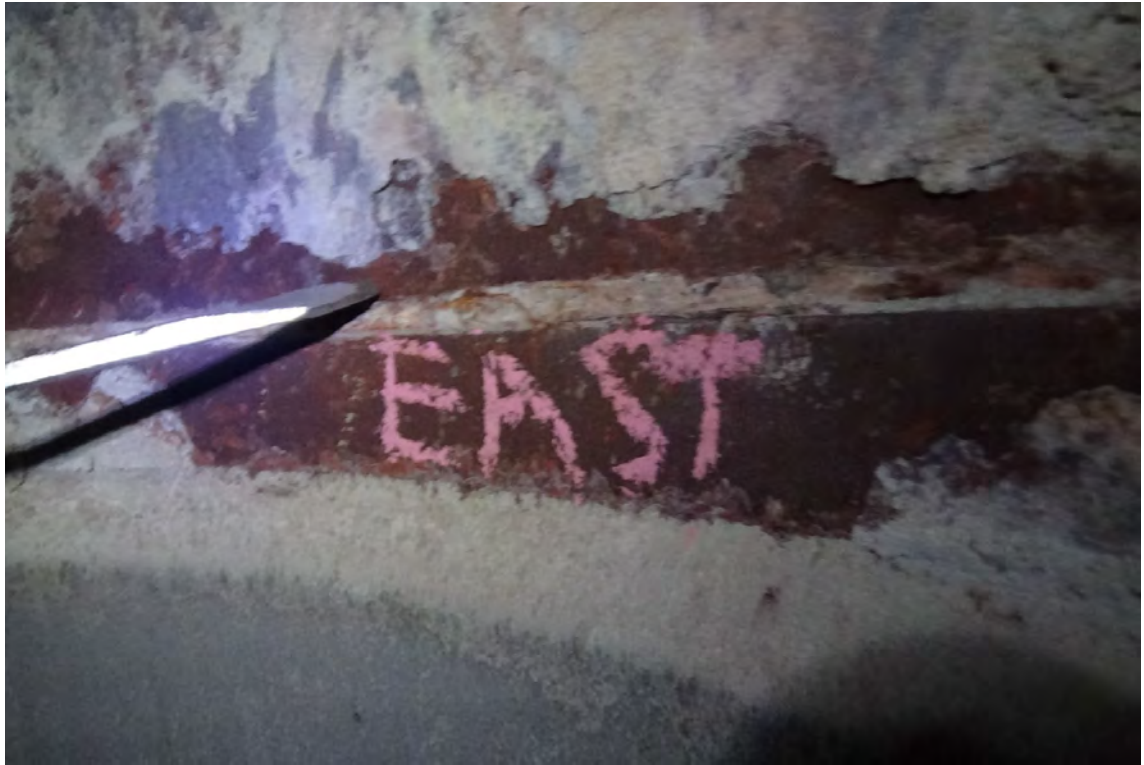
30' E/F1—The horizontal joints above and below the slider sections appear to be welded from the exterior of the flue. The joint has either been sealed with a high temperature cement or has accumulated process material over the years. The material filling the joint was found to be hard and mostly intact.

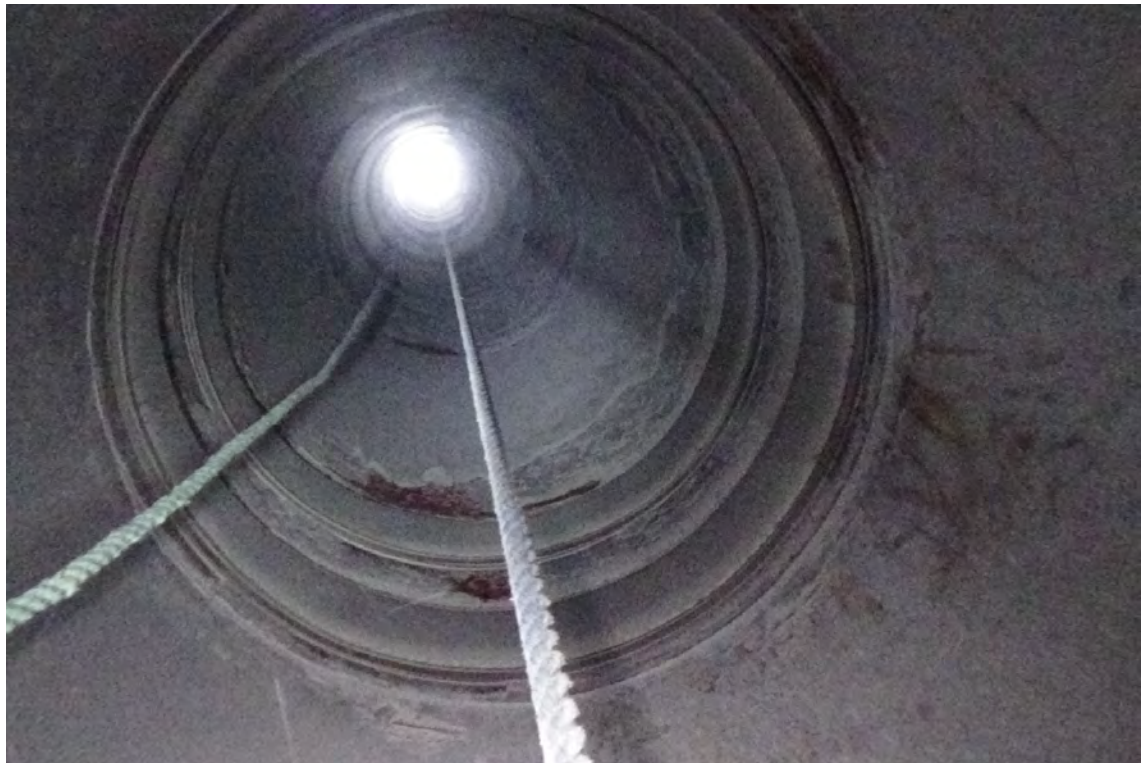
20' E/F1—View looking up the interior of flue #1 shows no signs of bulging or buckling within the liner wall. The expansion bellows system can be seen directly above.

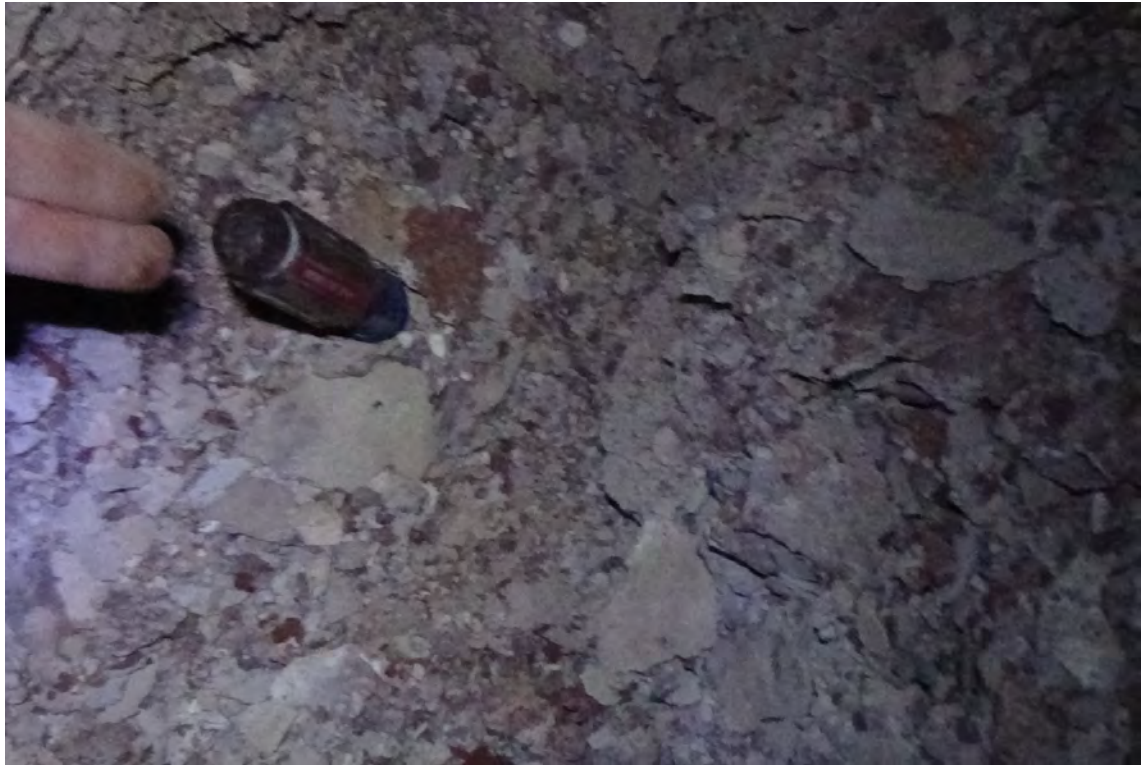
10'/F1—A substantial amount of scale and debris build-up was found in the base of flue #1. A depth measurement of the build-up was attempted. The measurement was found to be over 16" of build-up. The false floor wasn't reached.

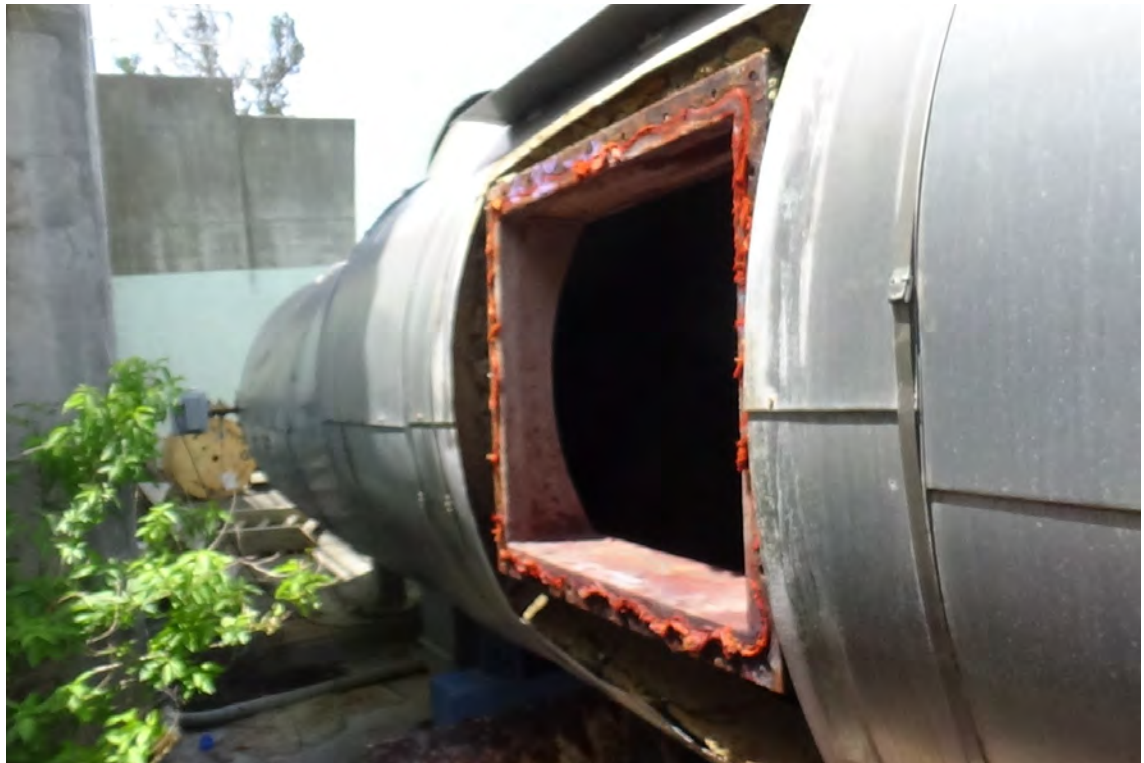
4' N/F1—The access door to flue #1 is located in the horizontal breaching duct approximately 30' from the base of the chimney. The opening measures 32" by 25". All the 1/2" bolts securing the access door were extremely corroded and were cut with a grinder/torch in order to remove the door.

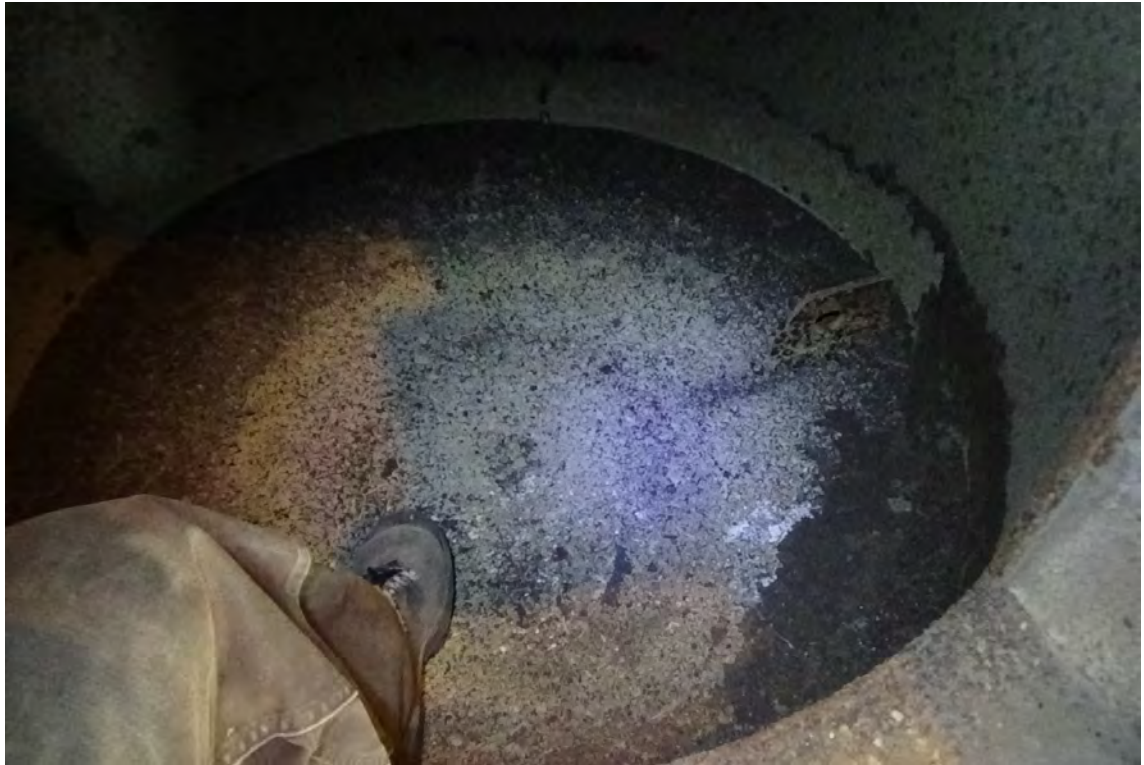
0' /F1—The build-up in the bottom of flue #1, under the false floor is extremely hard. The drain in the middle of the floor is plugged with a concrete like substance.

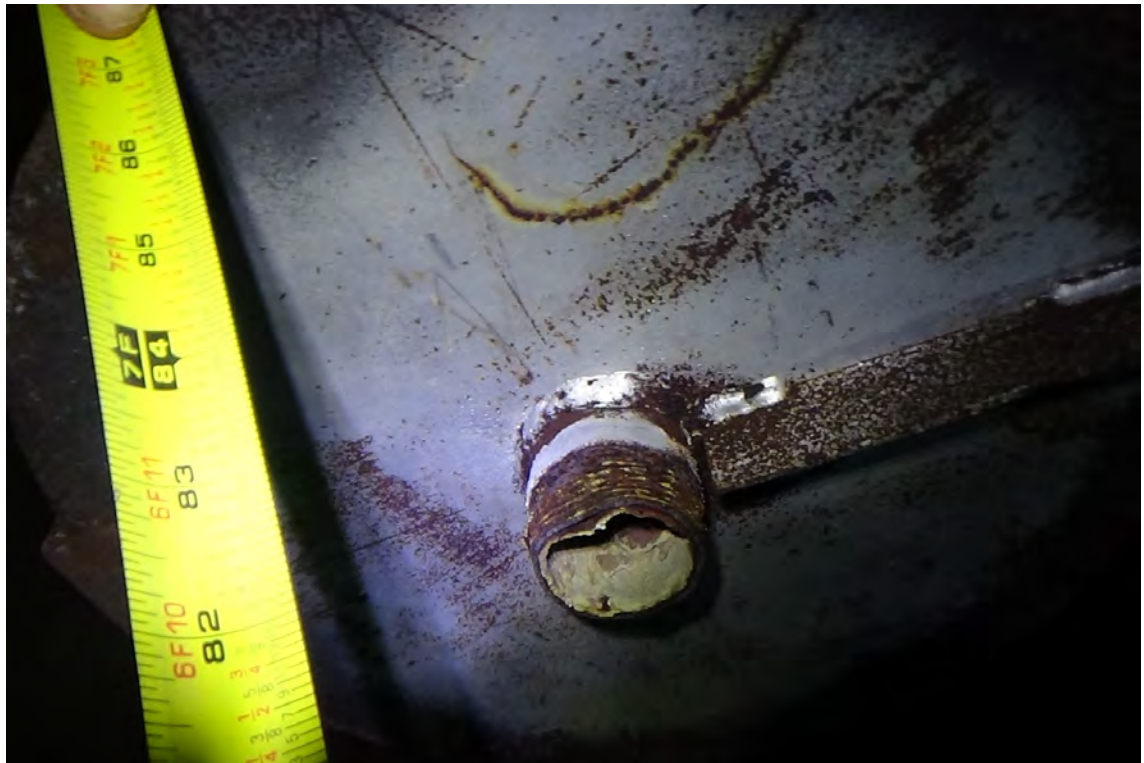
7' E/F1—The hopper portion of the false floor was measured to be 7' from the base of the liner. The nozzle on the hopper is open and appears to be corroded. A look up into the nozzle displays the scale build-up visible from within the flue.

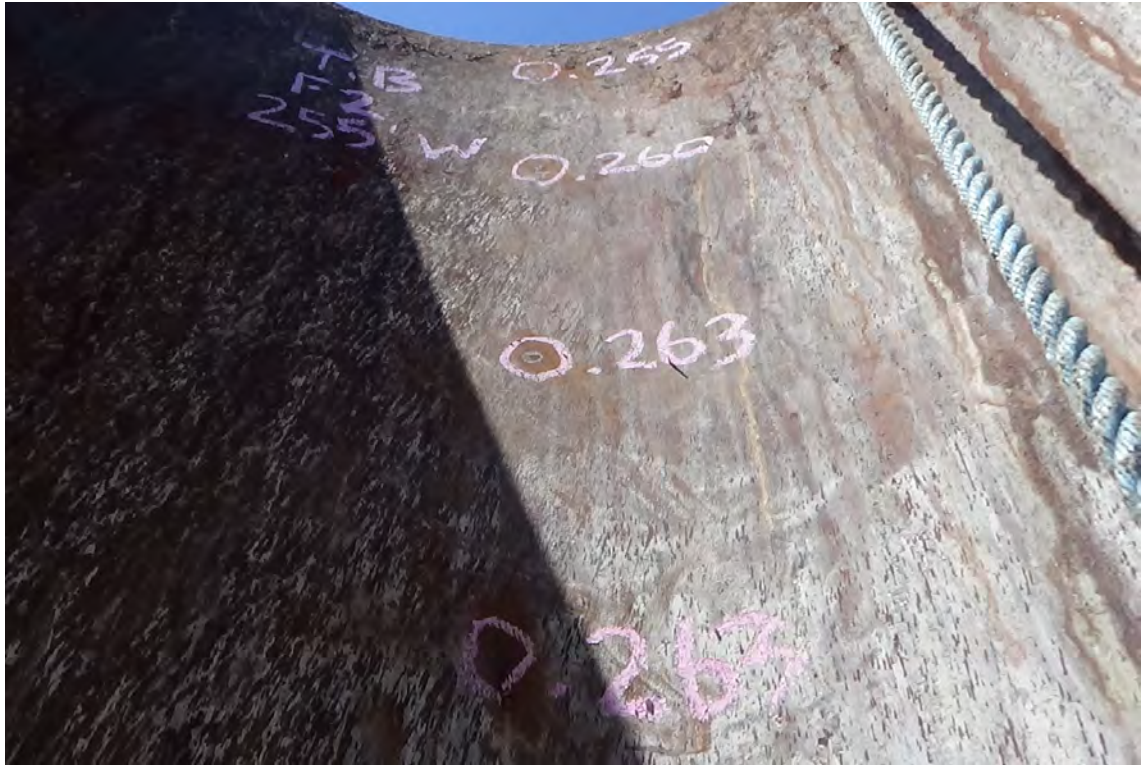
255' W/F2—UT readings were taken at 1' intervals throughout the top 10' of the liner. Measurements were then taken at 10' intervals for the remainder of the flue. All measurements taken within the stainless steel portion closely correspond to ¼" thick plate.

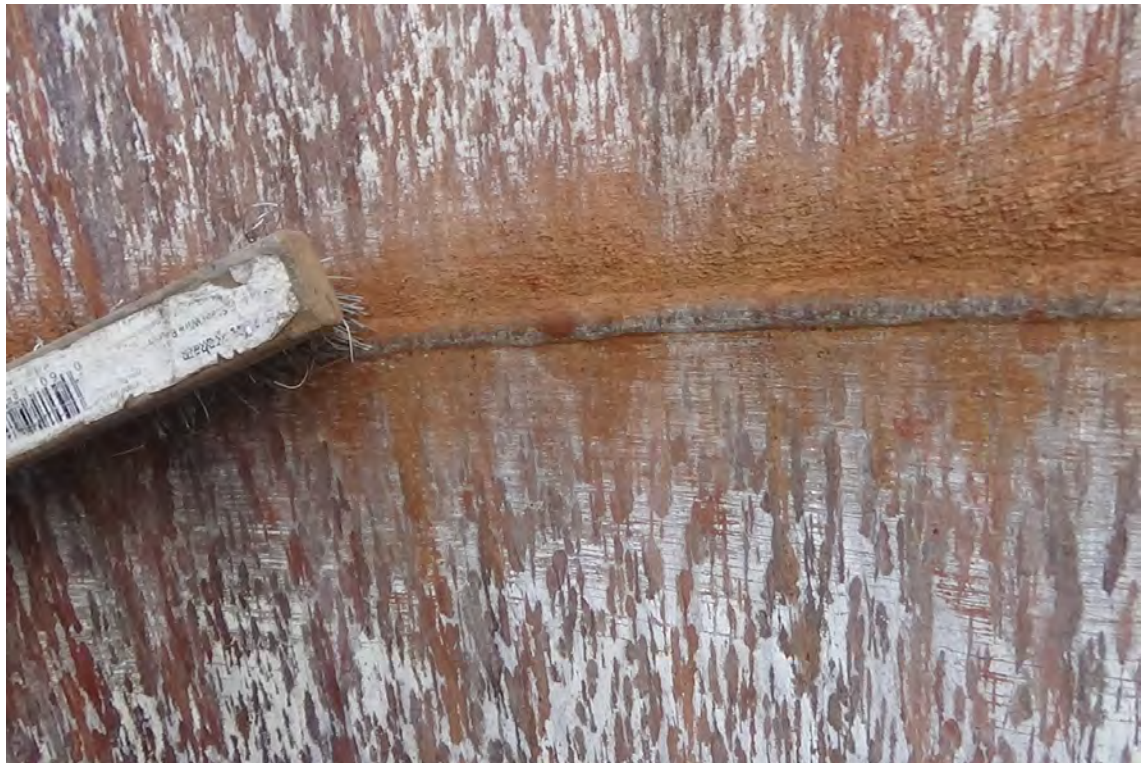
250' W/F2—The horizontal welds within the stainless steel portion of the liner were found to be consistent with a smooth profile. No cracking or other deformities were noticed. There does appear to be a mild amount of pitting to the stainless above and below the weld.

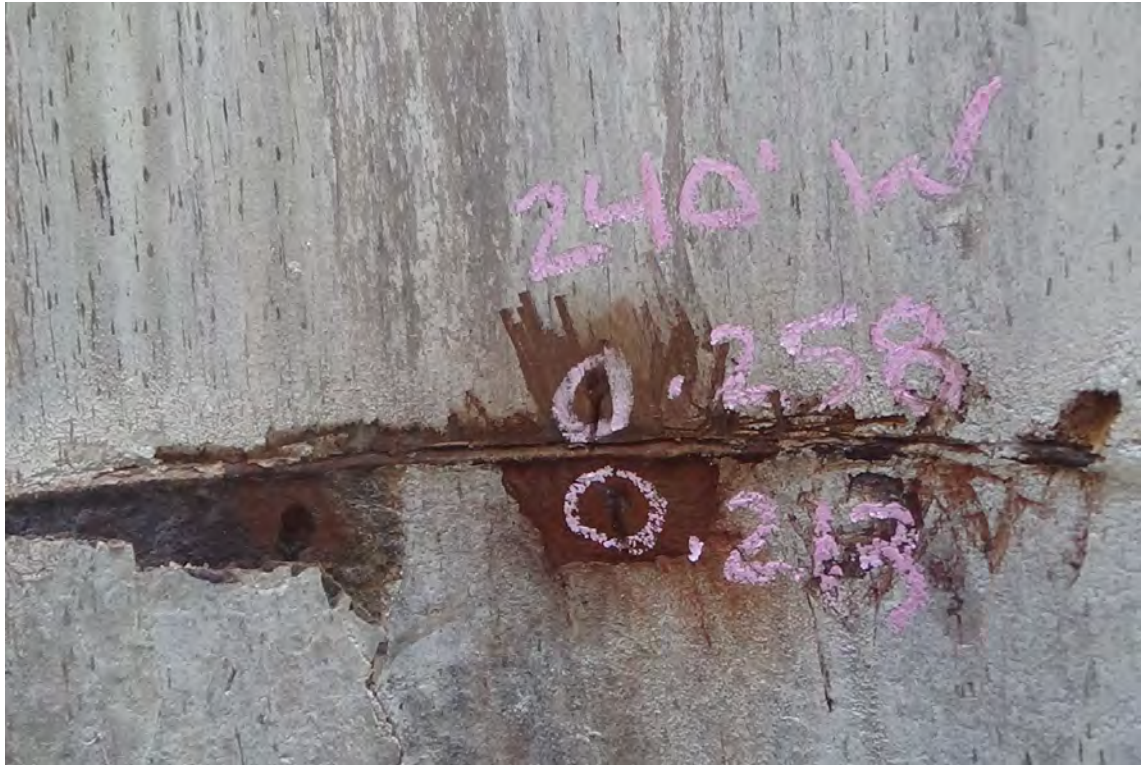
240' W/F2—UT readings taken above and below the transition weld illustrates the moderate steel thickness loss within the carbon steel section of the liner. The reading taken (.213) represents an approximate 15% loss in plate thickness at this elevation.

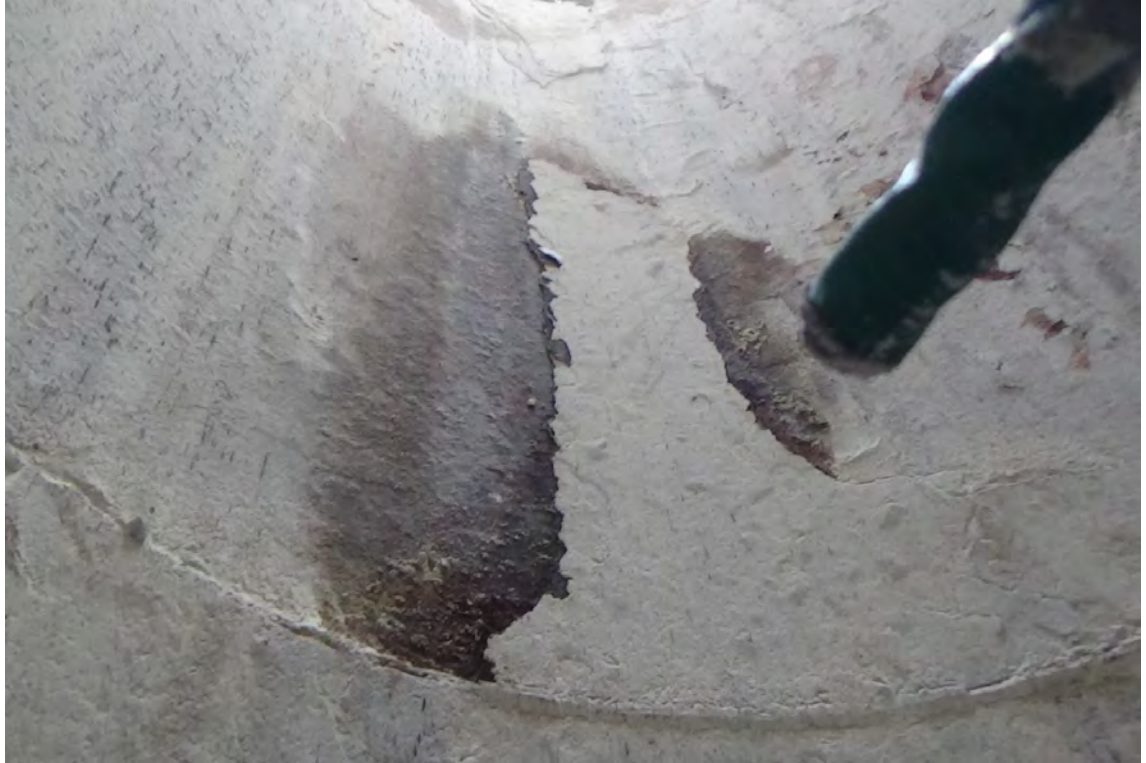
230' S/F2—Loose scale was removed from previous picture. Beneath the loose scale the carbon steel wall appears extremely rusted with multiple layers of scale.

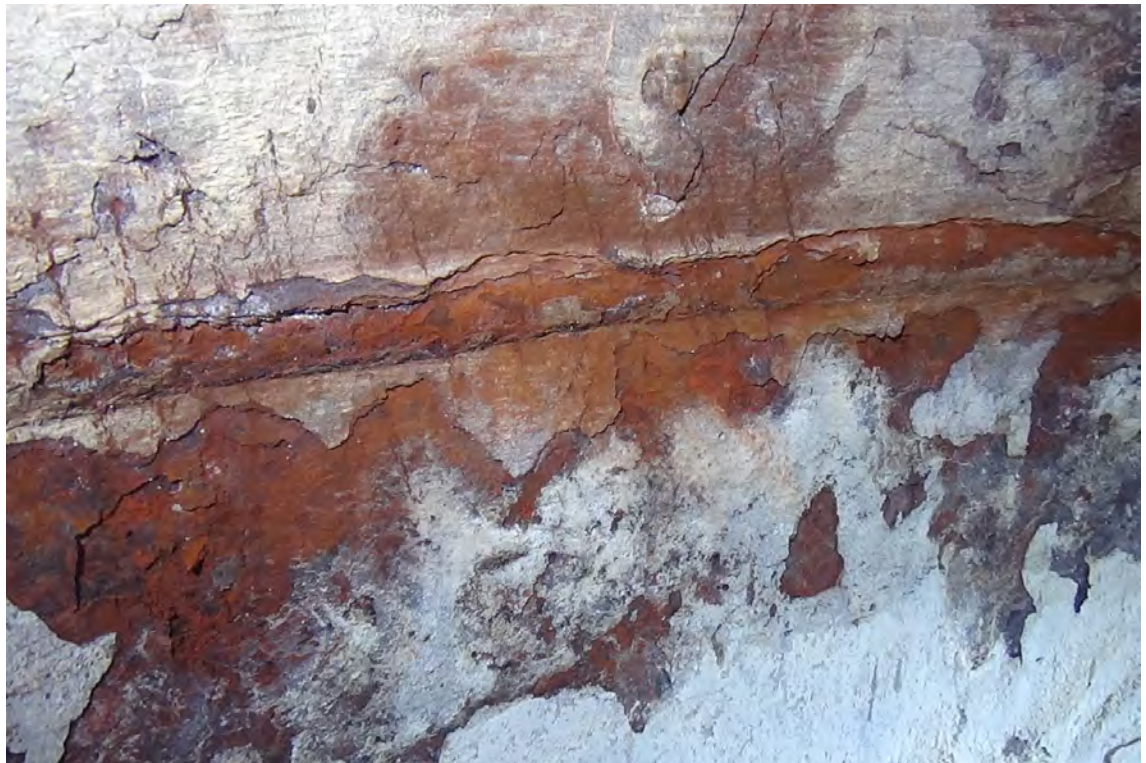
220' W/F2—Horizontal welds were cleaned and inspected at various elevations. The heavy scale had to first be removed in order to view the welds, which appeared rusted and pitted. However, they contained a consistent profile without signs of cracking.

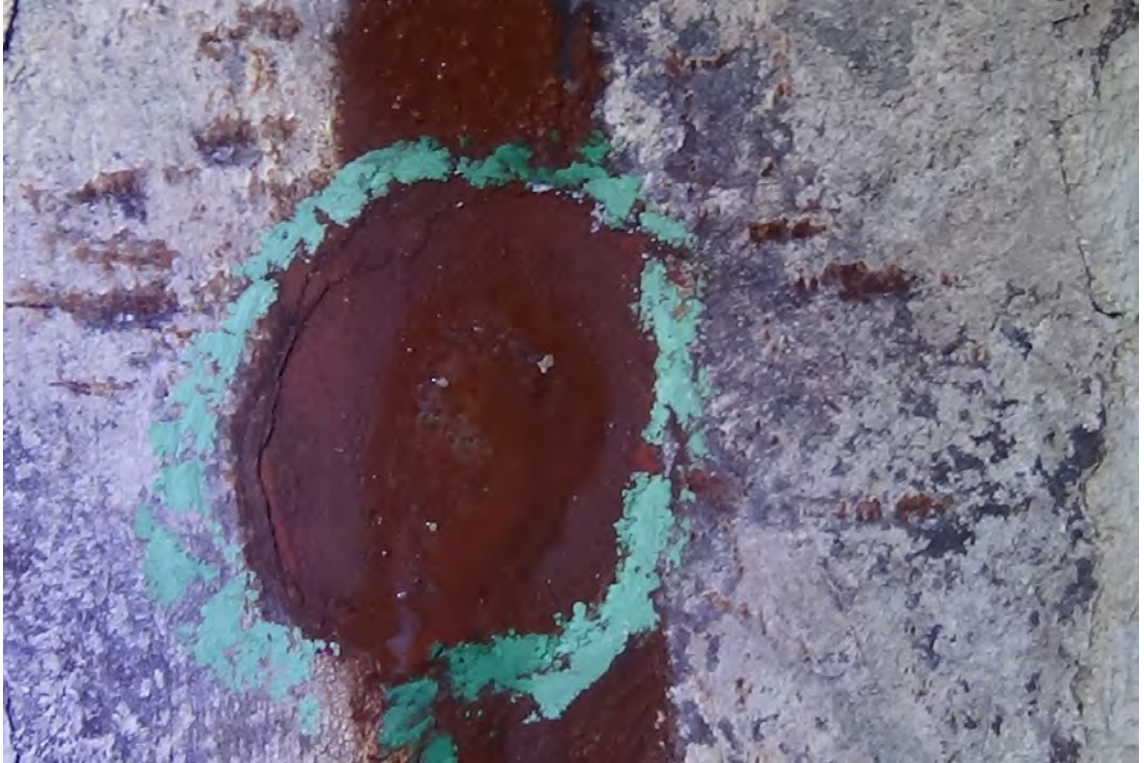
190' W/F2—Multiple layers of scale was removed before UT readings could be taken. Notice the pitting located within the clean steel.

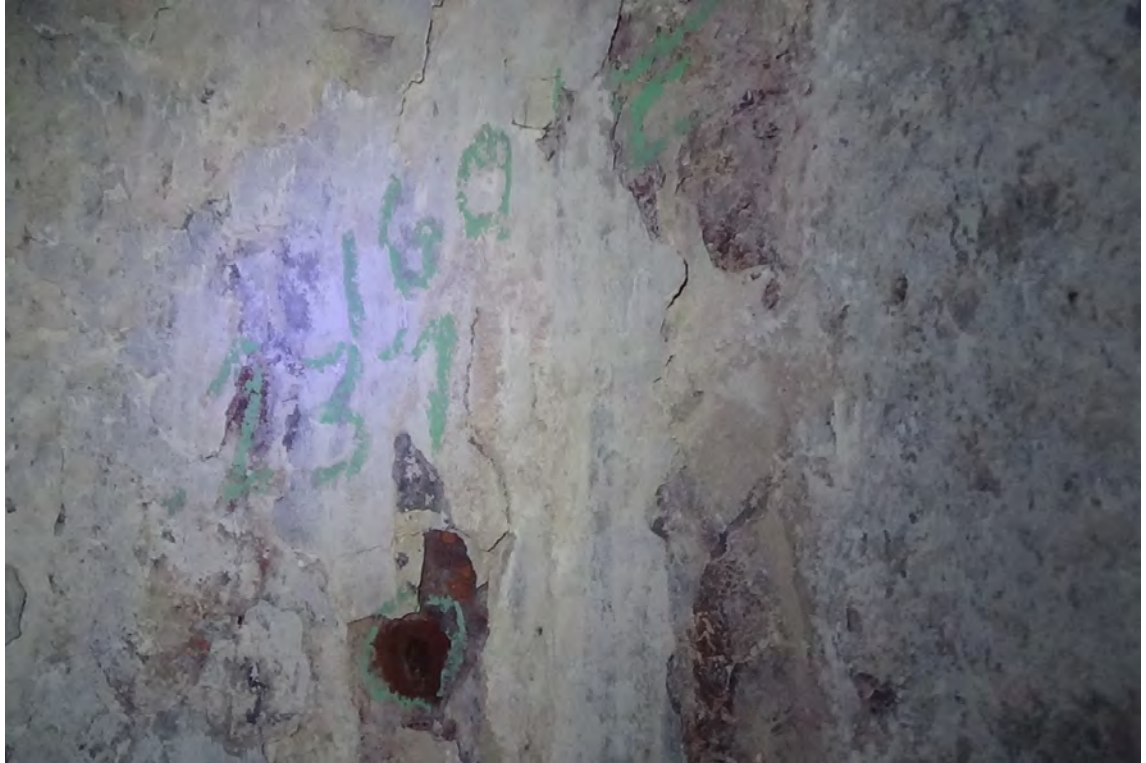
160' W/F2—A small area of scale was removed in order to take an ultrasonic measurement. Multiple layers of scale needed to be removed with a chipping hammer before measureable steel was found. Steel thickness measurements were found to be deteriorated but within acceptable ranges.

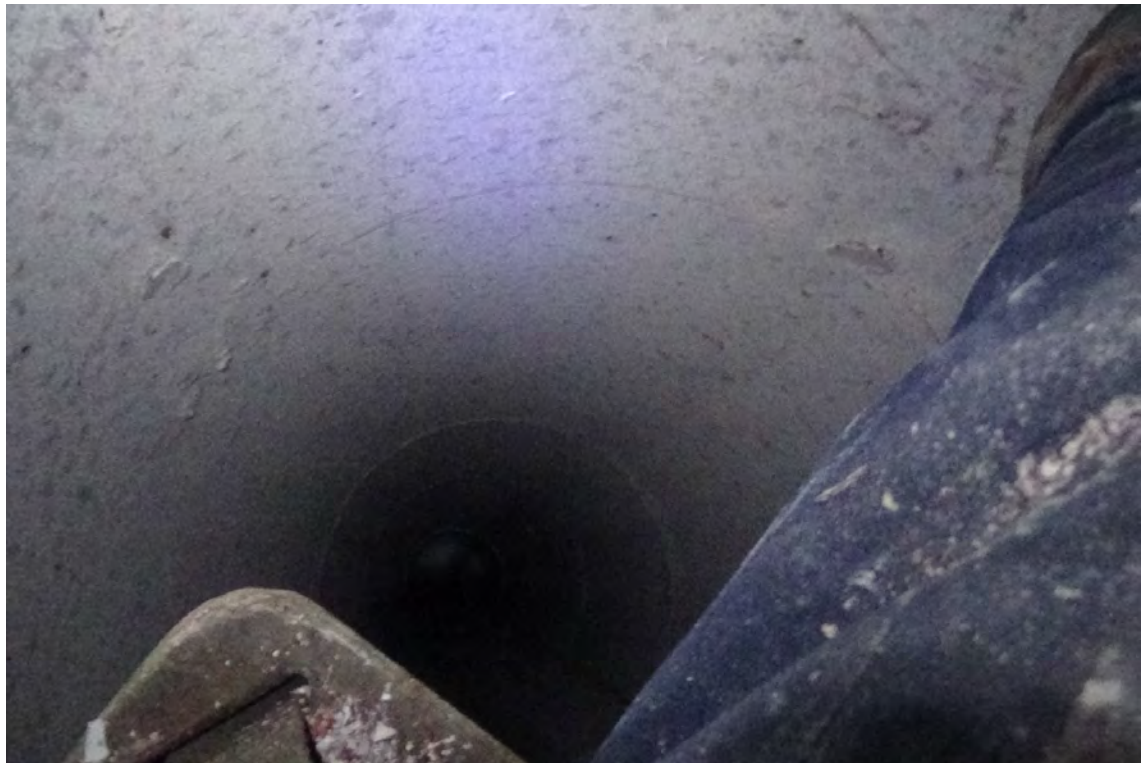
80' S/F2—View looking down the interior wall illustrates that scaling is less noticeable at lower elevations.

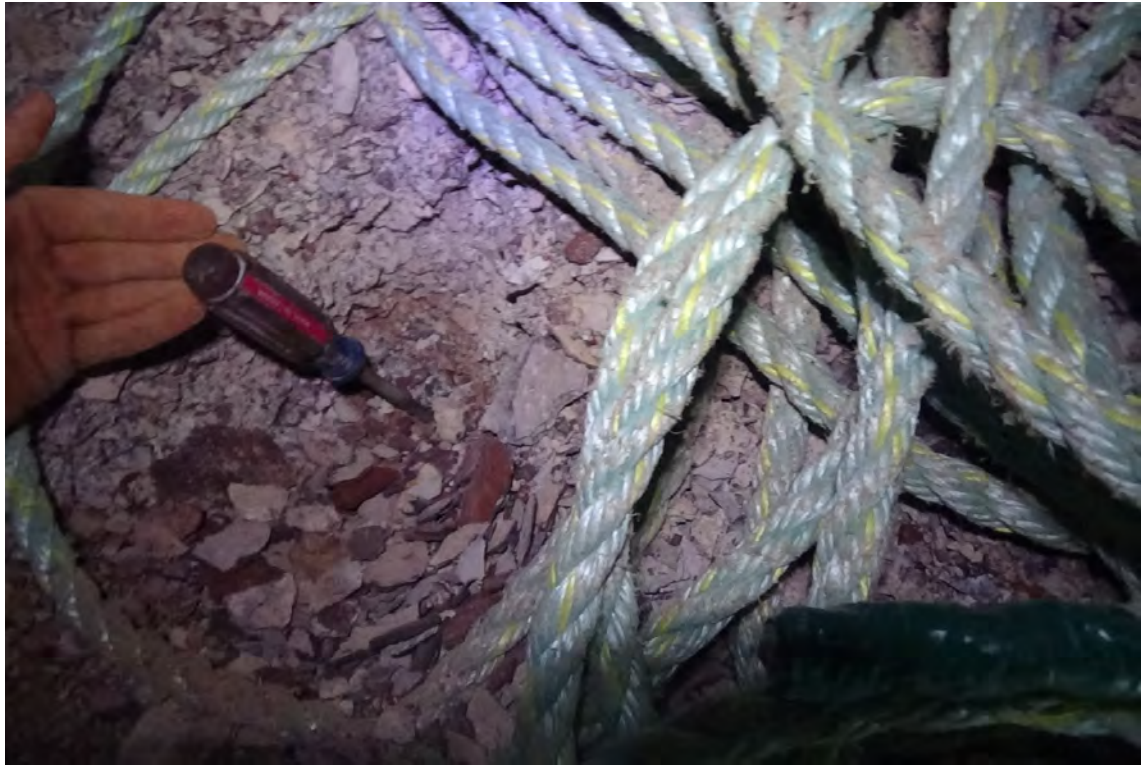
10'/F2—A substantial amount of scale and debris build-up was found in the base of flue #2. A depth measurement of the build-up was attempted. The measurement was found to be over 16" of build-up. The false floor wasn't reached.

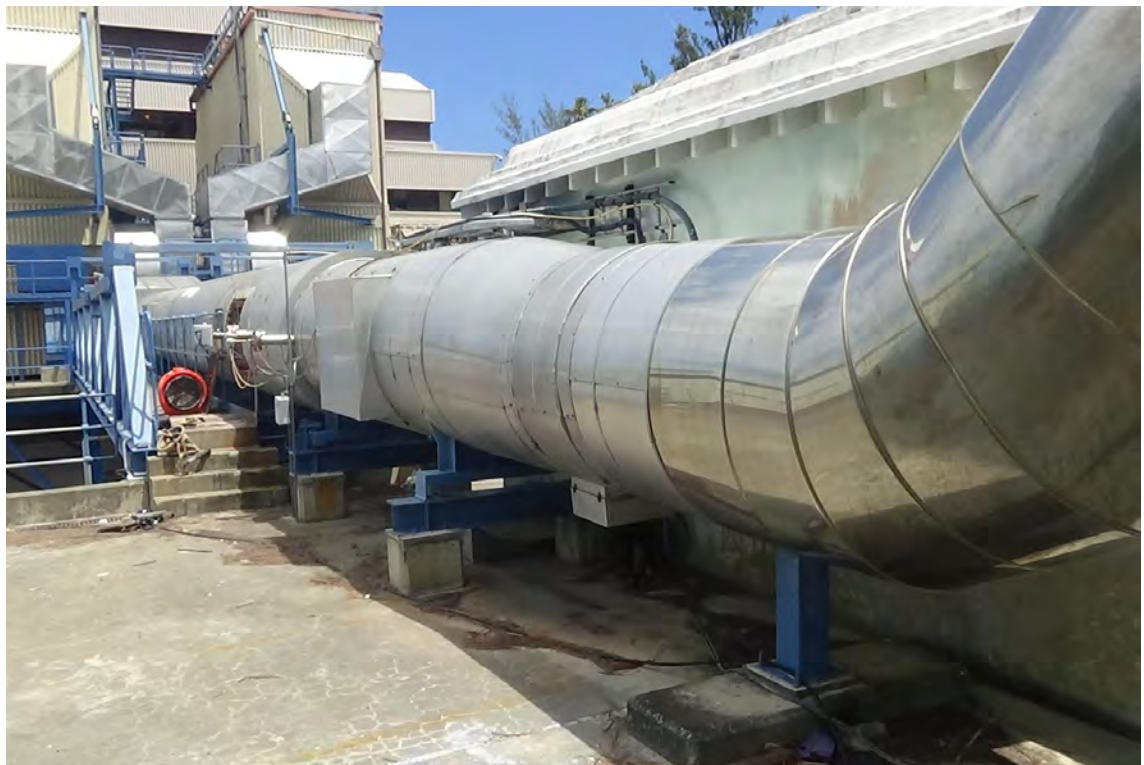
0' E/F2—The flue access door is approximately 30' away from the base of the chimney. The access door is the opening near the stairs to the bridge.

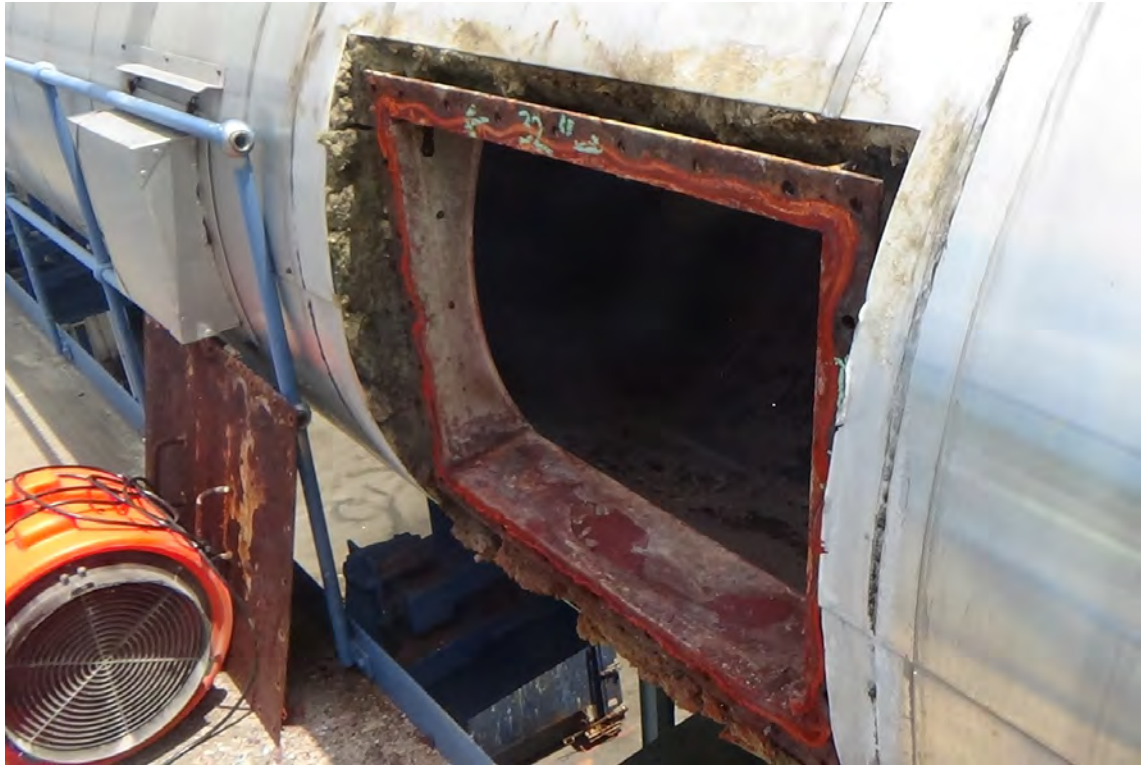
4' N/F2—The access door to flue #2 is located in the horizontal breeching duct approximately 30' from the base of the chimney. The opening measures 32" by 25". All the ½" bolts securing the access door were extremely corroded and were cut with a grinder/torch in order to remove the door.

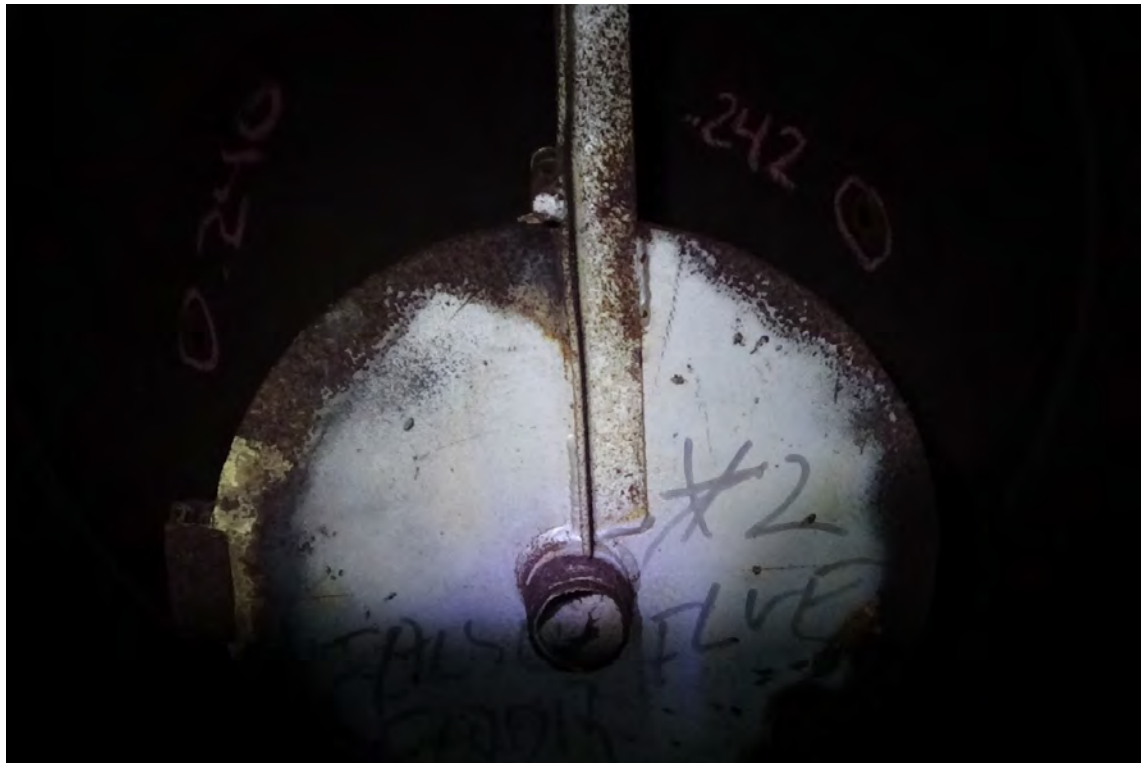
7' /F2—View looking at the hopper under the false floor. The cap for the hopper is missing, the pipe is clogged with scale and debris. UT readings were taken on the underside of the floor and correspond with ¼" plate thickness.

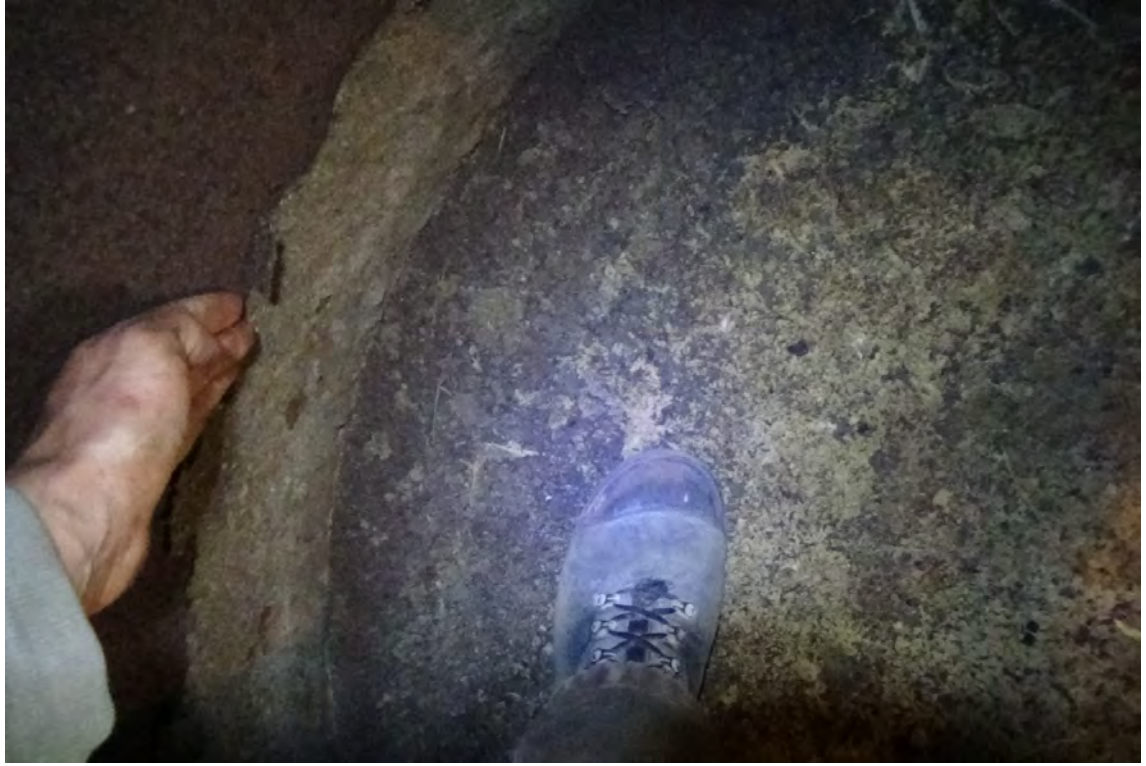
0' S/F2—A ring of scale approximately 6" wide is visible in the base of liner #2. This deficiency suggests that standing water was present in the base in the past.

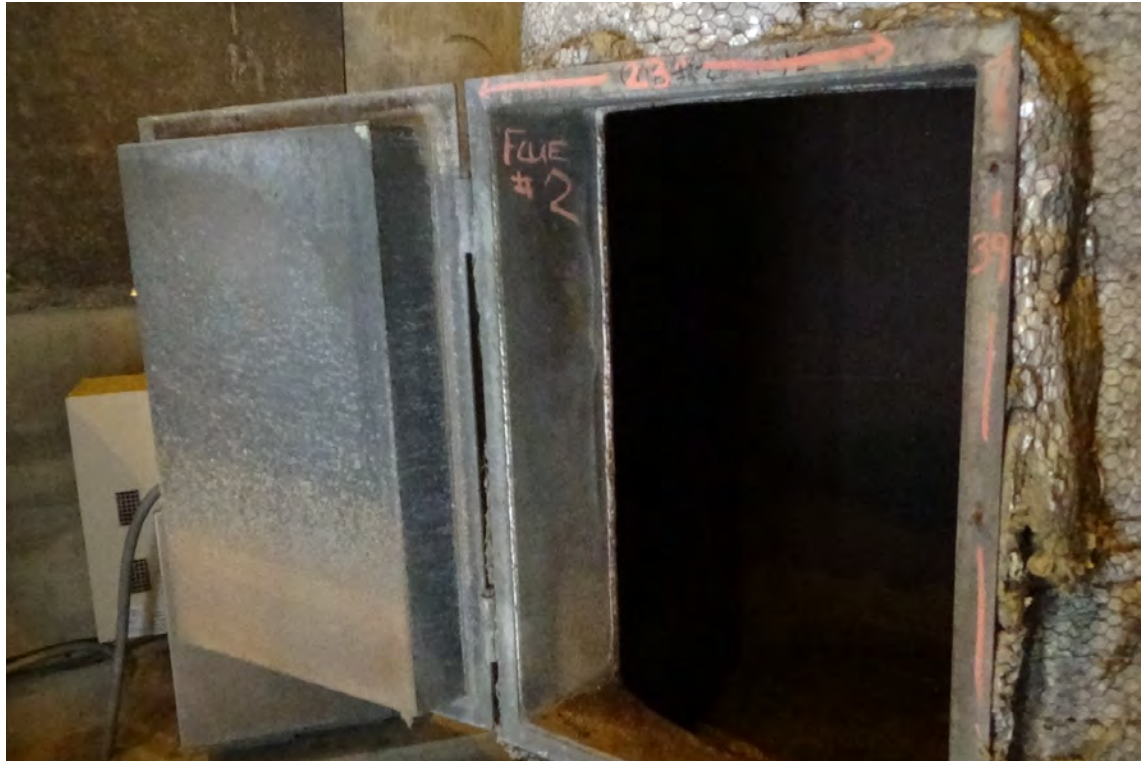
2' E/F2—The access door to the base of flue #2 measures 23" wide by 39" high. The door opens and closes freely. It is secured by three 3/8" bolts with wingnuts.
