Site Name: Warwick Tower
Structure Type: Guyed Tower
Structure Height: 250'
Make: Valmont
ASR: KD48X180
Tower Owner: Government of Bermuda
Address: Middle Road
Parish: Warwick
Latitude: 32.256385
Longitude: -64.833335
Date of Visit: 7/13/2022
Employees on Site: Angie Shyrigh
Ben Shyrigh

Proventus Structural Services, LLC

Purpose of this Site Visit

To fulfill the inspection requirements set forth in the TIA/EIA222-H, Annex J.1 standard for Maintenance and Condition Assessment of communication structures.

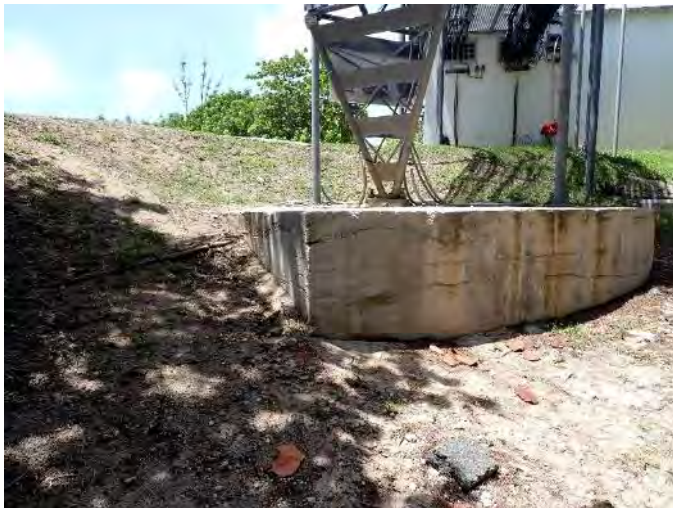
Tower foundation
Photo File 19

Elevation	Location	Description	Recommendation	Priority
0'	Tower foundation	Light honeycombing is present on the tower foundation.	Monitor the condition of the concrete for cracking or degradation.	Monitor

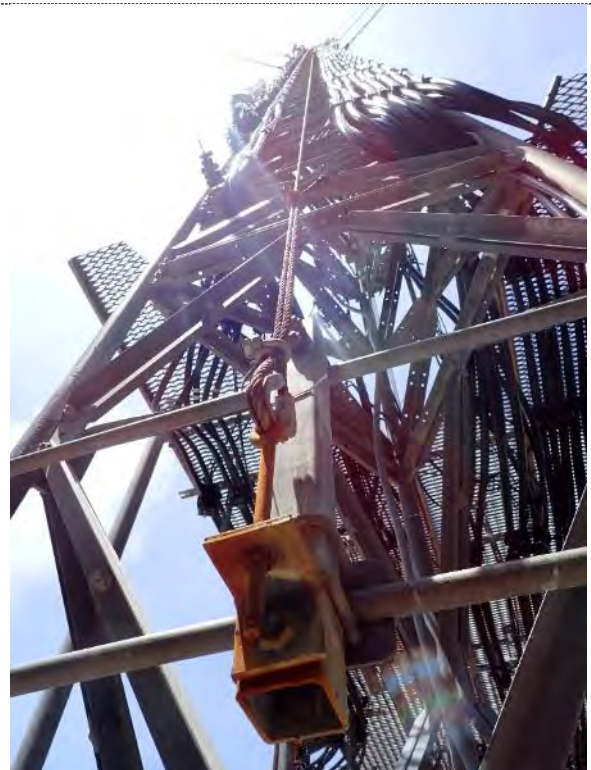
Safety cable bracket
Photo File 24

50' - 250'	Varies	Category 3 rust is present on the tower connection bolt assemblies.	It is recommended these bolt assemblies be replaced within 12 months.	To be scheduled
Throughout height	BC Face	The safety cable keepers are degraded beyond functionality, and as a result the safety cable has rubbed the surface of the tower horizontals and worn away the galvanizing.	It is recommended the safety cable be secured and prevented from rubbing the tower.	To be scheduled
125', 249'	Varies	Multiple deficiencies were observed with the old lighting system: <ul style="list-style-type: none"> Advanced, pitting category 3 rust is present on the lighting conduit, junction boxes and hardware securing it to the tower The side light conduit is taped yet broken resulting in the wiring being exposed The side light conduit is not secured to the tower and is instead resting on the diagonals The side light fixtures are upside down The B leg side light lens is broken The C leg lens is entirely missing The old beacon lens is entirely missing	Remove the old lighting system and associated components entirely. Dispose of off-site.	To be scheduled

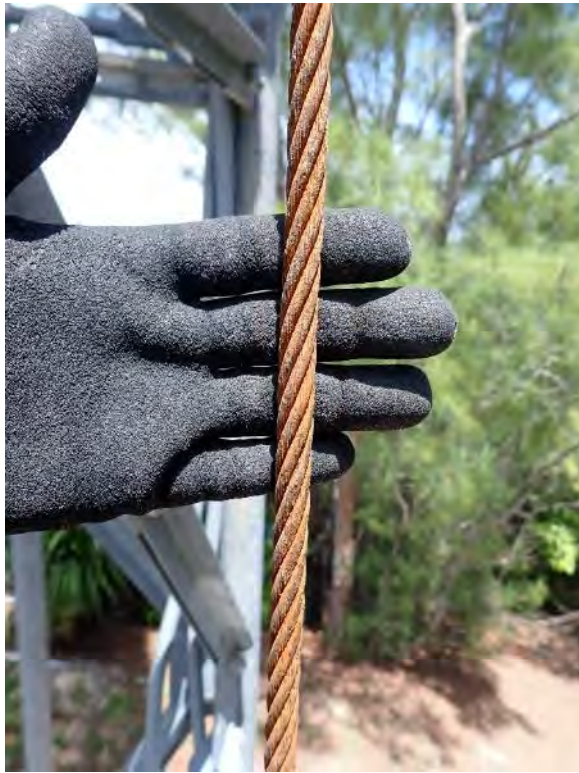
Safety cable condition
Photo File 25

inspection the lightning rod was observed to be present.		
Throughout height	Climbing face	Category 3 rust is present on the safety cable and associated components.	It is recommended the safety cable system and associated components be replaced.	To be scheduled
Varies	Varies	Numerous out of service and abandoned pieces of tower mounted equipment were observed.	It is recommended out of service or otherwise abandoned equipment be completely removed from the structure to reduce the resources required to maintain safe connection to the structure as well as to maintain accurate loading records.	To be scheduled
Varies	Varies	The stiff-arm associated with each antenna #16, #62 and #87 is connected to a tower bracing member.	To prevent damage to the bracing member it is recommended the stiff-arm connections be relocated to tower legs.	To be scheduled
206'	C Leg	Electrical tape is currently being used to connect this antenna (#86) to its mount.	Replace the tape with hot dip galvanized brackets.	To be scheduled

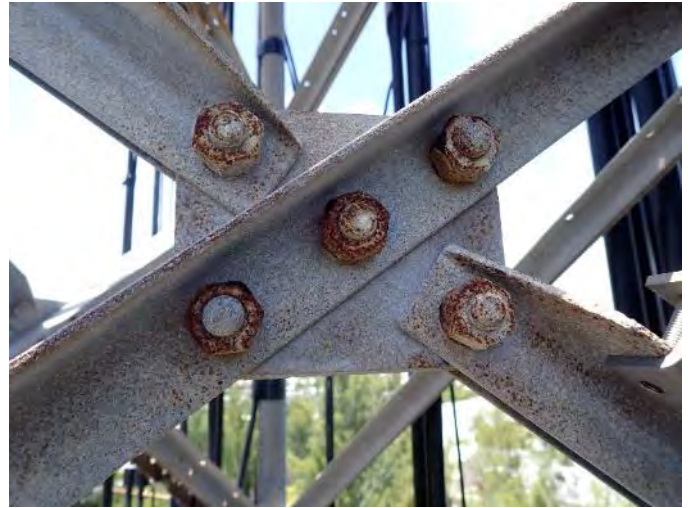
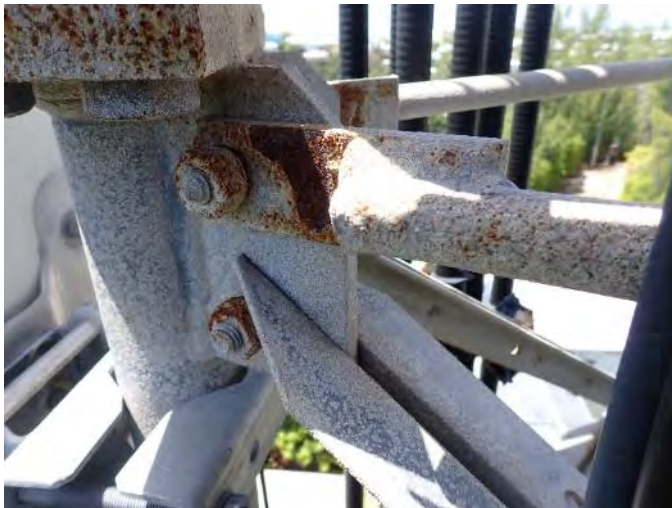
Elevation	Location	Description	Recommendation	Priority
Throughout height	Tower surface	The galvanizing is wearing thin and rust is forming, advancing to category 2 in the upper portions. A few isolated regions of pitting rust were observed, and loss of material was undetectable at the time of this inspection.	Paint the tower within 12 months to retard the advancement of corrosion. Ensure attention is paid to surface preparation and complete coverage of all tower surfaces.	To be scheduled
0' - 50'	Varies	Category 2 rust is present on the tower connection bolt assemblies.	It is recommended the bolt assemblies be brushed and treated within 12 months.	To be scheduled
50' - 250'	Varies	Category 3 rust is present on the tower connection bolt assemblies.	It is recommended these bolt assemblies be replaced within 12 months.	To be scheduled
Throughout height	BC Face	The safety cable keepers are degraded beyond functionality, and as a result the safety cable has rubbed the surface of the tower horizontals and worn away the galvanizing.	It is recommended the safety cable be secured and prevented from rubbing the tower.	To be scheduled

Tower surface condition
Photo File 42

Tower surface condition
Photo File 43

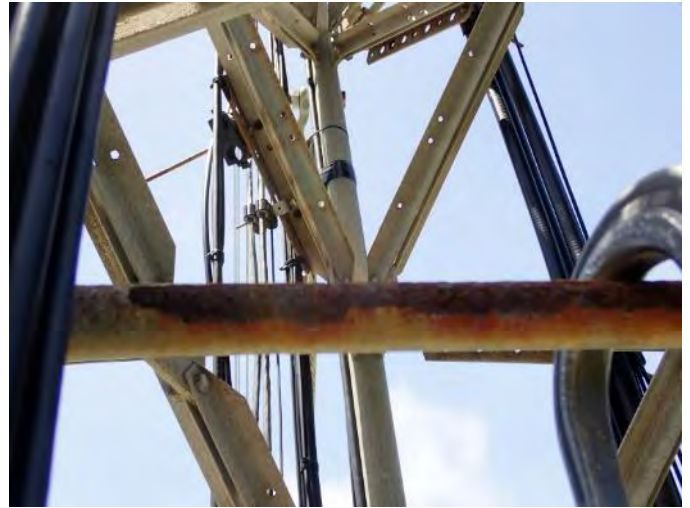
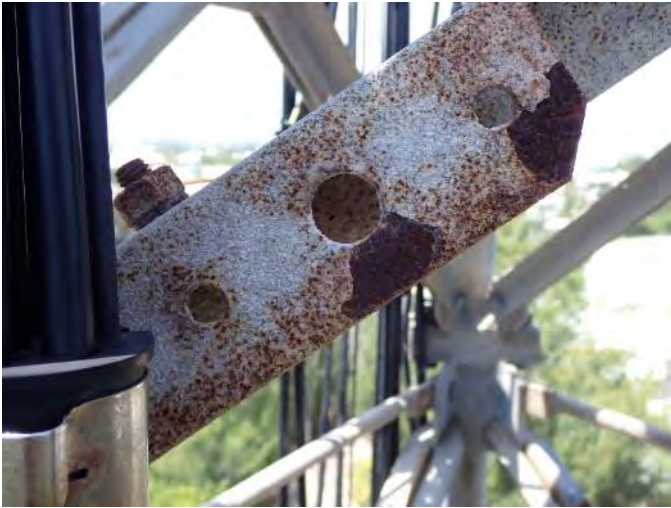
Tower surface condition
Photo File 48

Tower surface condition
Photo File 49

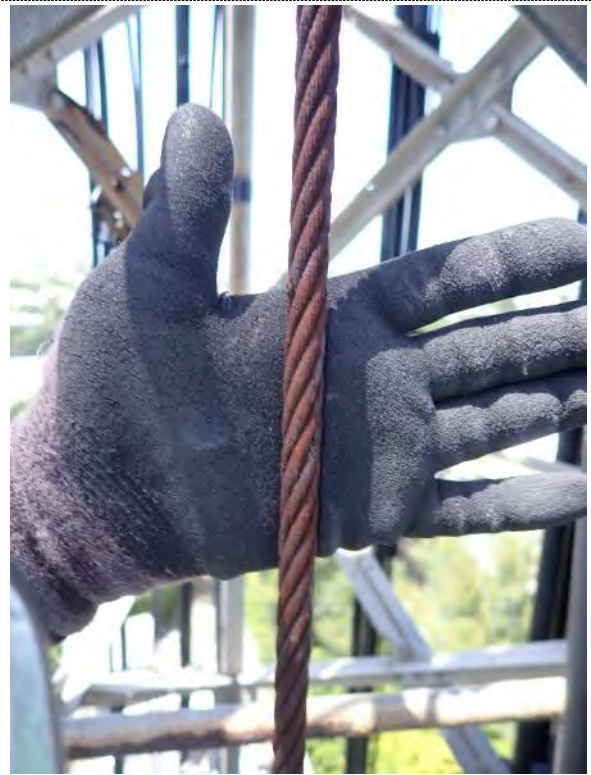
Elevation	Location	Description	Recommendation	Priority
Throughout height	Climbing face	Category 3 rust is present on the safety cable and associated components.	It is recommended the safety cable system and associated components be replaced.	To be scheduled

Safety cable condition
Photo File 62

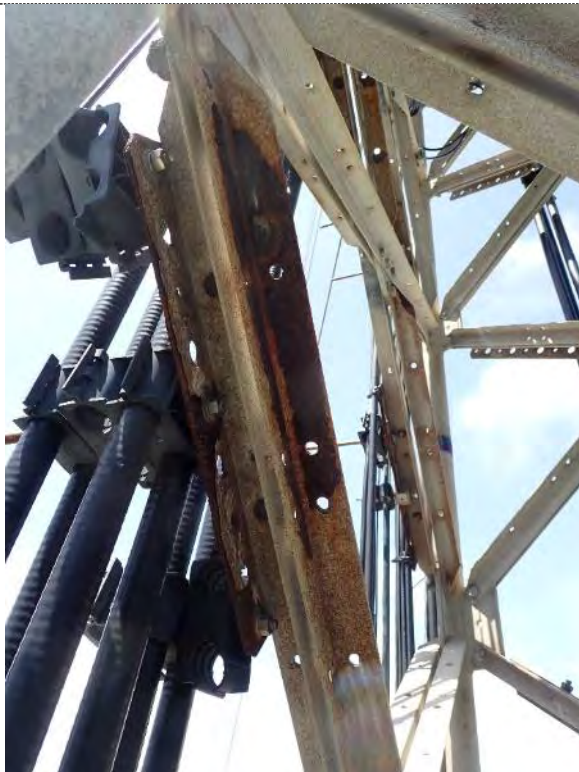
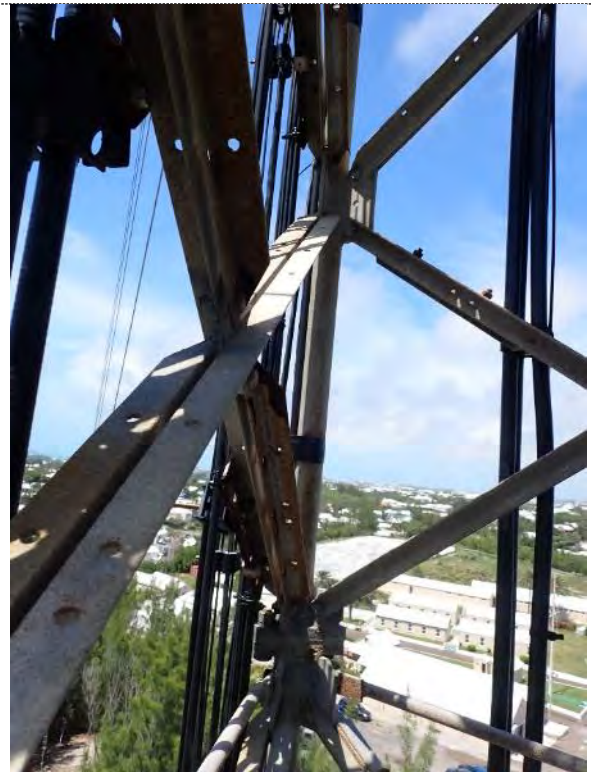
Tower surface condition
Photo File 63

Tower surface condition
Photo File 64

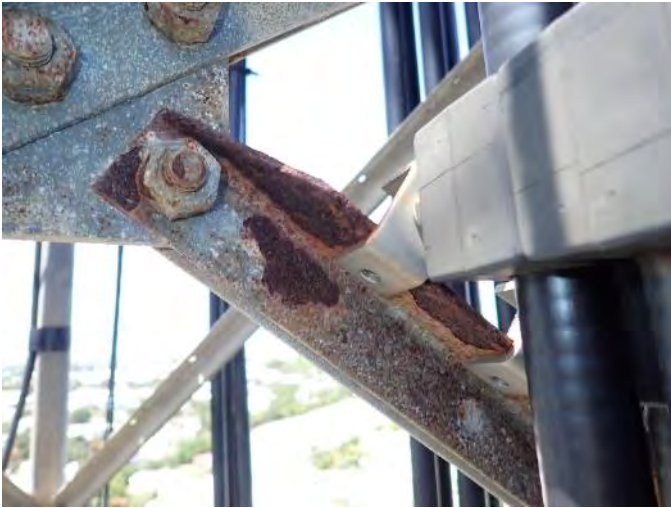
Tower surface condition
Photo File 71

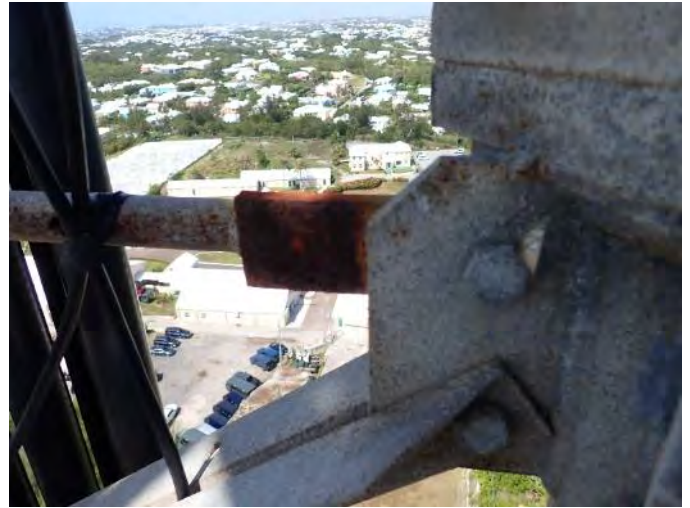
Tower surface condition
Photo File 134

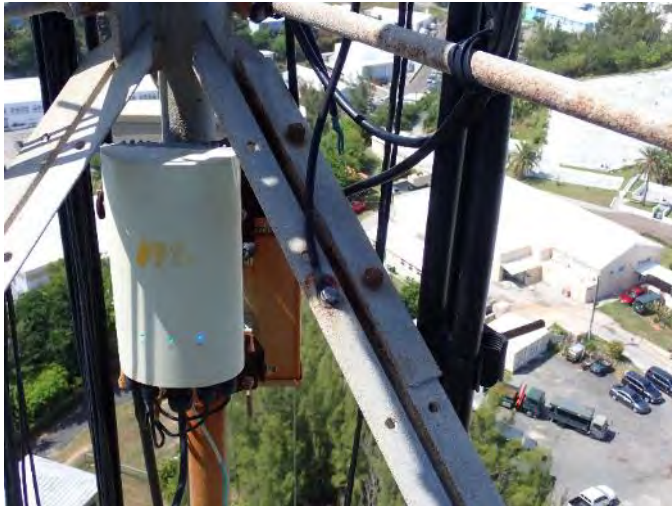
Tower surface condition
Photo File 135

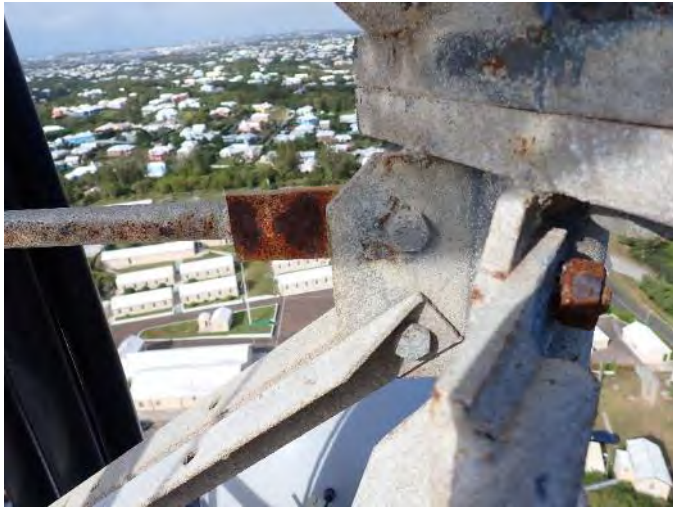
Tower surface condition
Photo File 217

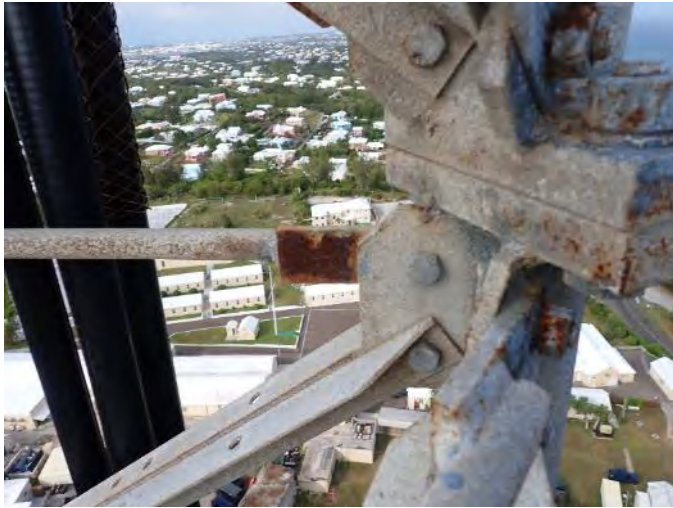
Tower surface condition
Photo File 225

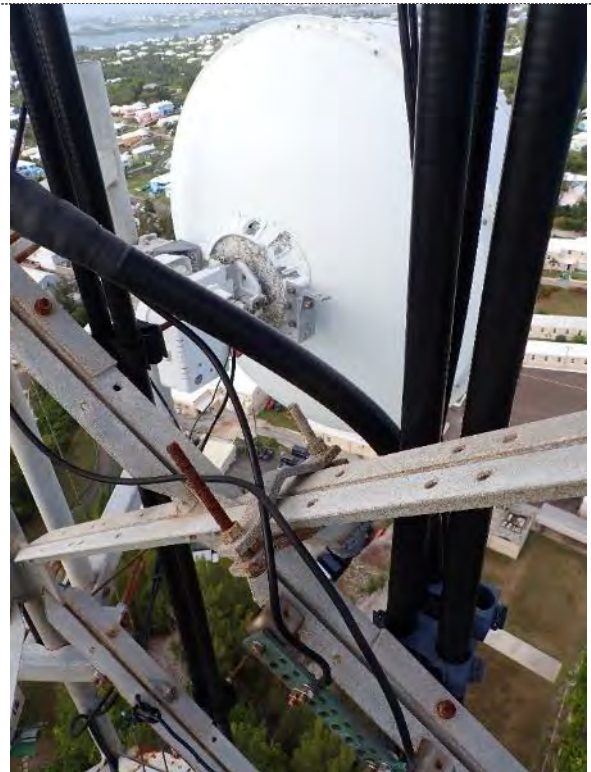
Stiff arm attached to tower diagonal
Photo File 228

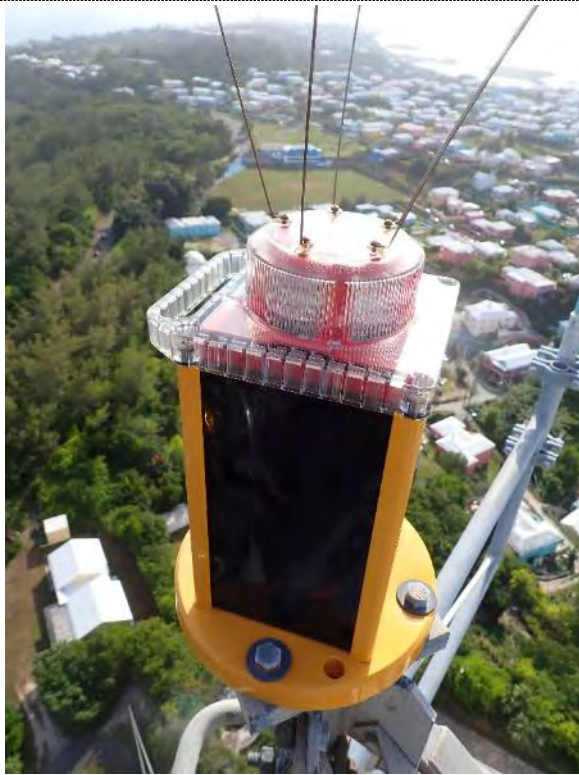
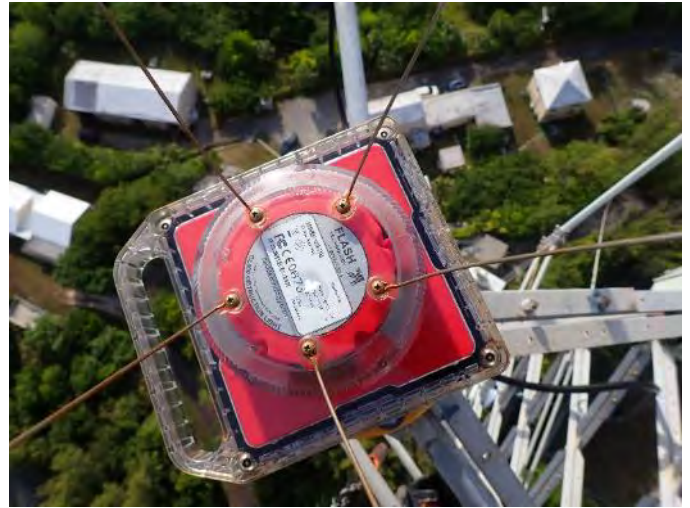
Operation beacon
Photo File 261

Operational beacon
Photo File 262

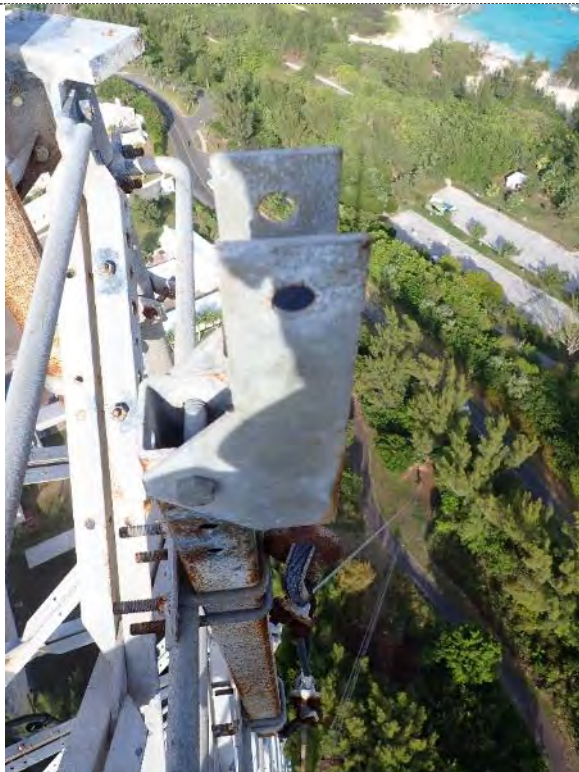
Top safety cable bracket
Photo File 263

Top safety cable bracket
Photo File 264

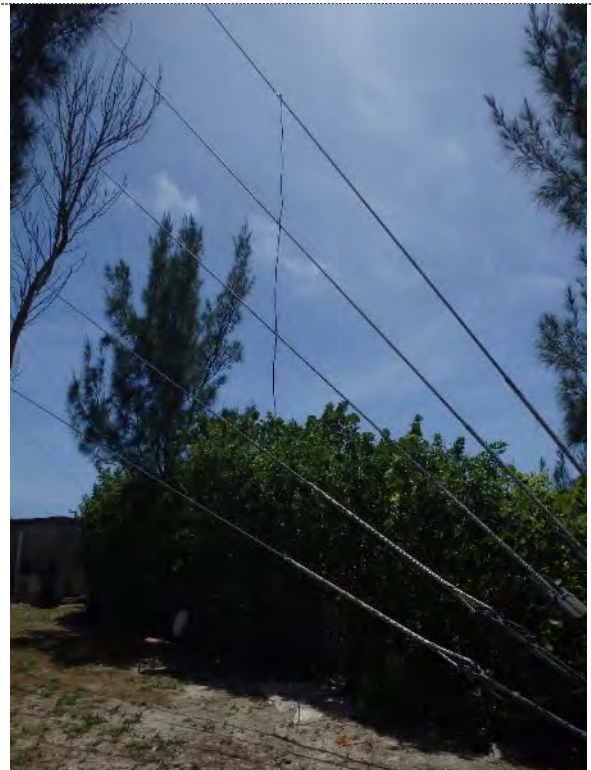
Anchor A grounding
Photo File 272

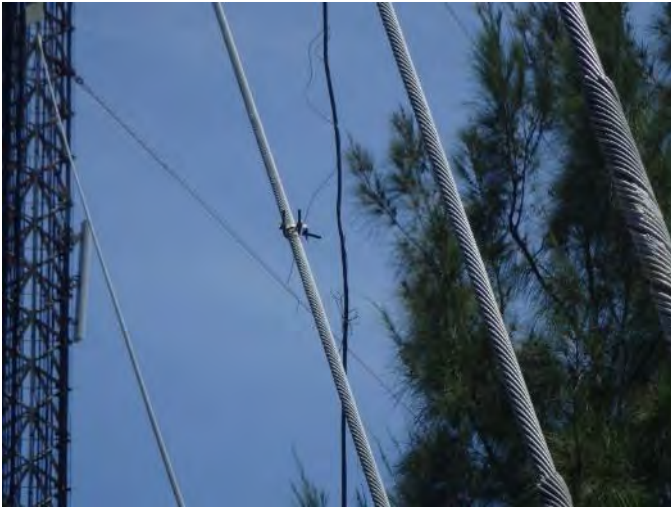
A 3 disconnected ground wire
Photo File 285

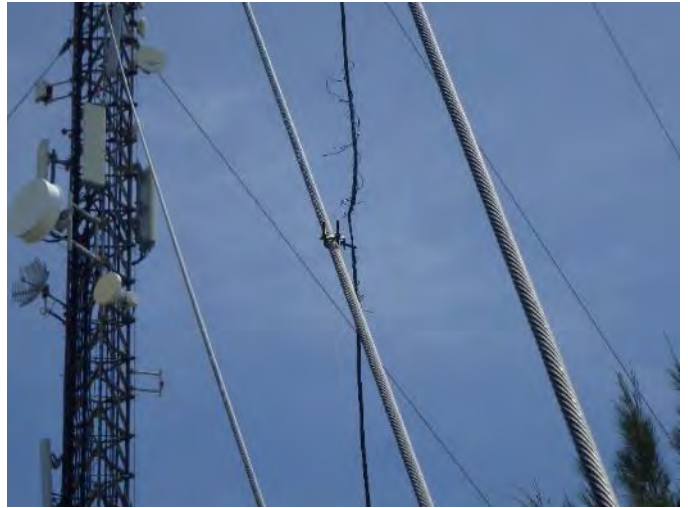
A 4 disconnected ground wire
Photo File 286

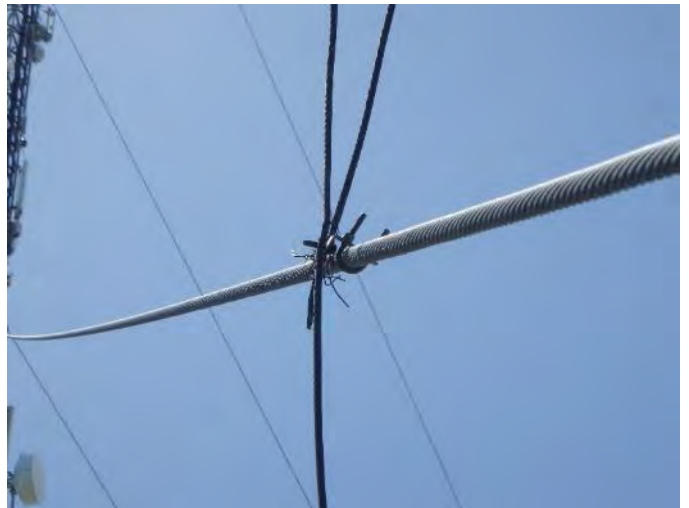
B 5 disconnected ground
Photo File 300

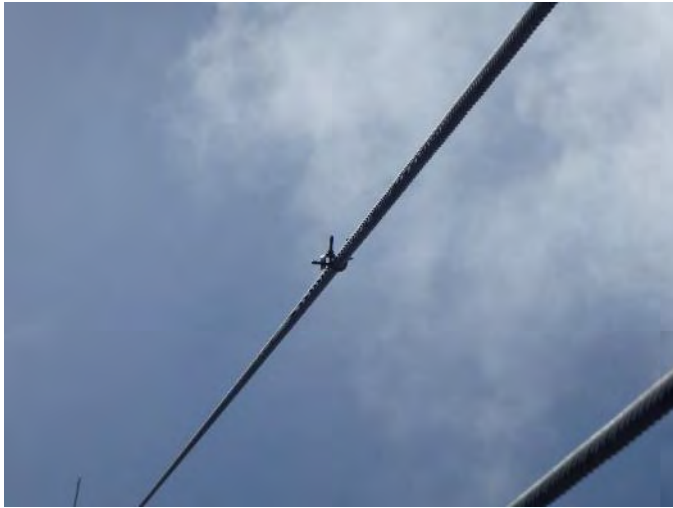
B 5 disconnected ground
Photo File 301

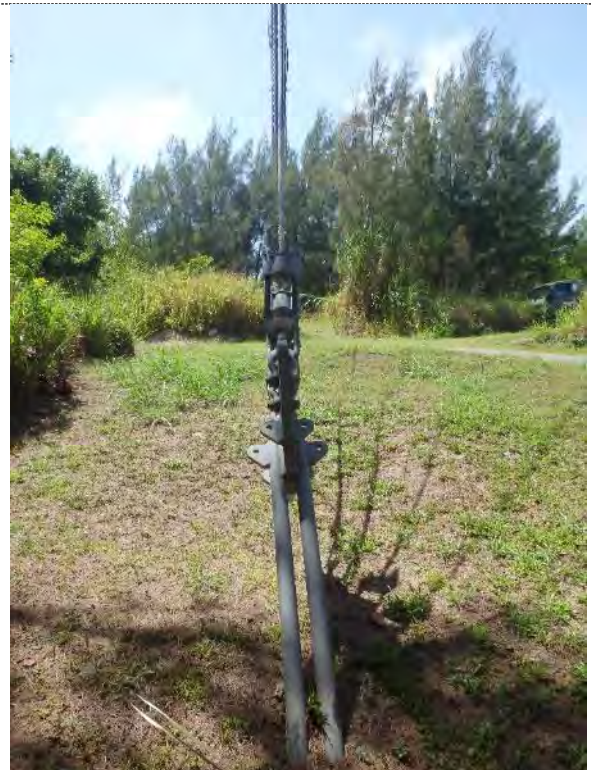
Anchor B fan plate out of alignment
Photo File 312

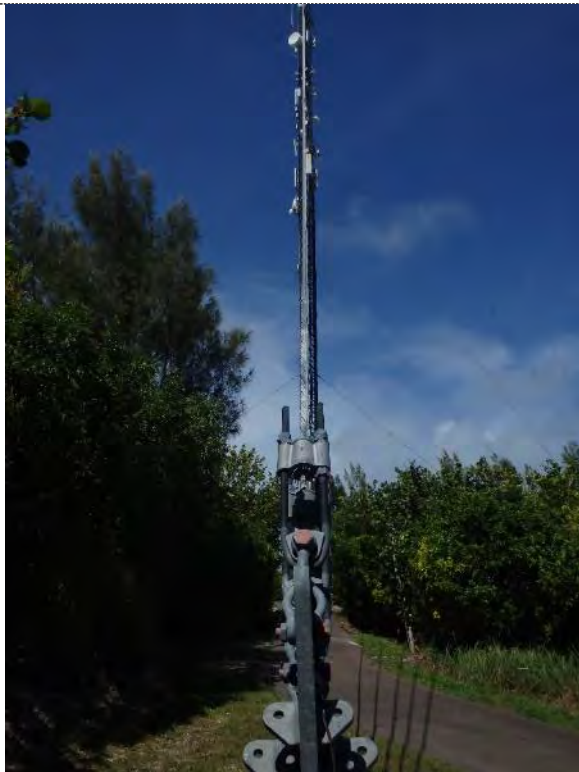
Anchor C fan plate out of alignment
Photo File 327
