# Heritage Wharf & Kings Wharf: Cruise Ship Docking Facilities Improvements

Cathodic Protection Performance Specification

March 2013

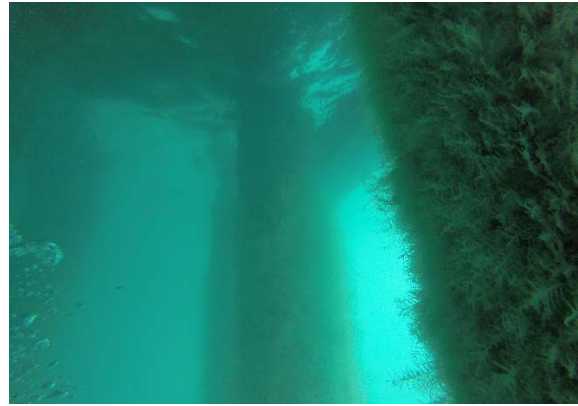
Fig. 1k Cluster 1 composed of 6 piles

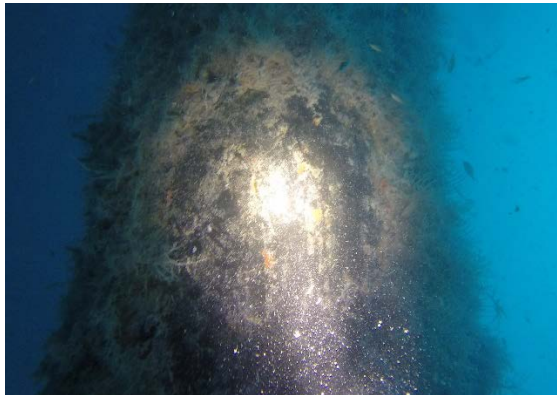
Fig. 1l 1<sup>st</sup> Level 2 inspection, Pile 45, protective coating intact

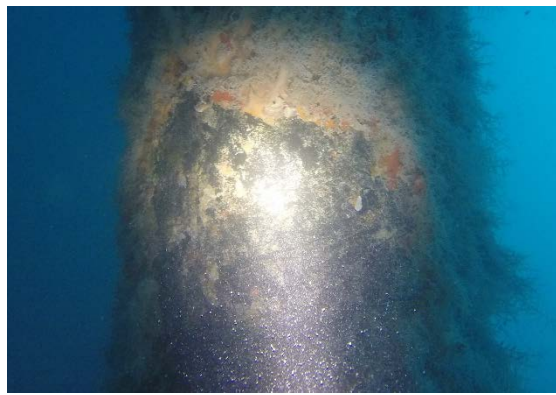
Fig. 1m 2<sup>nd</sup> Level 2 inspection, Pile 45, protective coating intact

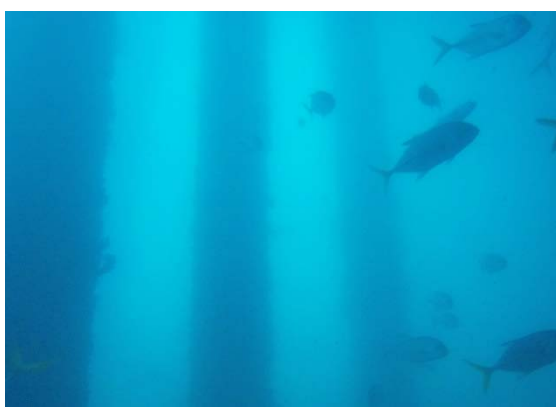
Fig. 1o General view of three of the piles from Cluster 2

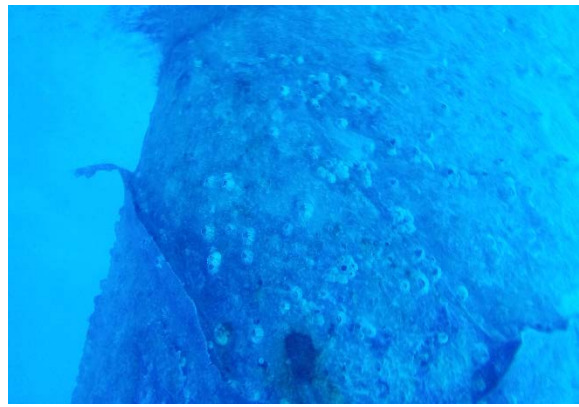
Fig. 1s - Protective coating peeled away just below surface

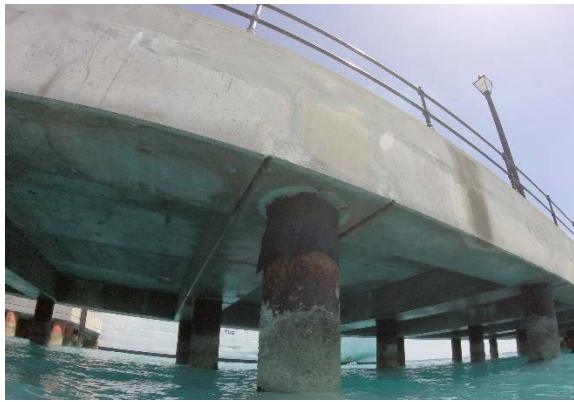
Fig. 2e – General view of Gangway splash zone

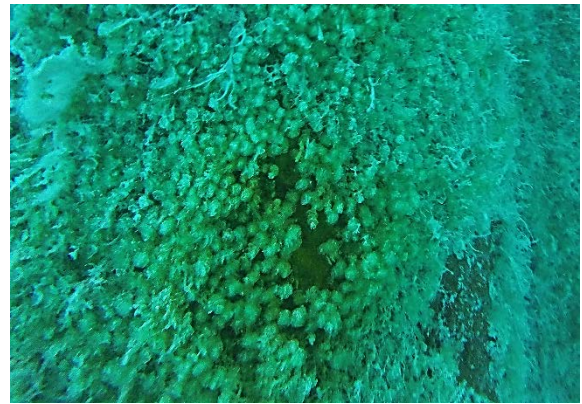
Fig. 2h - ALWC on metal sheet pile of North Arm

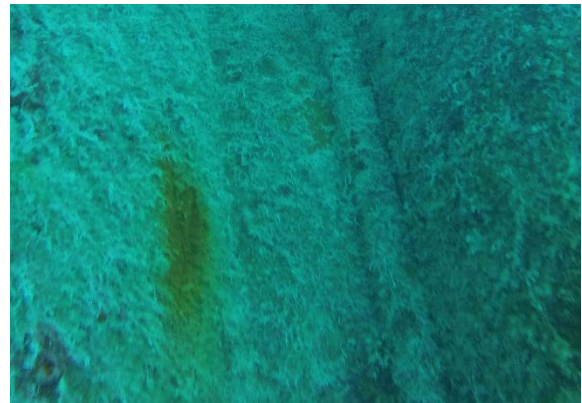
Fig. 2j - ALWC on metal sheet pile

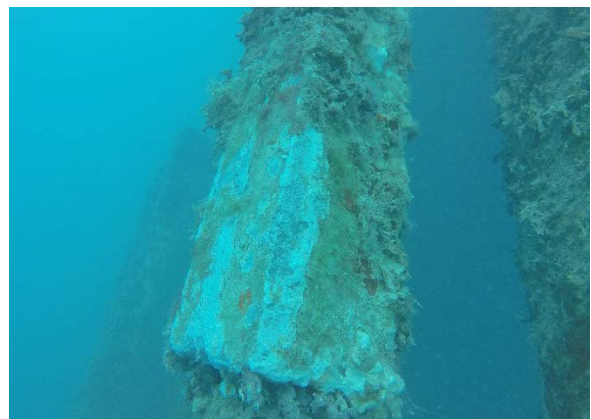
Fig. 3d - Level 2 inspection on anode, H-MD6

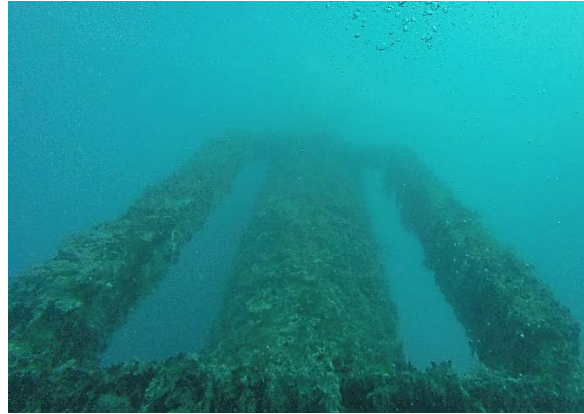
Fig. 3h - Anode on walkway dolphin

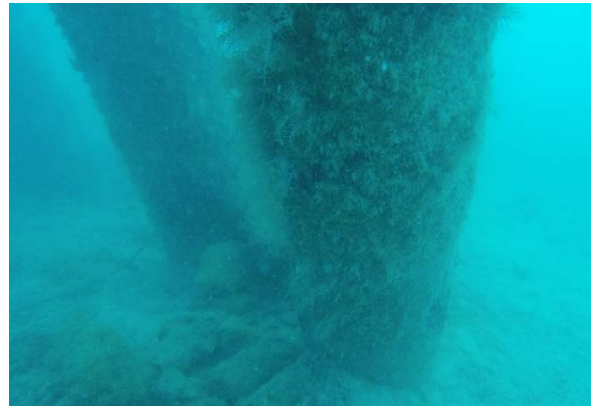
Fig. 3n Piles driven into sandy bottom, H-MD3

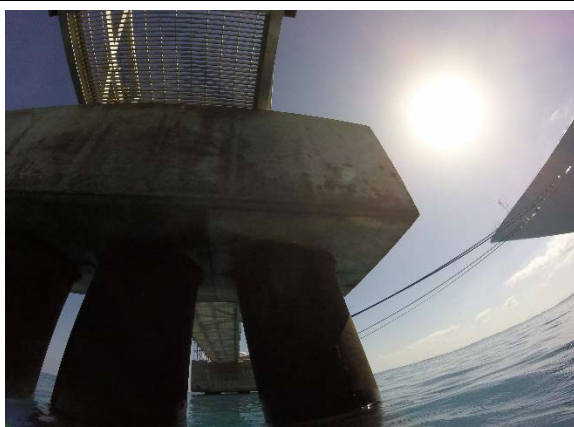
Fig. 3o General view of walkway dolphin

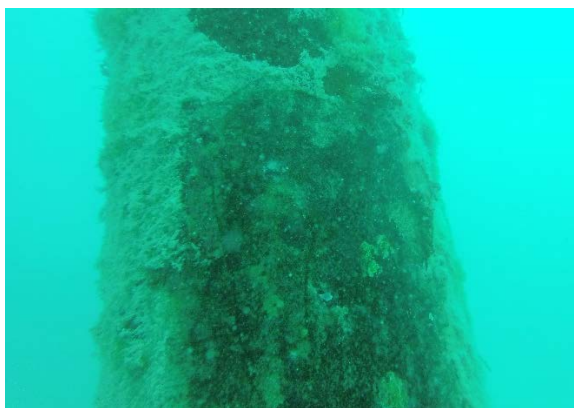
Fig. 3q - 1<sup>st</sup> Level 2 inspection, walkway dolphin

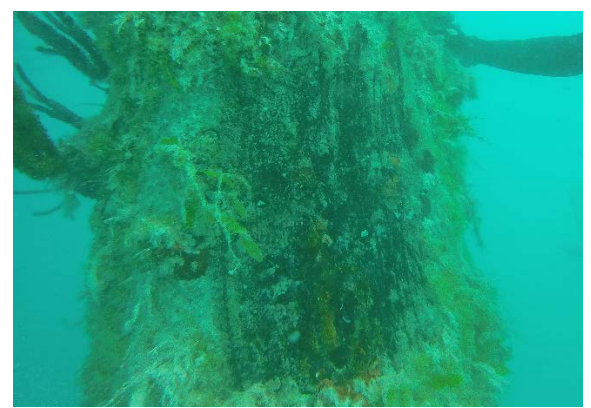
Fig. 3r - 2<sup>nd</sup> Level 2 inspection, walkway dolphin

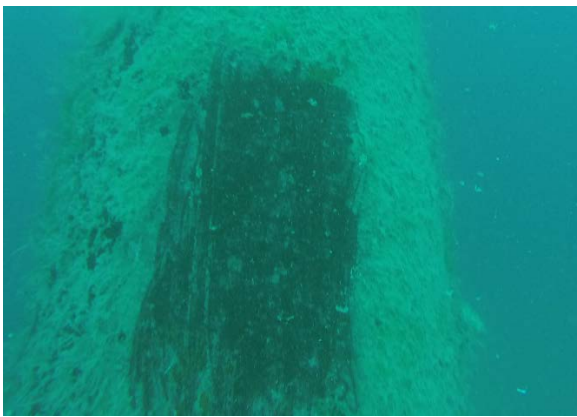
<ul style="list-style-type: none"><li>• Cathodic protection appears to be working effectively</li></ul>	
3t-3w	New Breasting Dolphins	H-BD3 & H-BD4	<ul style="list-style-type: none"><li>• Very good condition overall, compared to original structure.</li><li>• Very limited levels of corrosion observed on pile surface</li><li>• Red surface coating on piles still in good condition</li><li>• Cathodic protection appears to be working effectively</li></ul>	3

Fig. 3u - Level 2 inspection, H-BD3

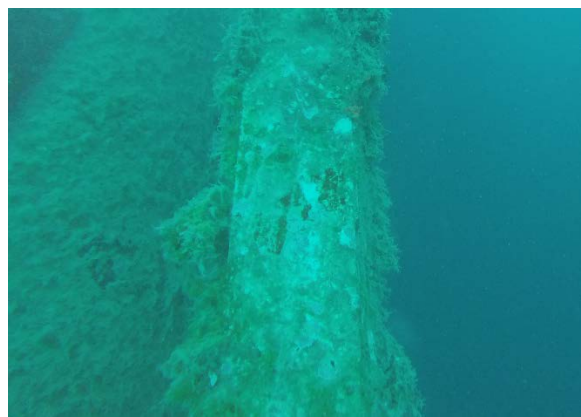
Fig. 3v - Level 2 inspection on anode, H-BD3
