Site Name: Warwick Tower
Structure Type: Guyed Tower
Structure Height: 250'
Make: Valmont
ASR: KD48X180
Tower Owner: Government of Bermuda
Address: Middle Road
Parish: Warwick
Latitude: 32.256385
Longitude: -64.833335
Date of Visit: 7/13/2022
Employees on Site: Angie Shyrigh
Ben Shyrigh

Proventus Structural Services, LLC

Purpose of this Site Visit

To fulfill the inspection requirements set forth in the TIA/EIA222-H, Annex J.1 standard for Maintenance and Condition Assessment of communication structures.

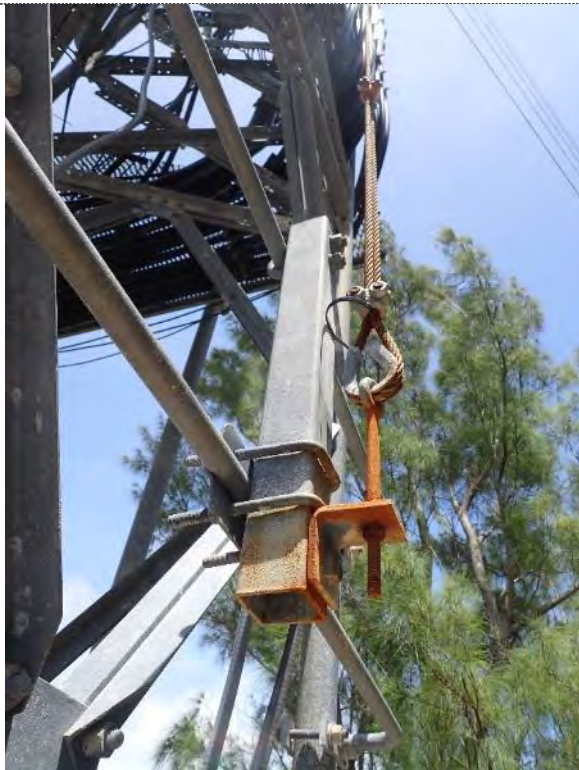
Safety cable bracket
Photo File 23

50' - 250'	Varies	Category 3 rust is present on the tower connection bolt assemblies.	It is recommended these bolt assemblies be replaced within 12 months.	To be scheduled
Throughout height	BC Face	The safety cable keepers are degraded beyond functionality, and as a result the safety cable has rubbed the surface of the tower horizontals and worn away the galvanizing.	It is recommended the safety cable be secured and prevented from rubbing the tower.	To be scheduled
125', 249'	Varies	Multiple deficiencies were observed with the old lighting system: <ul style="list-style-type: none"> Advanced, pitting category 3 rust is present on the lighting conduit, junction boxes and hardware securing it to the tower The side light conduit is taped yet broken resulting in the wiring being exposed The side light conduit is not secured to the tower and is instead resting on the diagonals The side light fixtures are upside down The B leg side light lens is broken The C leg lens is entirely missing The old beacon lens is entirely missing	Remove the old lighting system and associated components entirely. Dispose of off-site.	To be scheduled

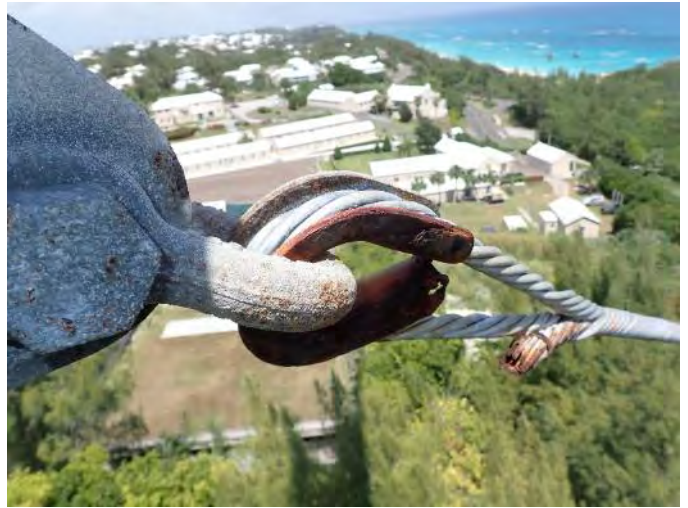
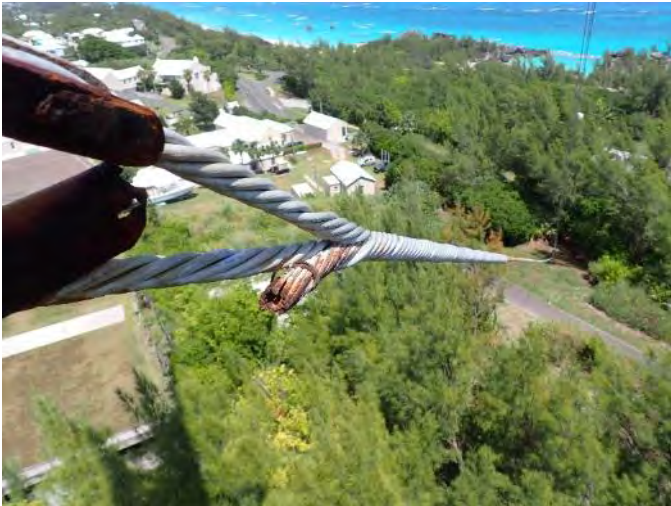
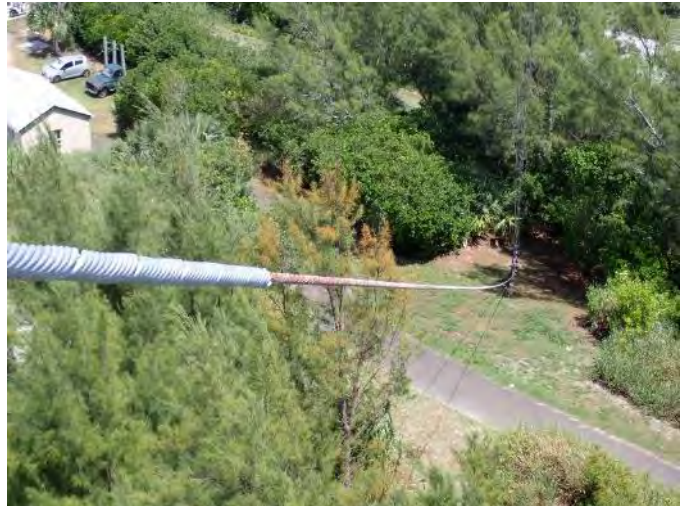
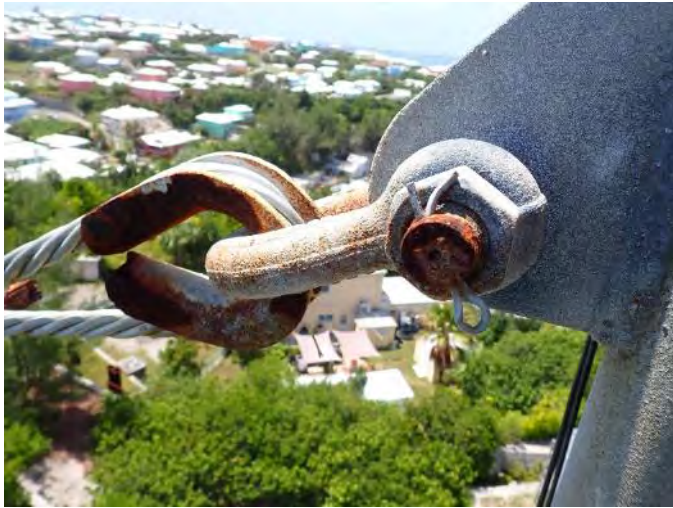
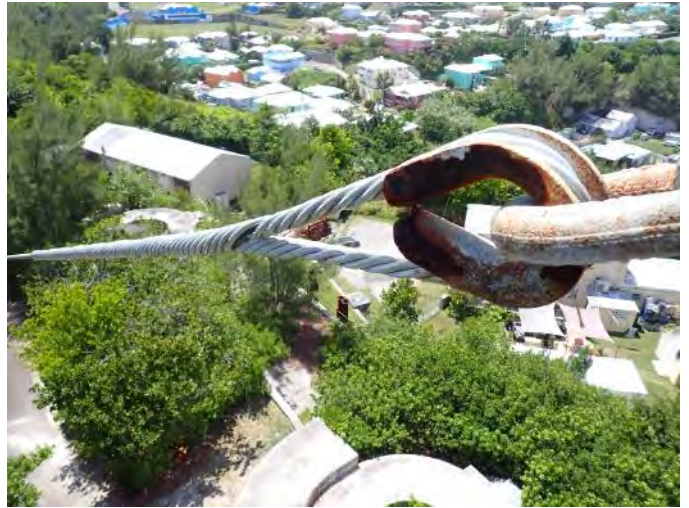
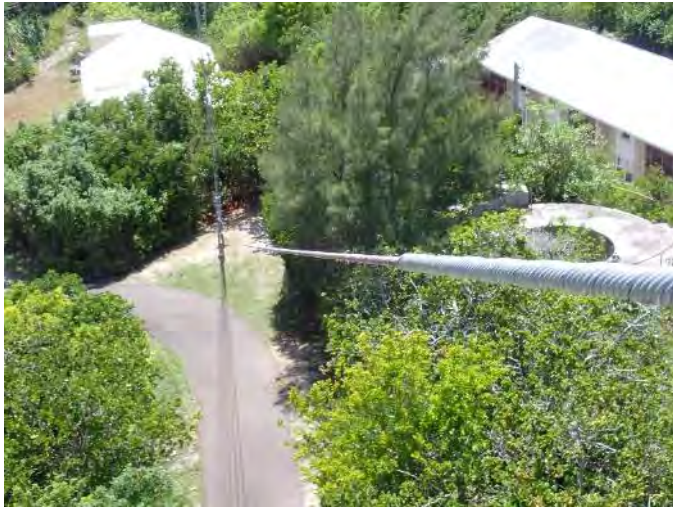
58' guy attachment
Photo File 50

Elevation	Location	Description	Recommendation	Priority
Throughout height	Varies	At each guy attachment elevation, category 3 rust was observed on the thimbles and guy wire ends. At the thimbles, loss of material of occurring. Category 2 rust was observed on the shackles and guy wires.	Replace the thimbles, treat the shackles and pins with zinc rich compound. Monitor the condition of the guy wires and replace prior to rust advancing to pitting stage.	To be scheduled
Throughout height	Varies	Category 1 to 2 rust is present on the guy wires, becoming more advanced in the upper portions of the tower.	Monitor the condition and replace the guy wires prior to advancement to category 3 rust/loss of material.	Monitor
Ground	Varies	At each guy anchor, category 1 to 2 rust was observed on the guy attachment hardware. Isolated regions of category 3 rust were observed, but loss of material was not detected at the time of this inspection.	It is recommended the affected regions be brushed and treated with zinc rich compound and monitored for advancement.	To be scheduled

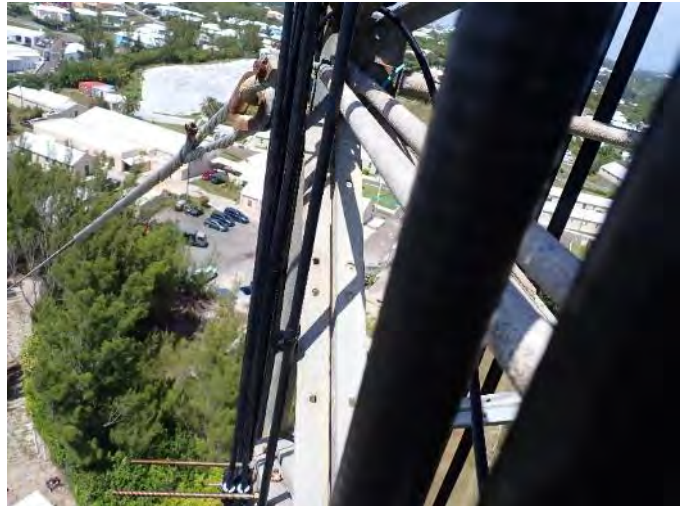
88' guy attachment
Photo File 80

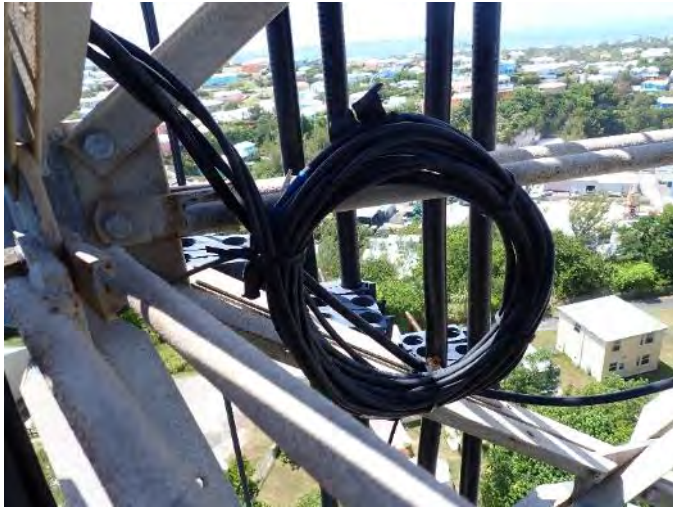
Abandoned feedlines
Photo File 81

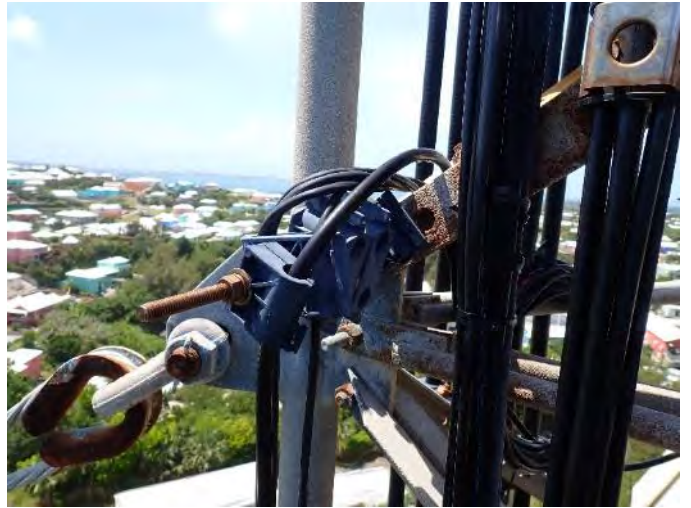
Abandoned feedlines
Photo File 82

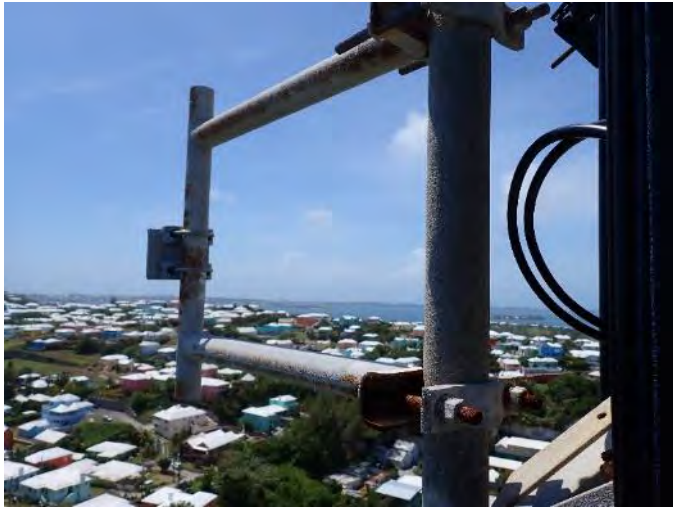
Mount remnant #9
Photo File 89

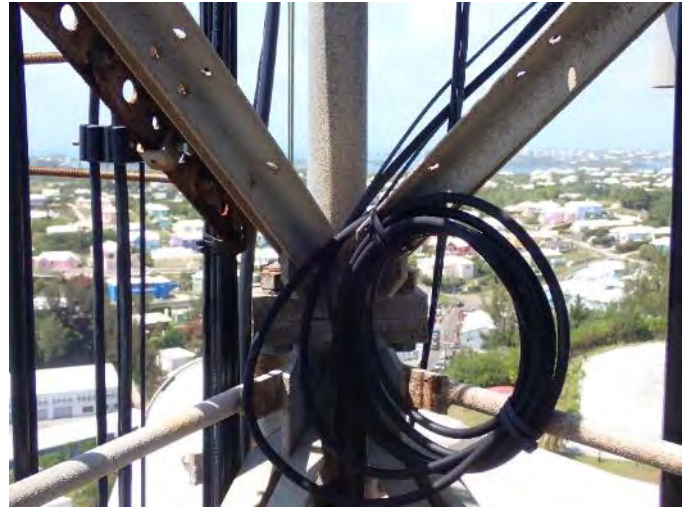
Dead feedlines
Photo File 94

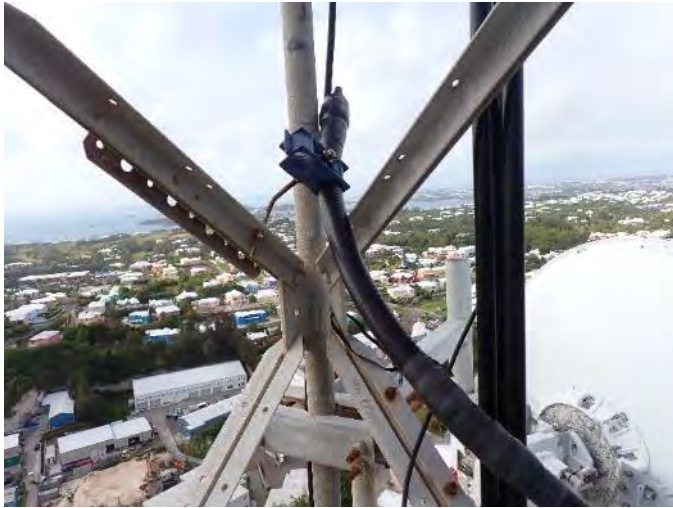
Elevation	Location	Description	Recommendation	Priority
Varies	Varies	Numerous out of service and abandoned pieces of tower mounted equipment were observed.	It is recommended out of service or otherwise abandoned equipment be completely removed from the structure to reduce the resources required to maintain safe connection to the structure as well as to maintain accurate loading records.	To be scheduled
Varies	Varies	The stiff-arm associated with each antenna #16, #62 and #87 is connected to a tower bracing member.	To prevent damage to the bracing member it is recommended the stiff-arm connections be relocated to tower legs.	To be scheduled
206'	C Leg	Electrical tape is currently being used to connect this antenna (#86) to its mount.	Replace the tape with hot dip galvanized brackets.	To be scheduled

Dead feedline
Photo File 229

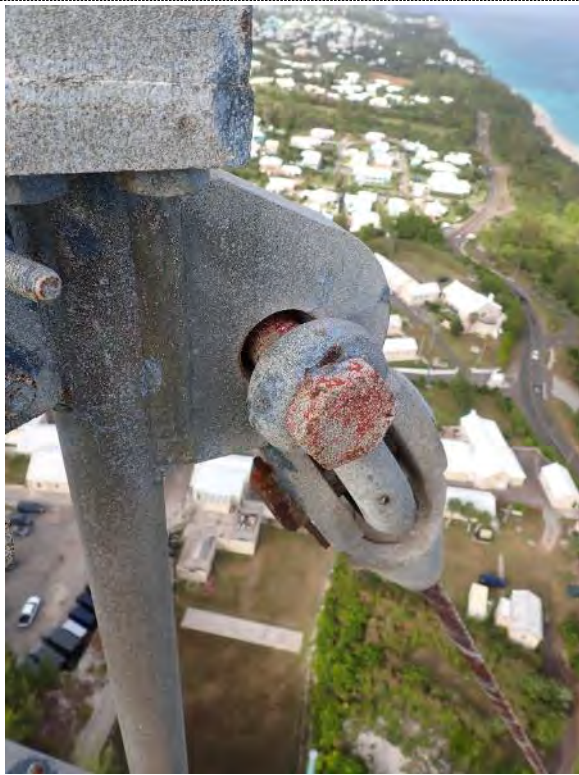
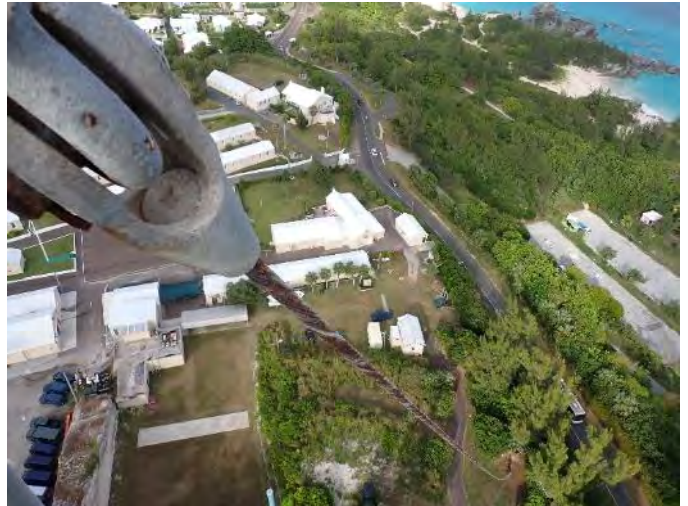
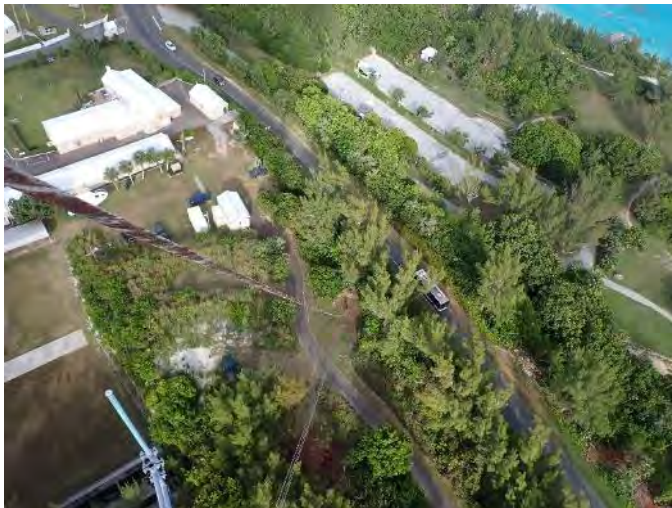
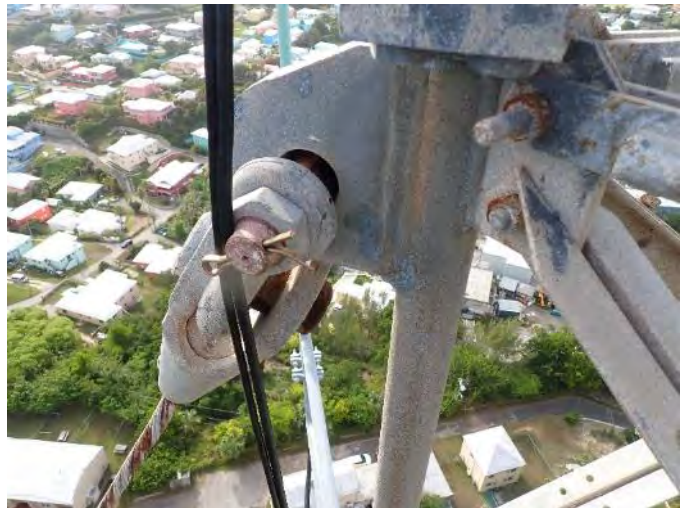
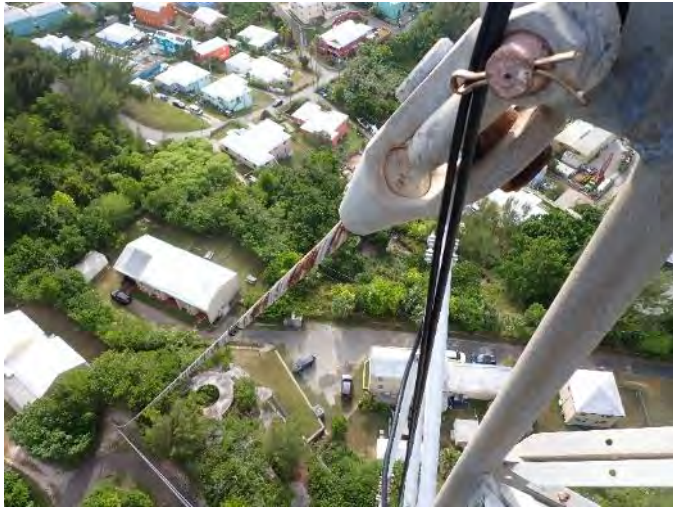
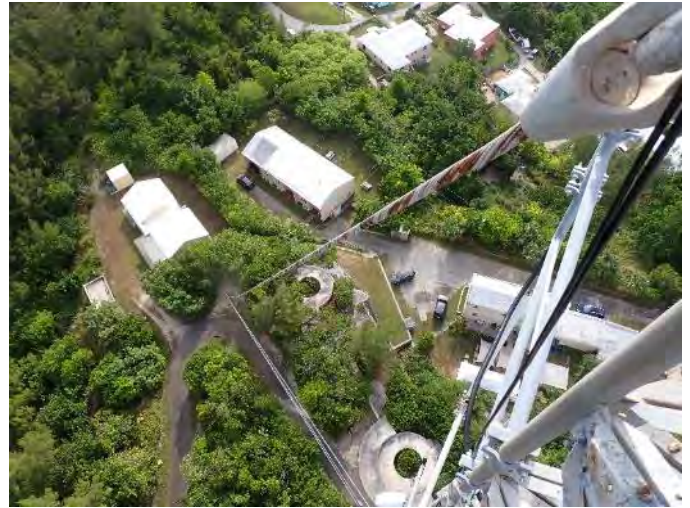
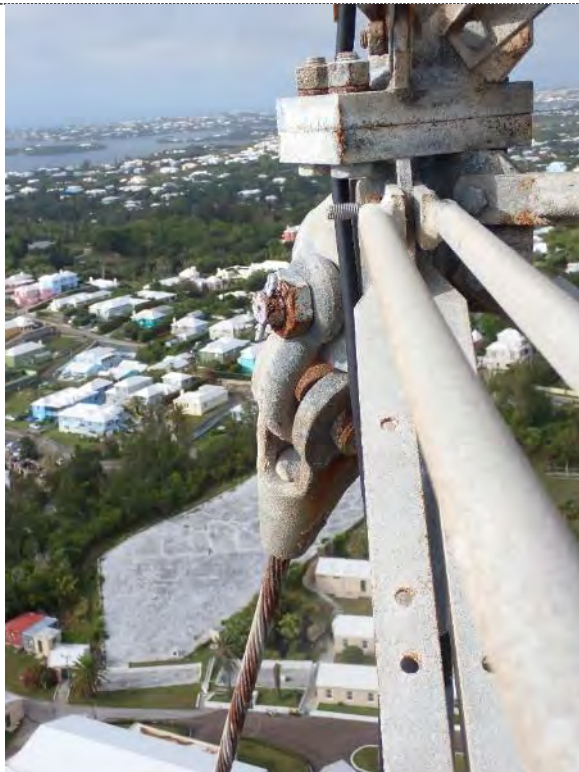
238' guy attachment
Photo File 241

238' guy attachment
Photo File 242

238' guy attachment
Photo File 243

238' guy attachment
Photo File 244

238' guy attachment
Photo File 245

238' guy attachment
Photo File 246

238' guy attachment
Photo File 247

238' guy attachment
Photo File 248

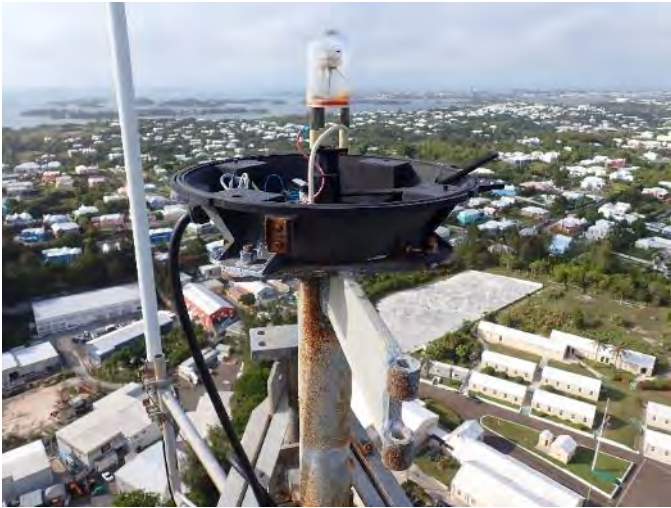
Elevation	Location	Description	Recommendation	Priority
125', 249'	Varies	<p>Multiple deficiencies were observed with the old lighting system:</p> <ul style="list-style-type: none"> • Advanced, pitting category 3 rust is present on the lighting conduit, junction boxes and hardware securing it to the tower • The side light conduit is taped yet broken resulting in the wiring being exposed • The side light conduit is not secured to the tower and is instead resting on the diagonals • The side light fixtures are upside down • The B leg side light lens is broken • The C leg lens is entirely missing • The old beacon lens is entirely missing 	Remove the old lighting system and associated components entirely. Dispose of off-site.	To be scheduled

Beacon remnant
Photo File 257

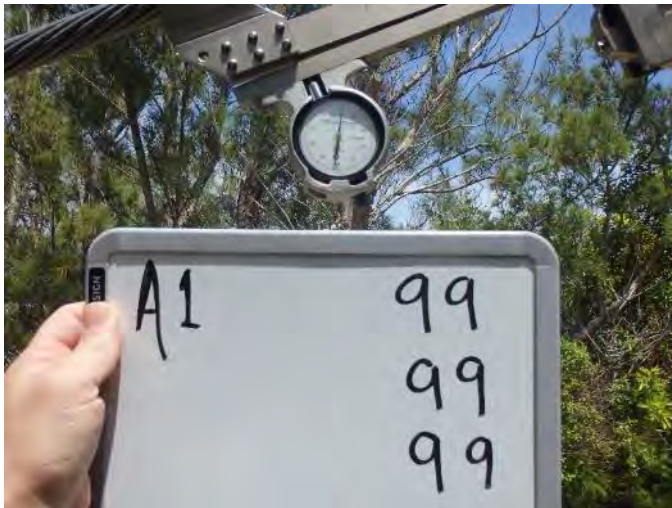
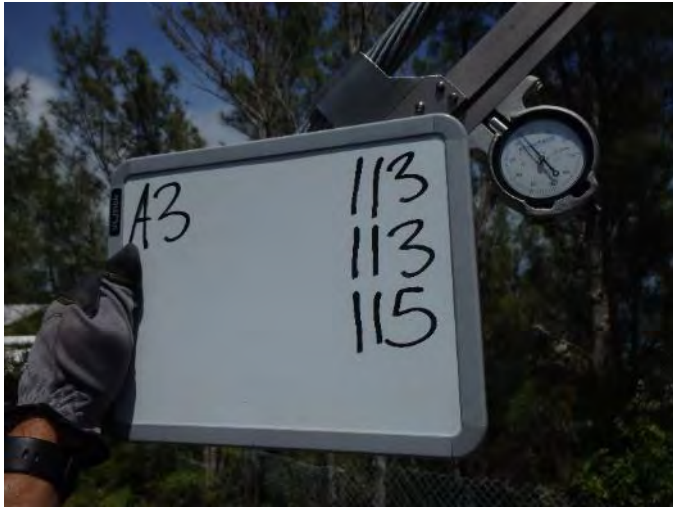
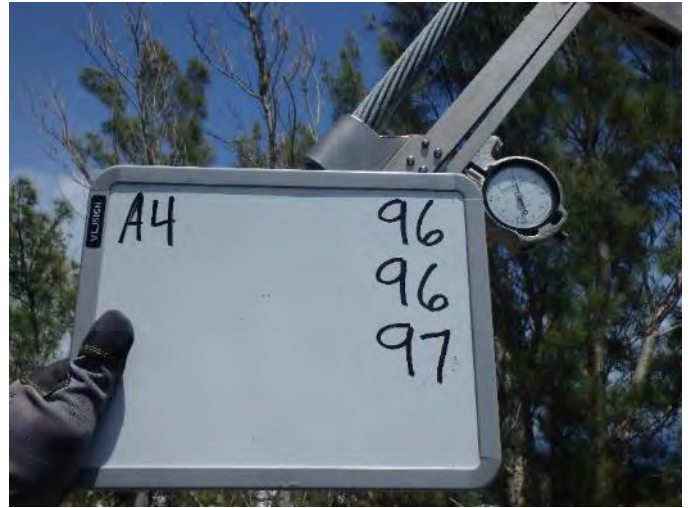
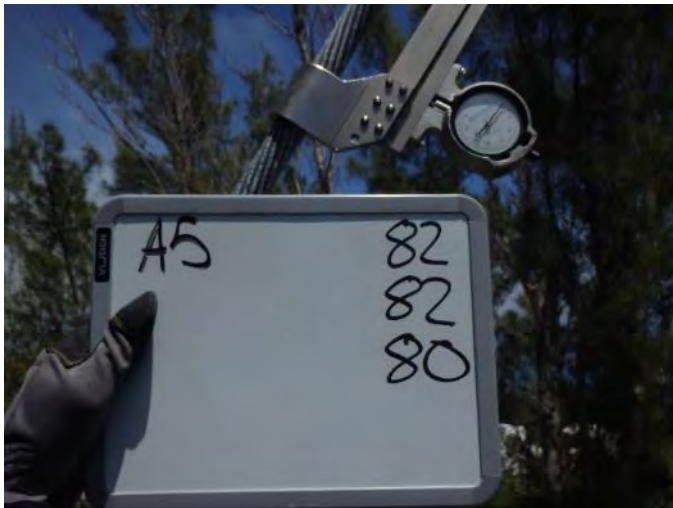
A 1 tensions
Photo File 279

The majority of the guy wire tensions are outside of the acceptable tension ranges. It is recommended that a tension service be performed within the next two years, and at regular 3 year intervals.
