# Heritage Wharf & Kings Wharf: Cruise Ship Docking Facilities Improvements

Cathodic Protection Performance Specification

March 2013

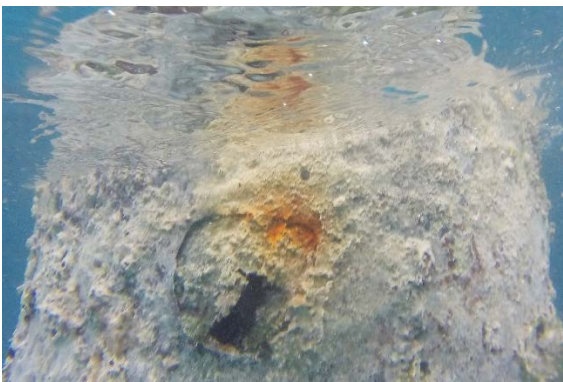
Fig. 1h - ALWC near high water mark

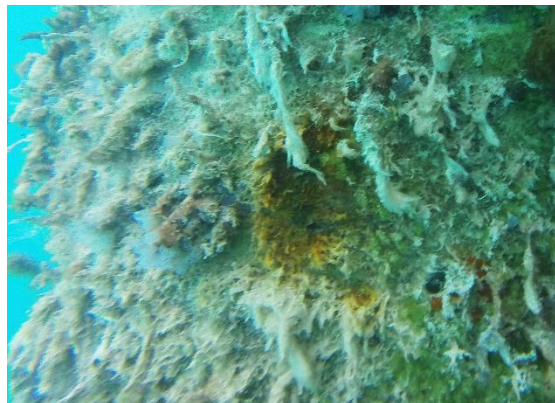
Fig. 1i - Typical example of ALWC on pile surface

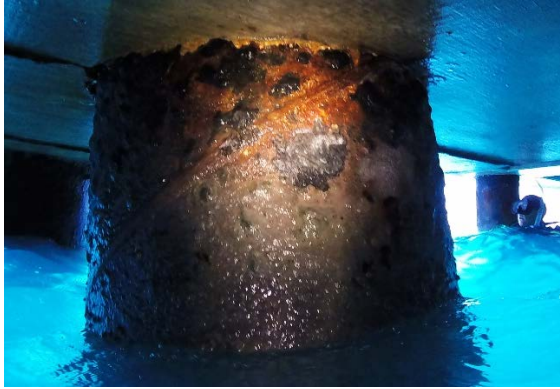
Fig. 1p Top of pile of Cluster 2

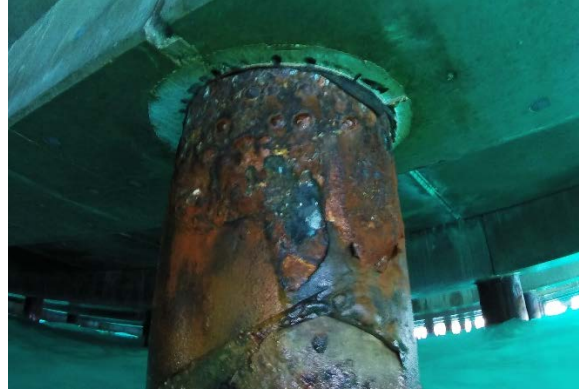
Fig. 1q Top of pile of Cluster 2

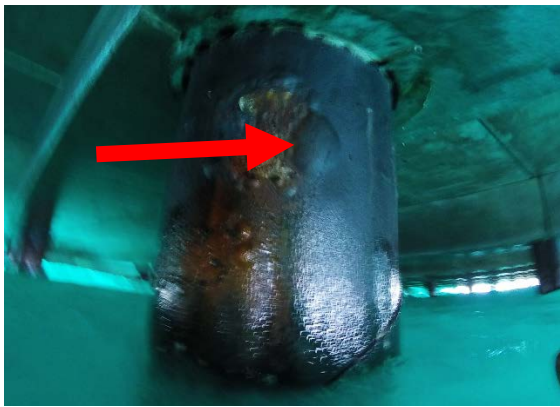
Fig. 1r – Blisters on protective coating in splash zone

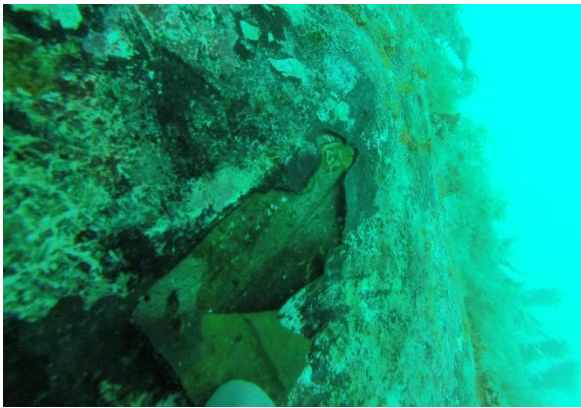
Fig. 2a Protective layer peeled away to show steel underneath, Pile 158

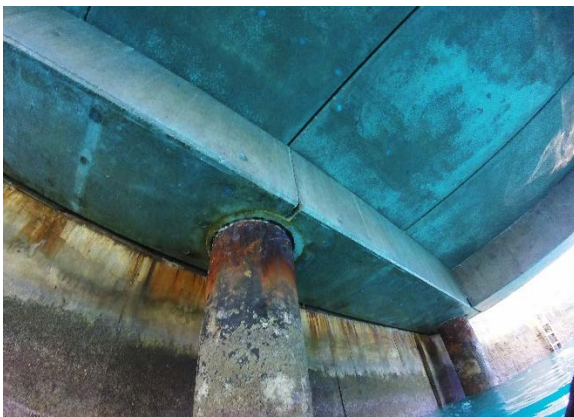
Fig. 2g – Pile 187, connection with concrete cap

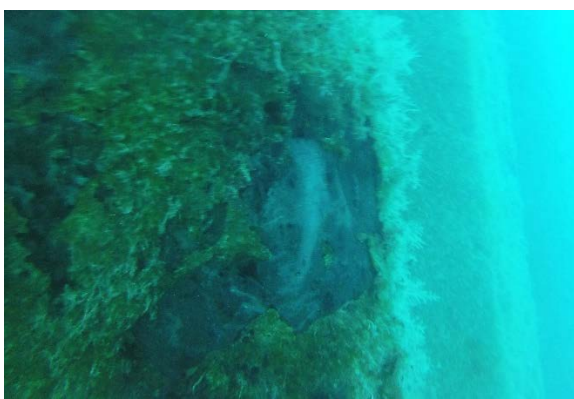
Fig. 2i - Level 2 inspection on sheet pile to probe ALWC depth

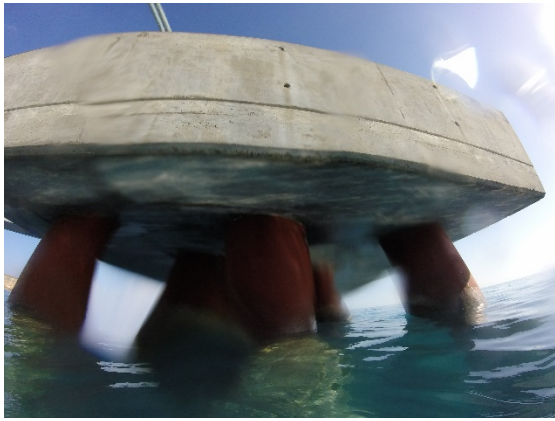
Fig. 3a General view of the, H-MD6

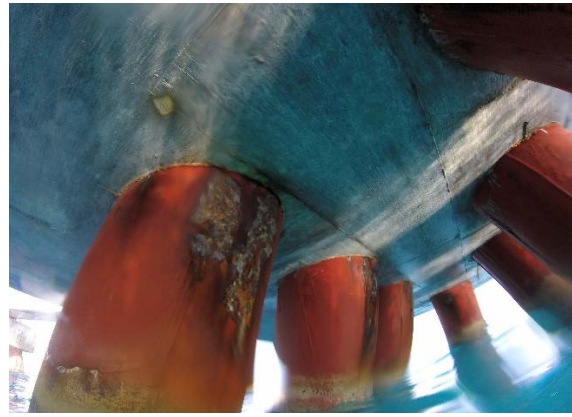
Fig. 3b - Underside of H-MD6

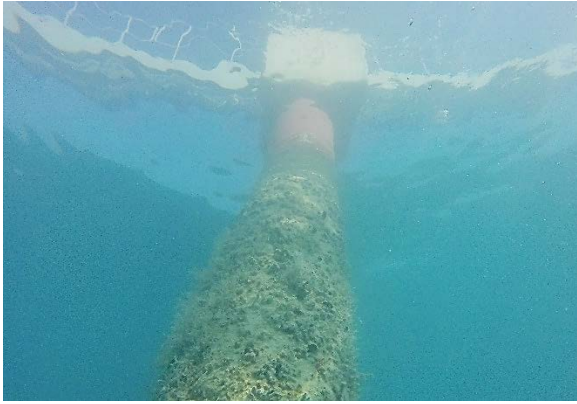
Fig. 3g - One of the three piles on walkway dolphin

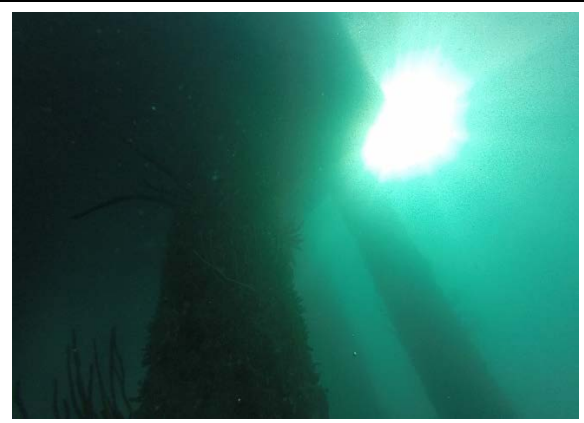
3j-3hh	Original Mooring Dolphins	H-MD1 to H-MD4	<ul style="list-style-type: none"> <li>• Same condition as Main Wharf and Gangway, similar number and severity of defects observed</li> </ul>	3
3s & 3x	Original Breasting Dolphins	H-BD1 to H-BD2	<ul style="list-style-type: none"> <li>• Same condition as Main Wharf and Gangway, similar number and severity of defects observed</li> </ul>	3
3a-3dd	New Mooring Dolphins	H-MD5 & H-MD6	<ul style="list-style-type: none"> <li>• Very good condition overall, compared to original structure.</li> <li>• Very limited levels of corrosion observed on pile surface</li> <li>• Red surface coating on piles still in good condition</li> </ul>	3

Fig. 3j - Piles under H-MD4

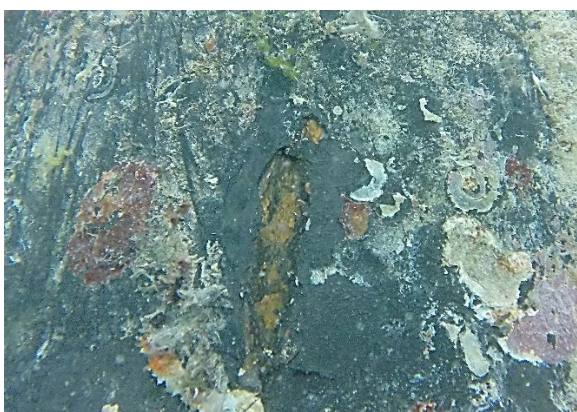
Fig. 3k - Steel exposed under protective layer, H-MD4

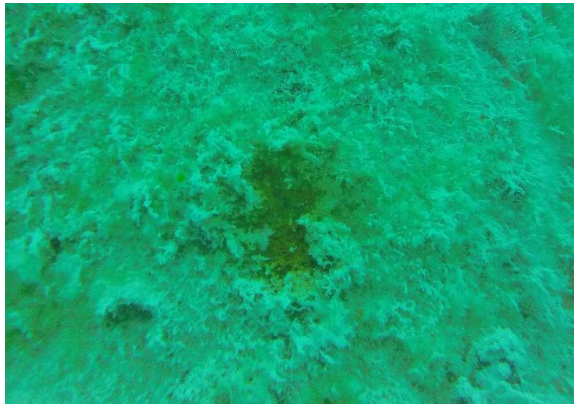
Fig. 3m - ALWC on H-MD3

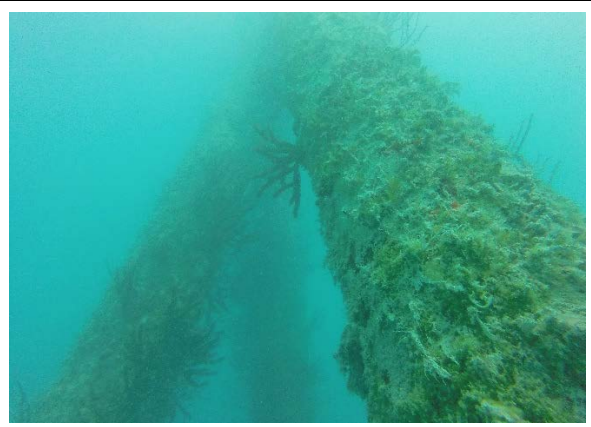
Fig. 3p General underwater view of original walkway dolphin piles

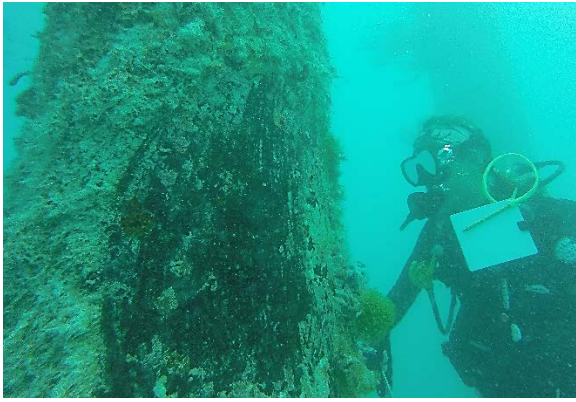
Fig. 3y - Level 2 inspection at middle of pile, H-MD2, protective coating intact

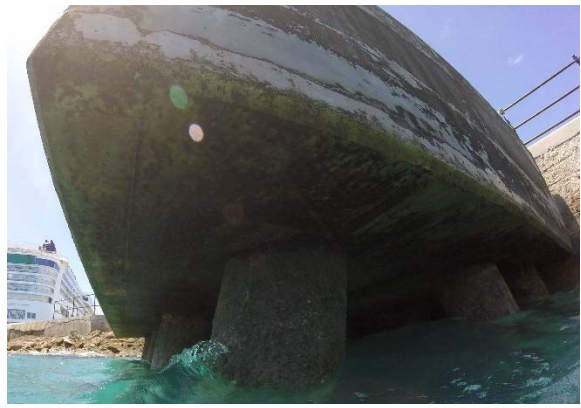
Fig. 3dd - Above water view of H-MD5
